**Airworthiness Directives; Eurocopter France Helicopters**

**ACTION:** Notice of proposed rulemaking (NPRM).

**Eurocopter France:** Docket No. FAA-2012-0631; Directorate Identifier 2011-SW-021-AD.

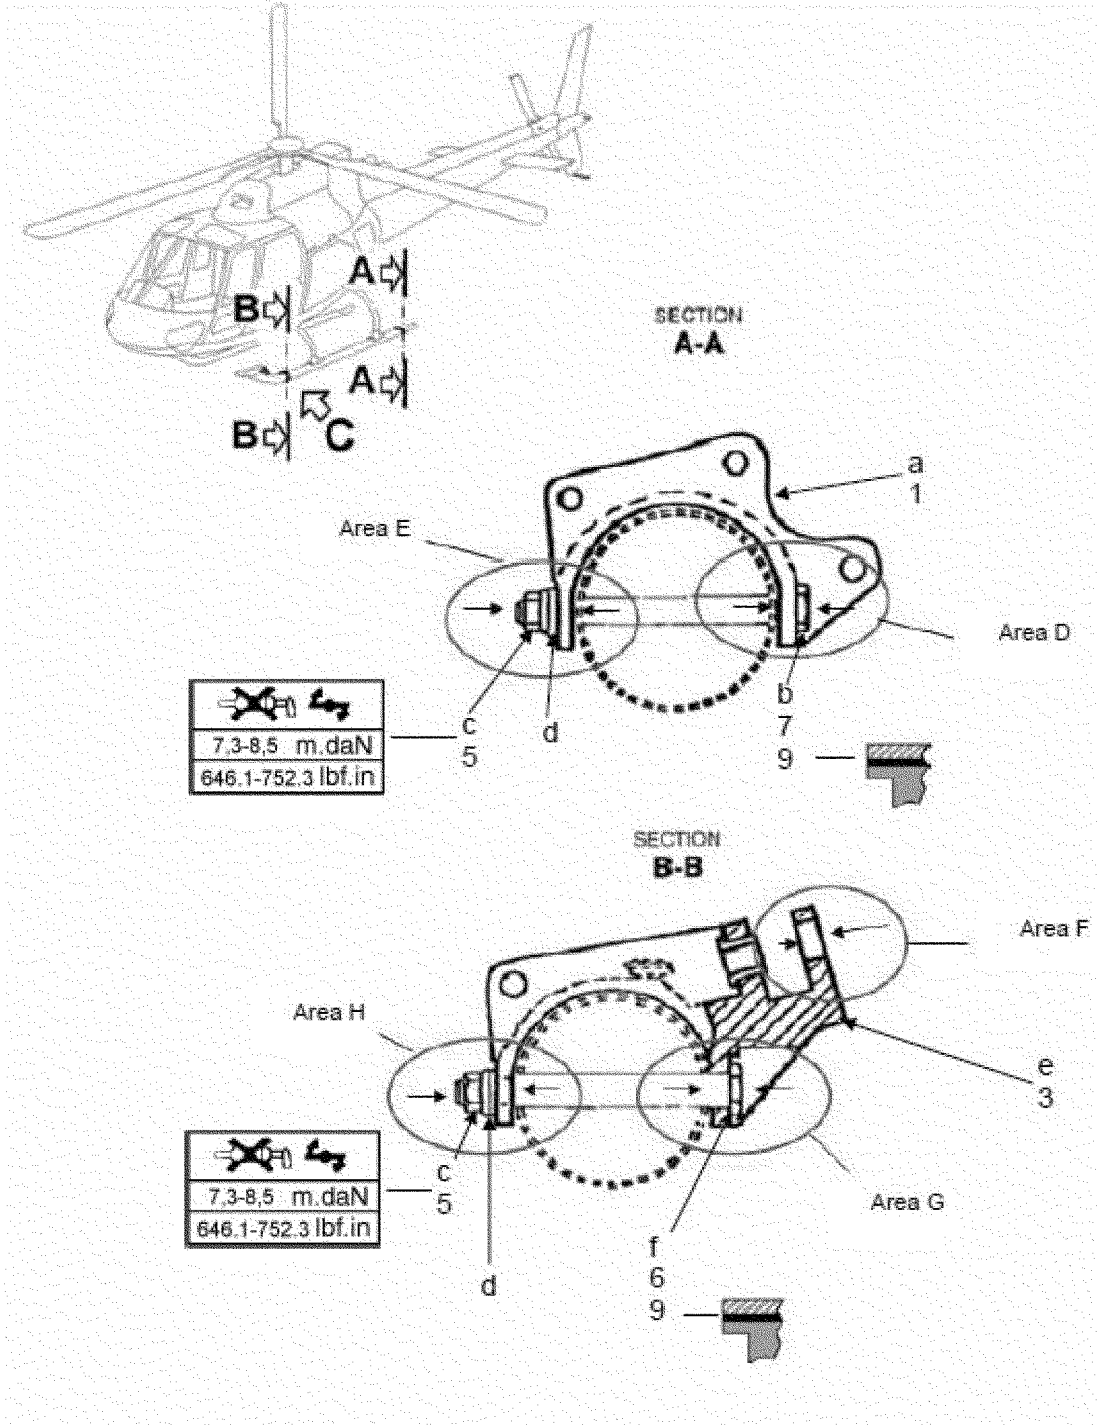
Figure 1. Emergency Flotation Gear Attachment Brackets

This AD defines the unsafe condition as a crack in an attachment bracket of the emergency flotation gear. This condition could result in failure of the emergency flotation system and loss of float stability in the event of a water landing.

- (1) Using a 5x or higher power magnifying glass, visually inspect the front emergency flotation gear attachment bracket (Figure 1 of this AD, section B-B, item (e)) in Areas F, G, and H; and the rear emergency flotation gear attachment bracket (Figure 1 of this AD, section A-A, item (a)) in Areas D and E for a crack.

(2) If there is a crack, replace the cracked emergency flotation gear attachment bracket with an airworthy emergency flotation gear attachment bracket prior to reinstallation of the emergency flotation equipment.
