Airworthiness Directives; Eurocopter France Helicopters

ACTION: Notice of proposed rulemaking (NPRM).

SUMMARY: We propose to adopt a new airworthiness directive (AD) for Eurocopter France Model AS350B, AS350BA, AS350B1, AS350B2, AS350B3, AS350C, AS350D, AS350D1, AS355E, AS355F, AS355F1, AS355F2, AS355N, and AS355NP helicopters with certain Aerazur emergency flotation gear attachment brackets (brackets) installed. This proposed AD would require an initial and recurring inspection of the brackets for a crack, and if there is a crack, replacing the cracked bracket with an airworthy bracket. This proposed AD is prompted by reports of cracks on the brackets. The proposed actions are intended to prevent failure of the emergency flotation system and loss of float stability in the event of a water landing.

Eurocopter France: Docket No. FAA-2012-0631; Directorate Identifier 2011-SW-021-AD.

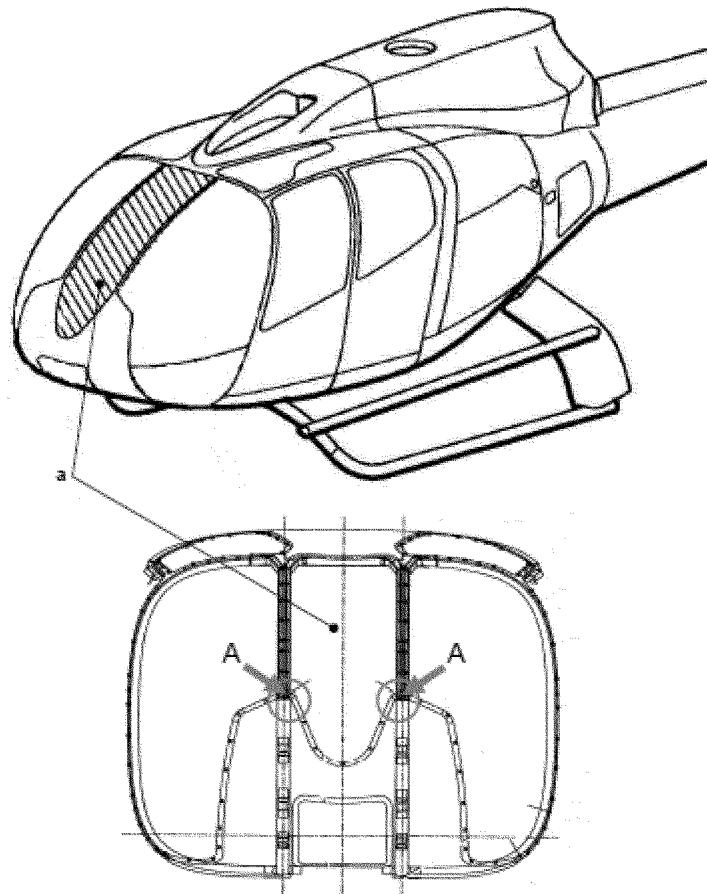
Figure 1

(2) If there is a crack or if a pilot indicates that the center windscreens distorted during flight, before further flight, replace the center windscreens with an airworthy center windscreens, P/N 350A25-9045-20, in accordance with the Accomplishment Instructions, paragraphs 2.B.2.b. through 2.B.2.b.4. of Eurocopter Service Bulletin No. 56-003, Revision 0, dated November 16, 2010.

(3) Within 12 months, replace the center windscreens with an airworthy center windscreens, P/N 350A25-9045-20, in accordance with the instructions contained in paragraph (d)(2) of this AD.

(4) Replacing the center windscreens with center windscreens, P/N 350A25-9045-20, constitutes terminating action for the requirements of this AD.

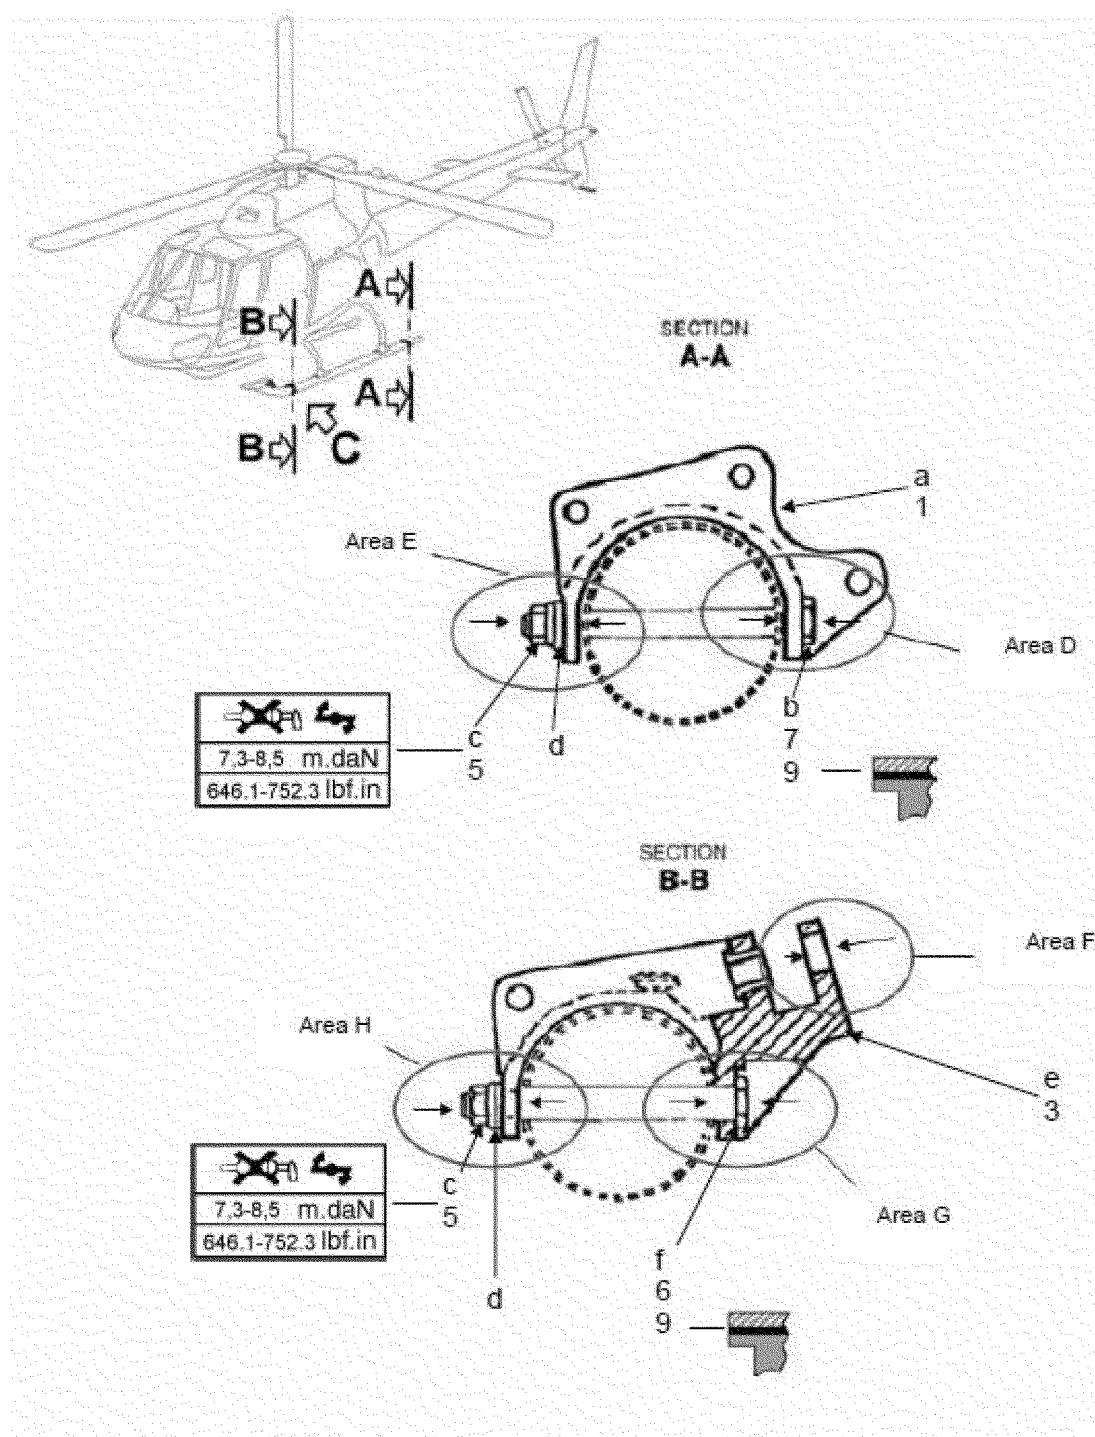
Figure 1. Emergency Flotation Gear Attachment Brackets

This AD defines the unsafe condition as a crack in an attachment bracket of the emergency flotation gear. This condition could result in failure of the emergency flotation system and loss of float stability in the event of a water landing.

- (1) Using a 5x or higher power magnifying glass, visually inspect the front emergency floatation gear attachment bracket (Figure 1 of this AD, section B-B, item (e)) in Areas F, G, and H; and the rear emergency floatation gear attachment bracket (Figure 1 of this AD, section A-A, item (a)) in Areas D and E for a crack.

(2) If there is a crack, replace the cracked emergency floatation gear attachment bracket with an airworthy emergency floatation gear attachment bracket prior to reinstallation of the emergency floatation equipment.
