[Docket No. FAA-2012-0739; Directorate Identifier 2012-SW-044-AD; Amendment 39-17125; AD 2012-14-11]

Airworthiness Directives; Various Restricted Category Helicopters

2012-14-11 Various Restricted Category Helicopters: Amendment 39-17125; Docket No. FAA-2012-0739; Directorate Identifier 2012-SW-044-AD.

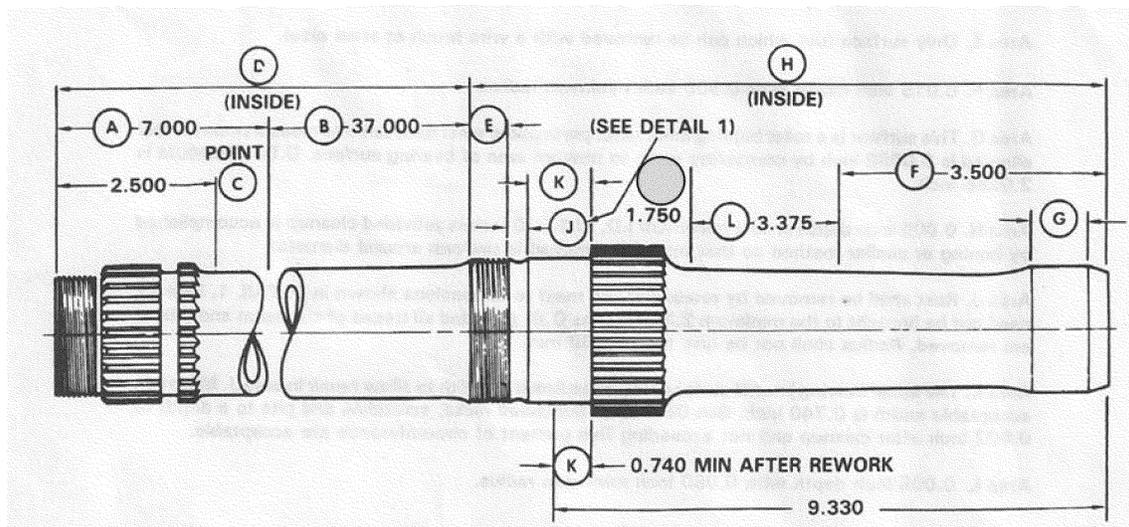
Figure 1 to Paragraph (e)

AFE reported two failures of a mast on an OH-58A+ and an OH-58C helicopter used in agricultural spraying operations. Investigation revealed that the mast failures were caused by fatigue cracking, which initiated from corrosion pitting found in the threaded section of the mast approximately 45 inches from

- (1) Within 30 days, unless accomplished previously within the last 12 months:
 - (i) Overhaul the main rotor mast assembly and magnetic particle inspect the mast; mast bearing nut; plate, mast and seal; and bearing liner for a crack.
 - (ii) Fluorescent penetrant inspect the locking plate for a crack.
 - (iii) Using a 10X or higher magnifying glass, inspect the threaded area of the mast

as shown in area E of figure 1 to paragraph (e) of this AD for pitting, corrosion, or a

crack. Remove any surface rust with a wire brush or steel wool.

(2) If there is a crack, pitting, or corrosion, before further flight, replace the mast with an airworthy mast.
