#### **Airworthiness Directives; Eurocopter Deutschland GmbH Helicopters**

**2012–13–11 Eurocopter Deutschland GmbH**

**Helicopters:** Amendment 39–17113;  
Docket No. FAA–2012–0704; Directorate  
Identifier 2012–SW–040–AD.

This AD defines the unsafe condition as an improperly swaged spherical bearing on the pitch link, which could result in loss of tail rotor control and subsequent loss of control of the helicopter.

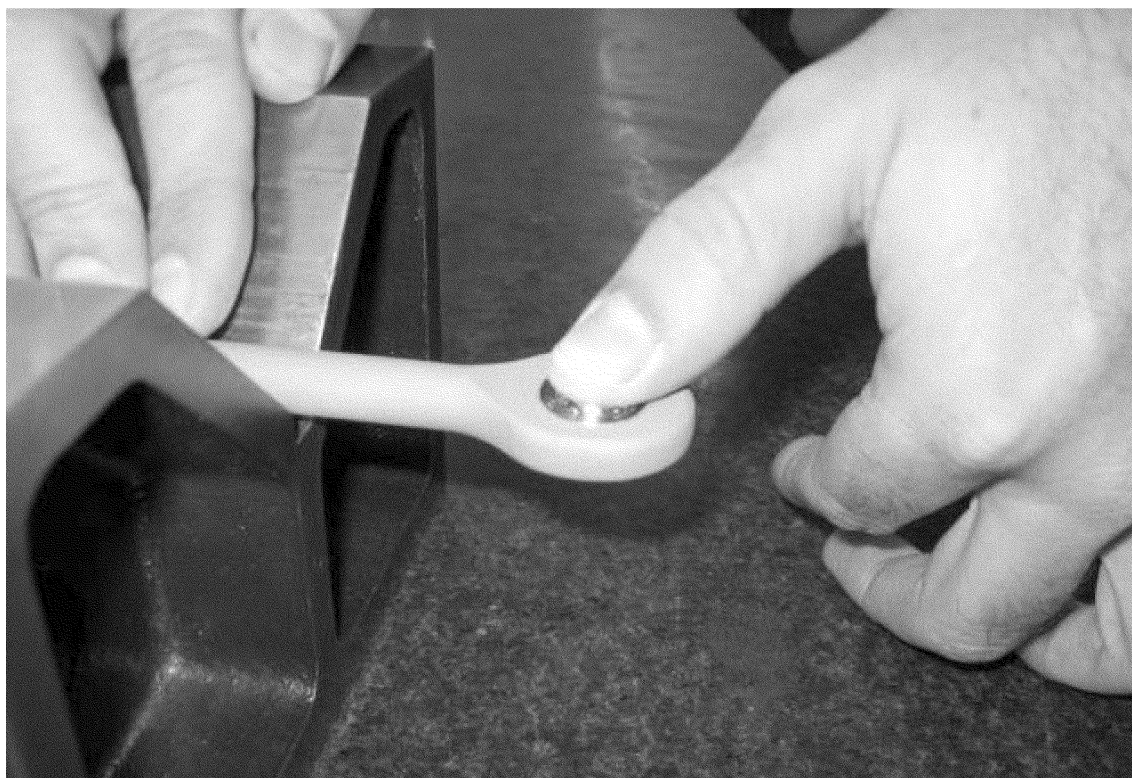
- (1) Remove the pitch link.
- (2) Clean the area around the spherical bearings and pitch link bearing bore chamfer.
- (3) Apply axial hand pressure to the faces of both spherical bearings as shown in Figure 1 to Paragraph (e) of this AD.

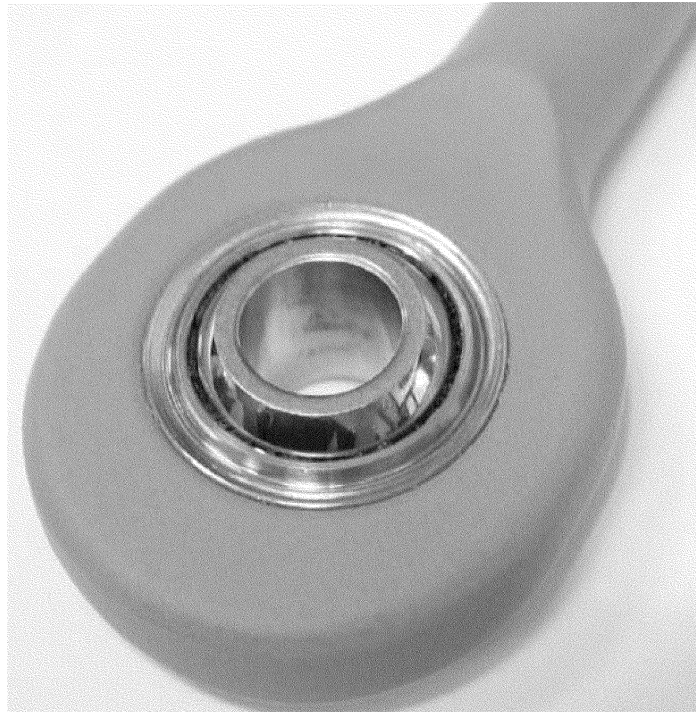
(4) Using an 8X or higher power magnifying glass, inspect the boundaries between the bearing and the bearing bore

chamfer surface. Determine that the bearings have been completely swaged and there is no gap between the edge of the bearing and the

chamfer as shown in Figure 2 to Paragraph (e) of this AD.

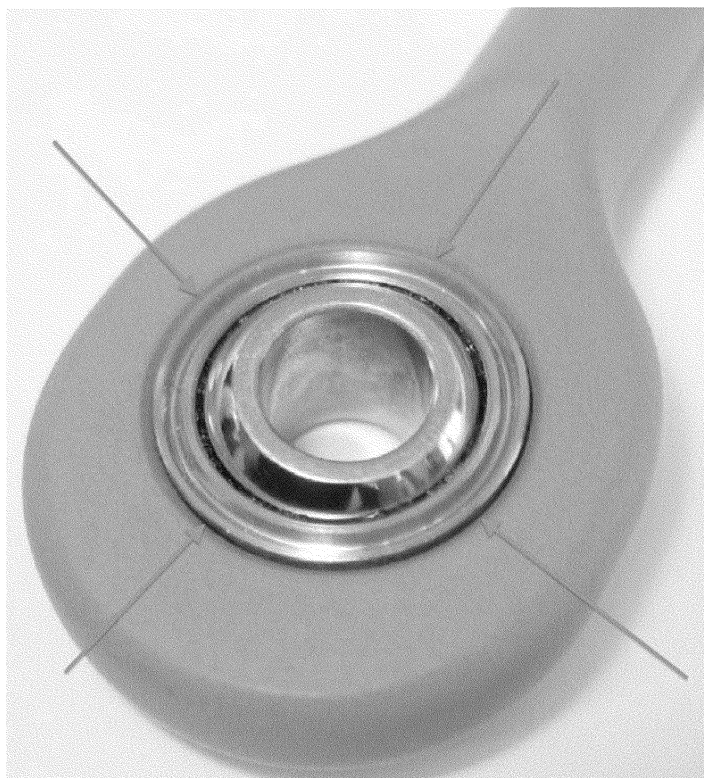
(5) If a bearing is not completely swaged or there is a gap between the edge of the

bearing and the chamfer, as shown in Figure

3 to Paragraph (e) of this AD, replace the pitch link with an airworthy pitch link.
