[Docket No. FAA-2012-0773; Directorate Identifier 2009-SW-71-AD]

Airworthiness Directives; Eurocopter Deutschland GmbH Helicopters**AGENCY:** Federal Aviation Administration, DOT.**ACTION:** Notice of proposed rulemaking (NPRM).

SUMMARY: We propose to adopt a new airworthiness directive (AD) for the Eurocopter Deutschland GmbH (Eurocopter) Model MBB-BK 117 C-2 helicopters. This proposed AD is prompted by the discovery that some helicopters have blind rivets installed in the place of solid rivets in the long tail rotor drive shaft. The proposed actions are intended to detect blind rivets installed in the long tail rotor drive shaft, which could lead to failure of the tail rotor drive shaft and subsequent loss of control of the helicopter.

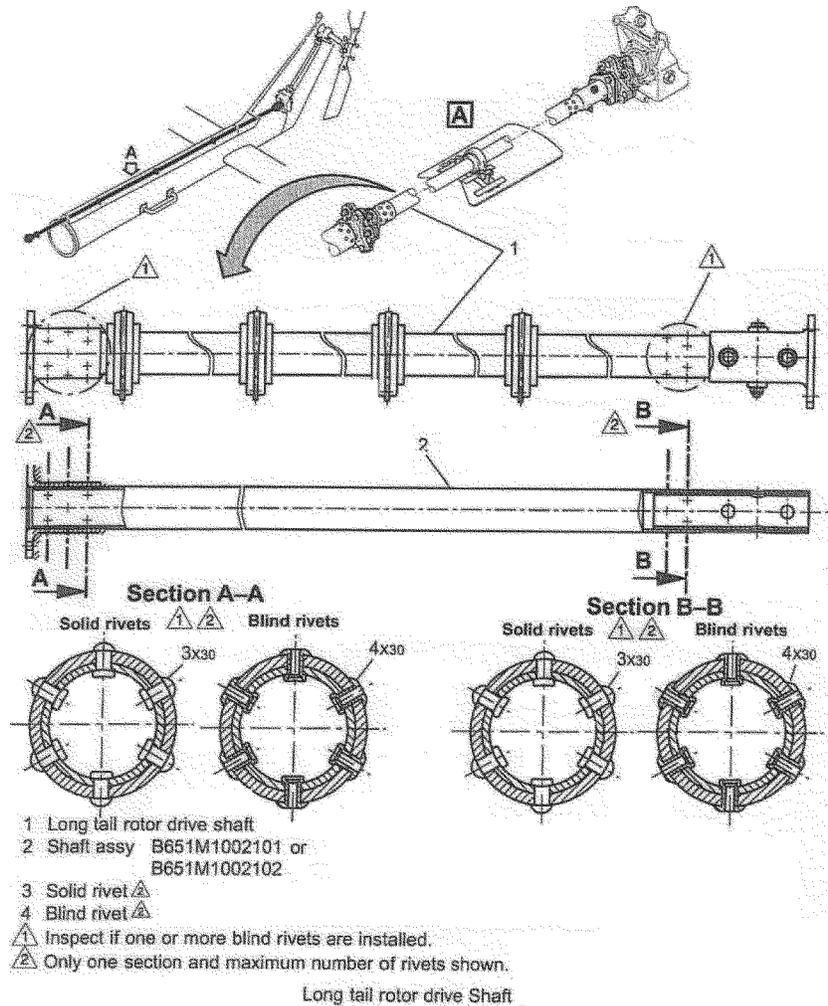
This AD defines the unsafe condition as the installation of blind rivets instead of solid rivets in the long tail rotor drive shaft. This condition could result in failure of the long tail rotor drive shaft and subsequent loss of control of the helicopter.

Within 100 hours time-in-service (TIS), inspect the long tail rotor drive shaft assembly for blind rivets as indicated in sections A-A and B-B of Figure 1 to Paragraph (d) of this AD.

(1) If there are no blind rivets installed on the shaft assembly, no further action is required by this AD.

(2) If there are one or more blind rivets installed on the shaft assembly in the areas depicted in Figure 1 to Paragraph (d) of this AD, before further flight, replace the shaft assembly of the long tail rotor drive shaft with an airworthy shaft assembly that does not have blind rivets installed.

(3) After the effective date of this AD, do not install a tail rotor drive shaft assembly that has blind rivets installed.
