Airworthiness Directives; Eurocopter Deutschland GmbH Helicopters

ACTION: Notice of proposed rulemaking (NPRM).

EUROCOPTER DEUTSCHLAND GmbH (ECD): Docket No. FAA-2012-0887; Directorate Identifier 2009-SW-02-AD.

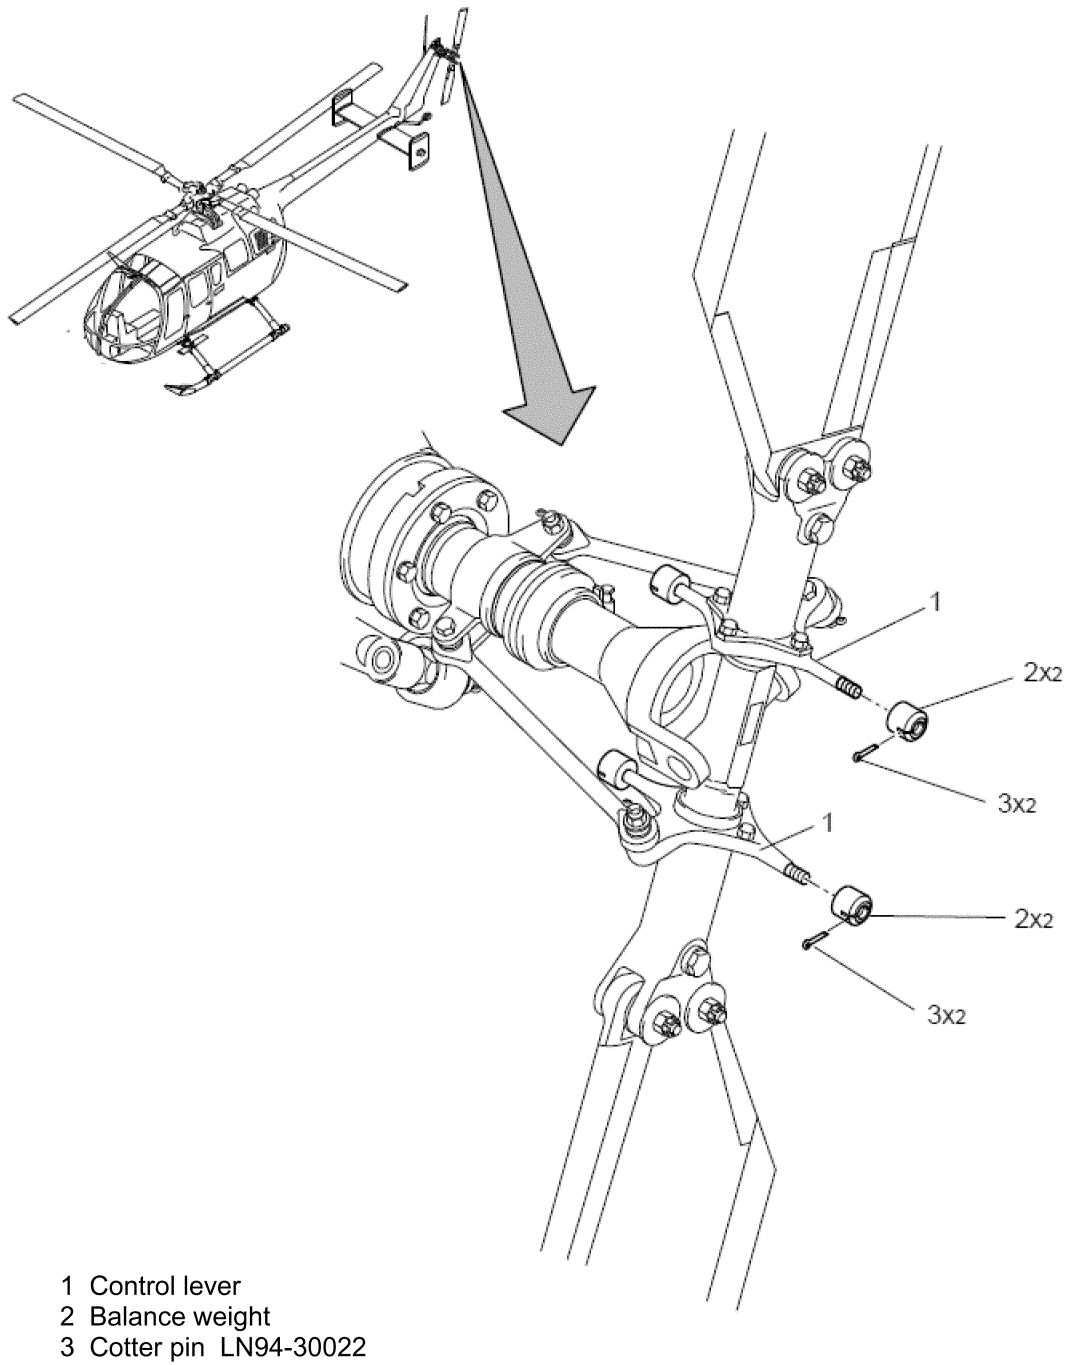
Figure 1 to paragraph (d) Tail Rotor Balance Weights

- (1) Remove the weights from the lever as depicted in Figure 1 to paragraph (d) of this AD. Apply marks to the weights before they are removed in order to be able to re-establish the correct assignment and the old installation position towards the lever when the weights are installed.

(3) Apply corrosion preventive paste onto the thread of the lever and install weights to

the lever as depicted in Figure 1 to paragraph (d) of this AD. Ensure during installation of the weights that the weights are correctly assigned and installed to the control lever in accordance with the applied marks.

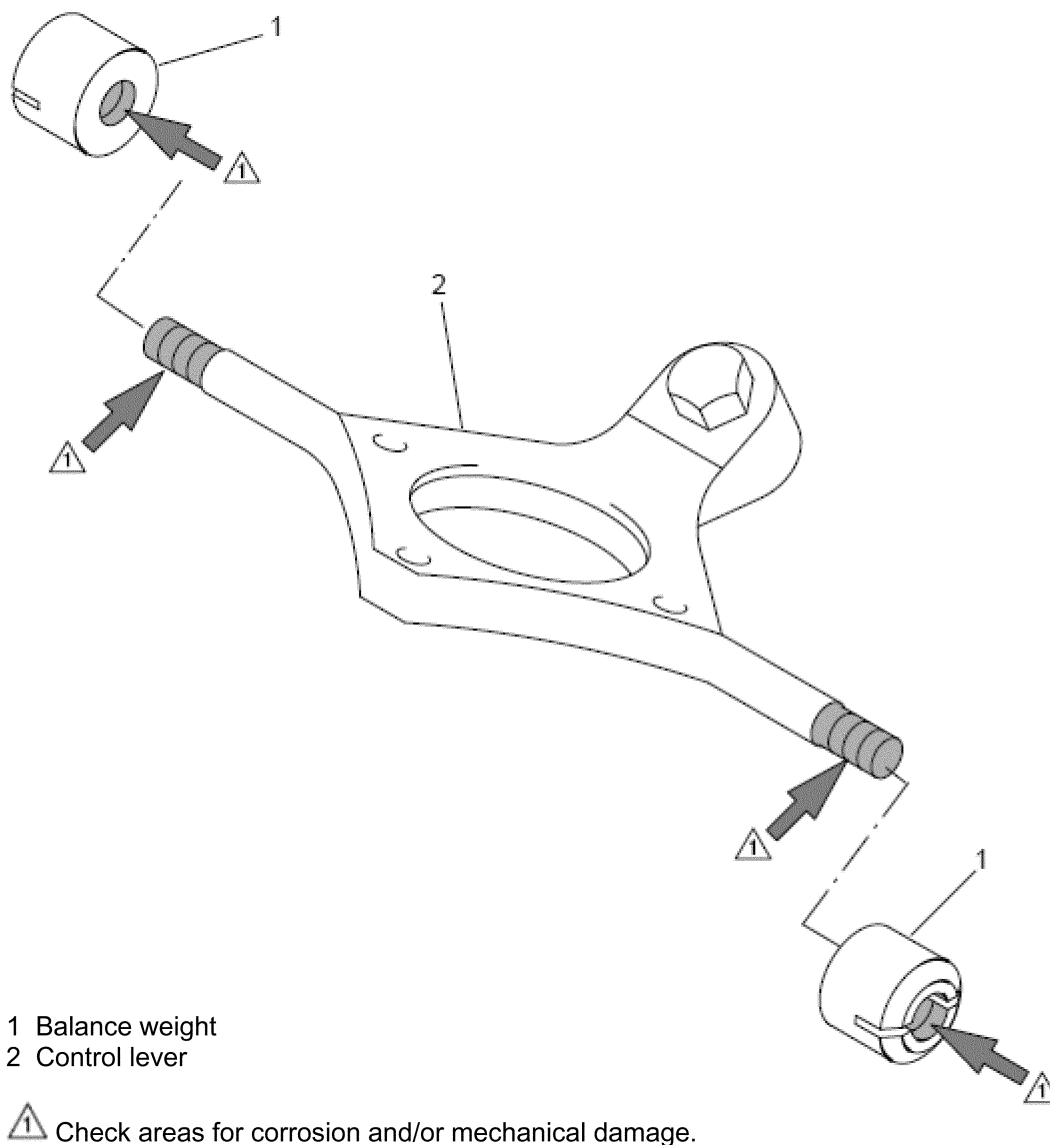
Figure 2 to paragraph (d) Inspection of Balance Weights and Control Lever

(2) Visually inspect each weight and lever for corrosion and damage in the threaded

areas as depicted in Figure 2 to paragraph (d) of this AD.

(ii) If there is corrosion or thread damage on the threaded portion of a *weight*:

(A) If the total area of corrosion or thread damage, or both, covers less than 25 percent of the length of the threaded area, the weight can be threaded (screwed) onto the lever, and the cylindrical mating surface has no damage, before further flight, remove the

(B) If the total area of corrosion or thread damage, or both, covers 25 percent or more of the length of the threaded area, the weight cannot be threaded (screwed) onto the lever, or the cylindrical mating surface has damage, before further flight, replace the weight with an airworthy weight by following paragraph (d)(3) of this AD.

(iii) If there is corrosion or thread damage on the threaded portion of the *lever*, polish out the corrosion and thread damage using a polishing cloth 600 and:

(i) If there is no corrosion or thread damage on either the weight or lever, before further flight, reinstall the weight by following paragraph (d)(3) of this AD.

corrosion and reinstall the weight by following paragraph (d)(3) of this AD.

(A) If the thread depth does not exceed 0.3 millimeter (mm) and the diameter of the lever in the area before the threaded area is not less than 9.95 mm after polish out, before further flight, install airworthy weights to the lever by following paragraph (d)(3) of this AD.

(B) If the thread depth is 0.3 mm or greater or the diameter of the lever in the area before the threaded area is less than 9.95 mm after polish out, before further flight, replace the lever with an airworthy lever.
