Airworthiness Directives; Eurocopter Deutschland GmbH Helicopters

ACTION: Notice of proposed rulemaking (NPRM).

EUROCOPTER DEUTSCHLAND GmbH

(ECD): Docket No. FAA-2012-0887; Directorate Identifier 2009-SW-02-AD.

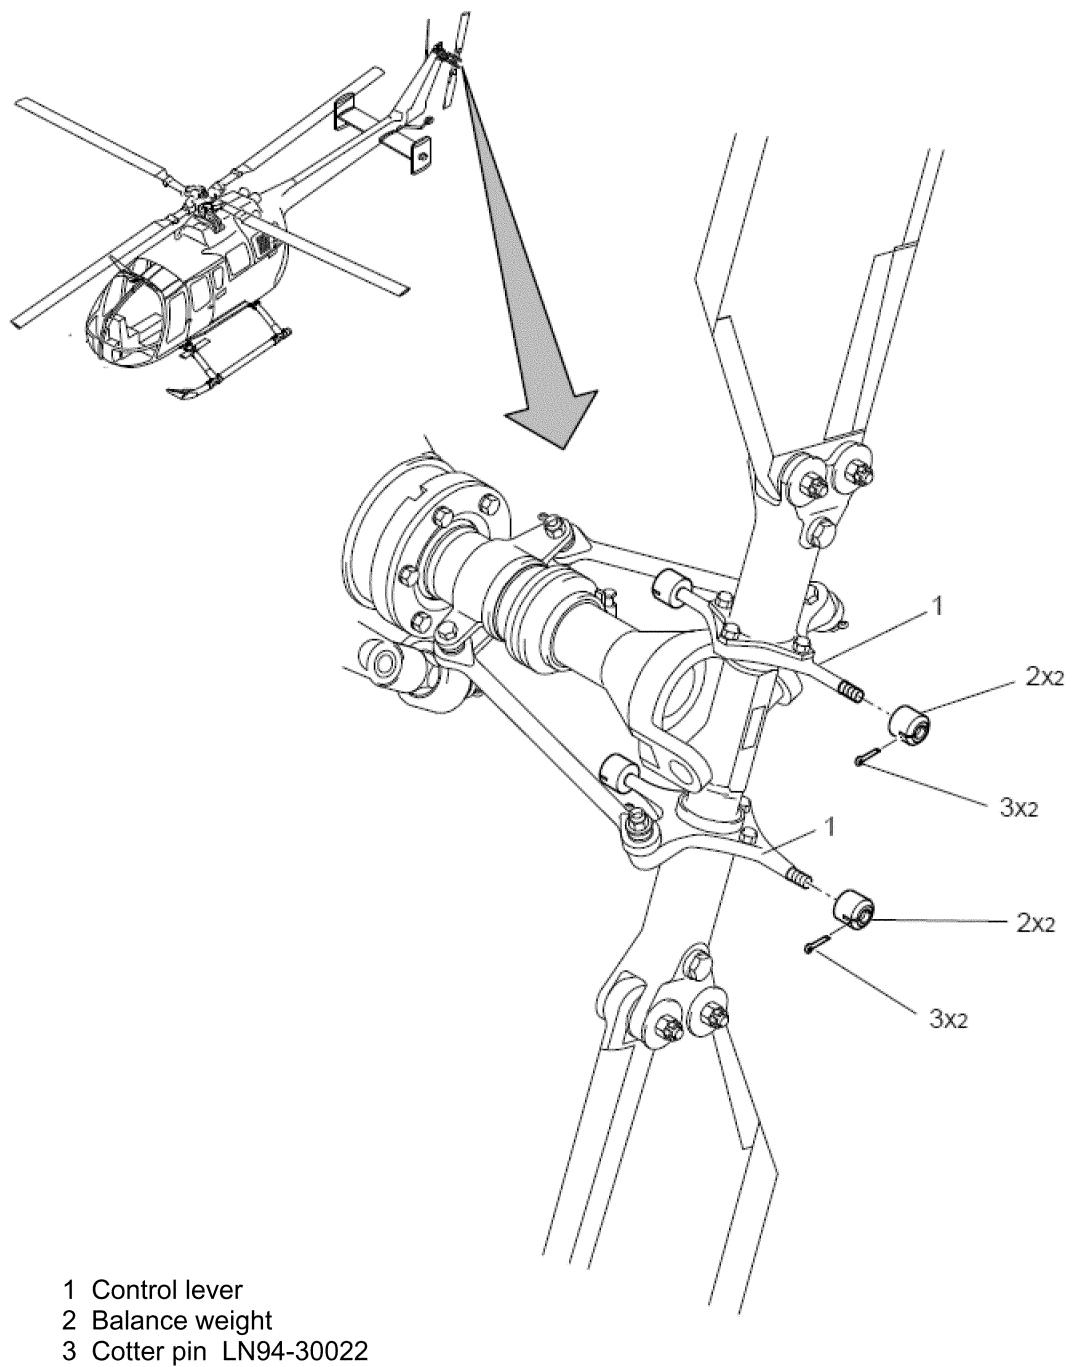
Figure 1 to paragraph (d) Tail Rotor Balance Weights

This AD defines the unsafe condition as corrosion or thread damage in the threaded area of a lever or weight. This condition could result in failure of a weight or lever, separation of a tail rotor part, severe tail rotor vibration, and subsequent loss of control of the helicopter.

- (1) Remove the weights from the lever as depicted in Figure 1 to paragraph (d) of this AD. Apply marks to the weights before they are removed in order to be able to re-establish the correct assignment and the old installation position towards the lever when the weights are installed.

(3) Apply corrosion preventive paste onto the thread of the lever and install weights to

the lever as depicted in Figure 1 to paragraph (d) of this AD. Ensure during installation of the weights that the weights are correctly assigned and installed to the control lever in accordance with the applied marks.

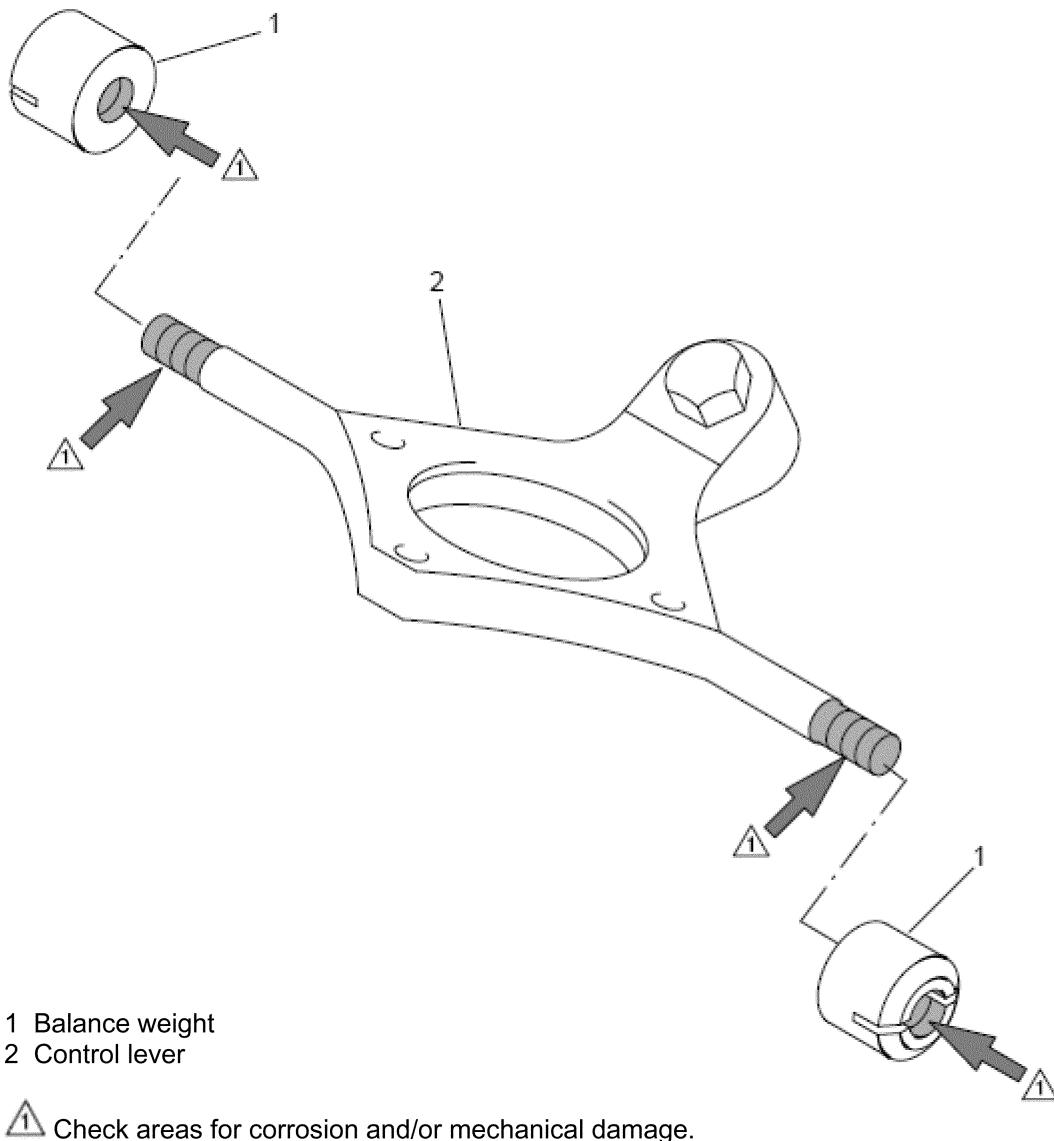
Figure 2 to paragraph (d) Inspection of Balance Weights and Control Lever

(2) Visually inspect each weight and lever for corrosion and damage in the threaded areas as depicted in Figure 2 to paragraph (d) of this AD.

(A) If the total area of corrosion or thread damage, or both, covers less than 25 percent of the length of the threaded area, the weight can be threaded (screwed) onto the lever, and the cylindrical mating surface has no damage, before further flight, remove the

(B) If the total area of corrosion or thread damage, or both, covers 25 percent or more of the length of the threaded area, the weight cannot be threaded (screwed) onto the lever, or the cylindrical mating surface has damage, before further flight, replace the weight with an airworthy weight by following paragraph (d)(3) of this AD.

(A) If the thread depth does not exceed 0.3 millimeter (mm) and the diameter of the lever in the area before the threaded area is not less than 9.95 mm after polish out, before further flight, install airworthy weights to the lever by following paragraph (d)(3) of this AD.

(B) If the thread depth is 0.3 mm or greater or the diameter of the lever in the area before the threaded area is less than 9.95 mm after polish out, before further flight, replace the lever with an airworthy lever.

(i) If there is no corrosion or thread damage on either the weight or lever, before further flight, reinstall the weight by following paragraph (d)(3) of this AD.

corrosion and reinstall the weight by following paragraph (d)(3) of this AD.

(iii) If there is corrosion or thread damage on the threaded portion of the *lever*, polish out the corrosion and thread damage using a polishing cloth 600 and:
