DEPARTMENT OF TRANSPORTATION

[Docket No. FAA-2009-1088; Directorate Identifier 2008-SW-76-AD]

Airworthiness Directives; Sikorsky Aircraft Corporation Helicopters

ACTION: Supplemental notice of proposed rulemaking (NPRM); reopening of comment period.

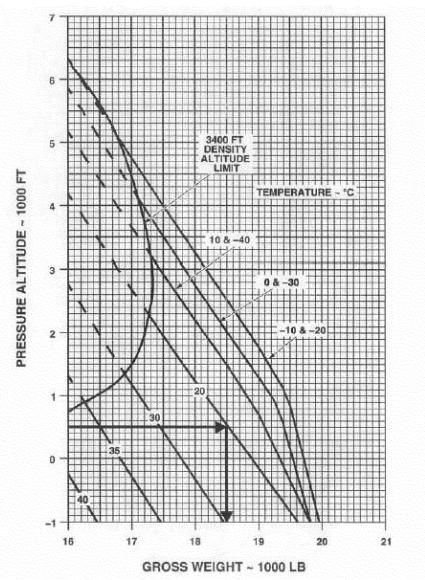
Figure 1-2A to Paragraph (d), Maximum Gross Weight for HEC Requiring Cat 'A'

NOTE 1 to Figure 1-2A to Paragraph (d) of this AD: THIS CHART DEPICTS THE GROSS WEIGHT, PRESSURE ALTITUDE, TEMPERATURE COMBINATION WHERE OEI HOGE CAPABILITY EXISTS USING 30 SECOND OEI POWER WITH A 60 SHP MARGIN.

NOTE 2 to Figure 1-2A to Paragraph (d) of this AD: 15 FT OF GROUND CLEARANCE IS ASSURED IN THE EVENT OF AN ENGINE FAILURE AT 20 TO 80 FT AGL.

(ii) Add this paragraph and figure: "HOIST Maximum gross weight for Human External Cargo, which requires category 'A' performance capabilities, is limited to the gross weight determined in accordance with the following Figure 1–2A to Paragraph (d) of this AD for your altitude and temperature with the air-conditioner, anti-ice, and bleed air turned off."
