#### Airworthiness Directives; Eurocopter France Helicopters

#### 2012-19-09 Eurocopter Helicopters:

Amendment 39-17204; Docket No. FAA-2012-1018; Directorate Identifier 2011-SW-052-AD.

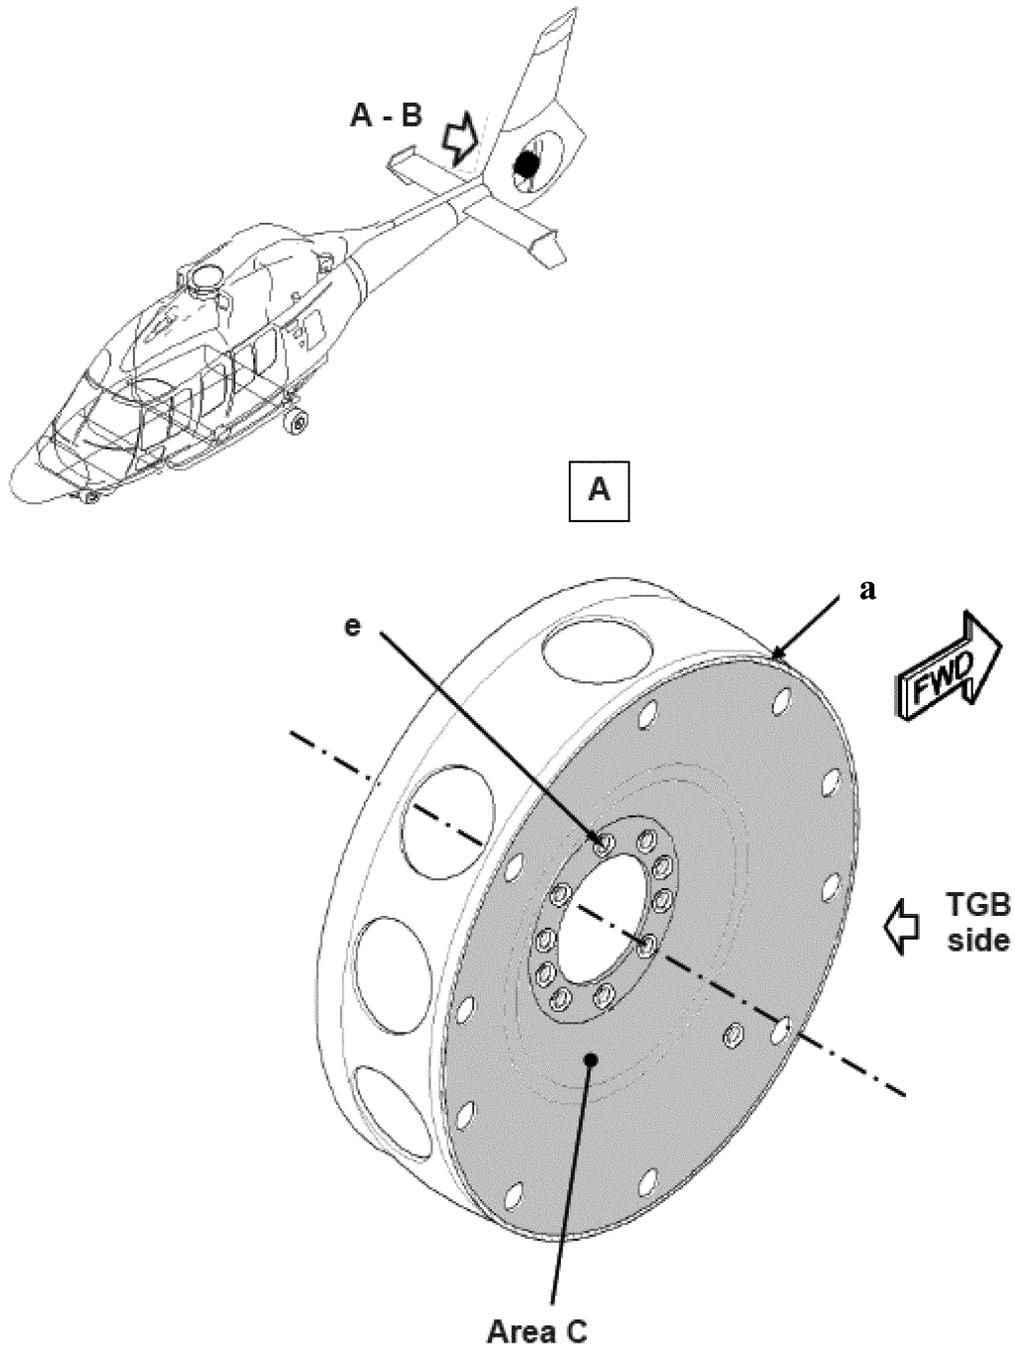
Figure 1 to Paragraph (e)(1) TRH Hub

(1) Within 55 hours time-in-service (TIS), and thereafter at intervals not to exceed 55 hours TIS, using a light, visually inspect the TRH for a crack in the entire area shown as Area C of the TRH (a) in Figure 1 to paragraph (e)(1) of this AD. The inspection area is on the tail gearbox (TGB) side of the TRH. The TGB is shown as (c) in Figures 2 and 3 to paragraph (e)(1) of this AD. You must pay particular attention to the area around the screws, shown as (e) in Figure 3 to paragraph (e)(1) of this AD, and the TRH between the lower part of the TGB and its fairing, shown as (d) in Figures 2 and 3 to paragraph (e)(1) of this AD, using details D and E of Figure 3 to paragraph (e)(1) of this AD. You must turn the tail rotor by hand to inspect the entire Area C.

(2) If there is a crack on the TRH, remove the TRH from service.
