[Docket No. FAA-2012-0060; Directorate Identifier 2012-NE-02-AD; Amendment 39-17123; AD 2012-14-09]

Airworthiness Directives; Pratt & Whitney (P&W) Division Turbofan Engines

2012–14–09 Pratt & Whitney Division:
Amendment 39–17123; Docket No. FAA–2012–0060; Directorate Identifier 2012–NE–02–AD.

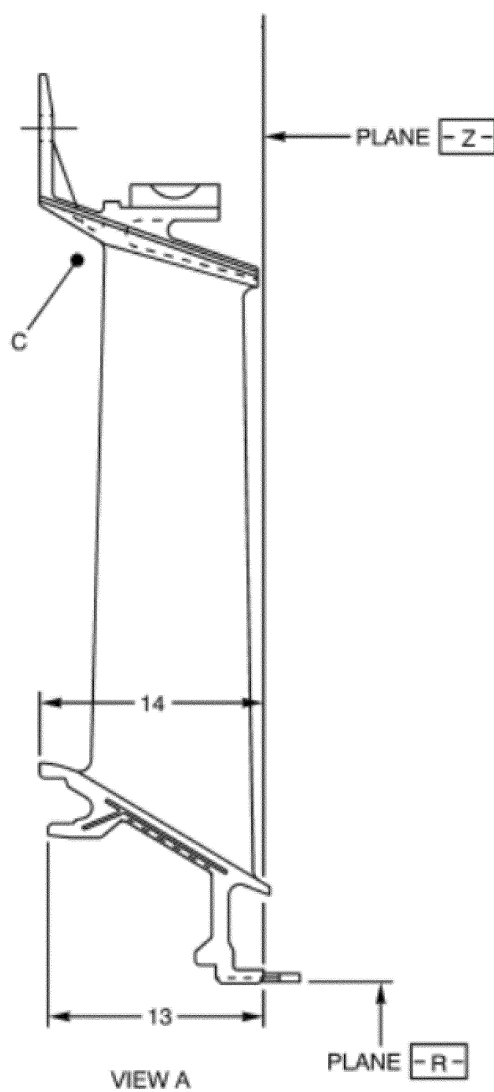
Figure 1 to Paragraph (e) - Determination of Vane Eligibility

(iii) Dimensionally examine index 13 through index 34 of the LPT 3rd stage vane cluster assembly. Use Table 2 to paragraph (e) of this AD and Figure 1, Figure 2, and

Figure 3 to paragraph (e) of this AD to determine whether the vane is eligible for installation.

Inspect:	Eligible for installation limits:
13	1.820–1.830 inches (46.23–46.48 mm).
14	1.920–1.930 inches (48.77–49.02 mm).
15	3.200 inches (81.280 mm) Basic.
16	0.900 inch (22.860 mm) Basic.
17	0.365 inch (9.271 mm) Basic.
18	0.350 inch (8.890 mm) Basic.
19	0.160 inch (4.064 mm) Basic.
20	0.772 inch (19.609 mm) Basic.
21	72° Basic.
22	22.382 inch (568.503 mm) Radius—Origin on Plane S Basic.
23	21.052 inch (534.721 mm) Radius—Origin on Plane S, concentric with Index 8 Basic.
24	Angle from Plane S to Plane SL 3°4'37" Basic.
25	Angle from Plane S to Plane SM 6°9'14" Basic.
26	90° Basic for typical airfoil section.
27:	
Distance from rear foot outer diameter surface to airfoil section along Planes S, SL, and SM. For Section B–B:	5.241 inches (133.121 mm).

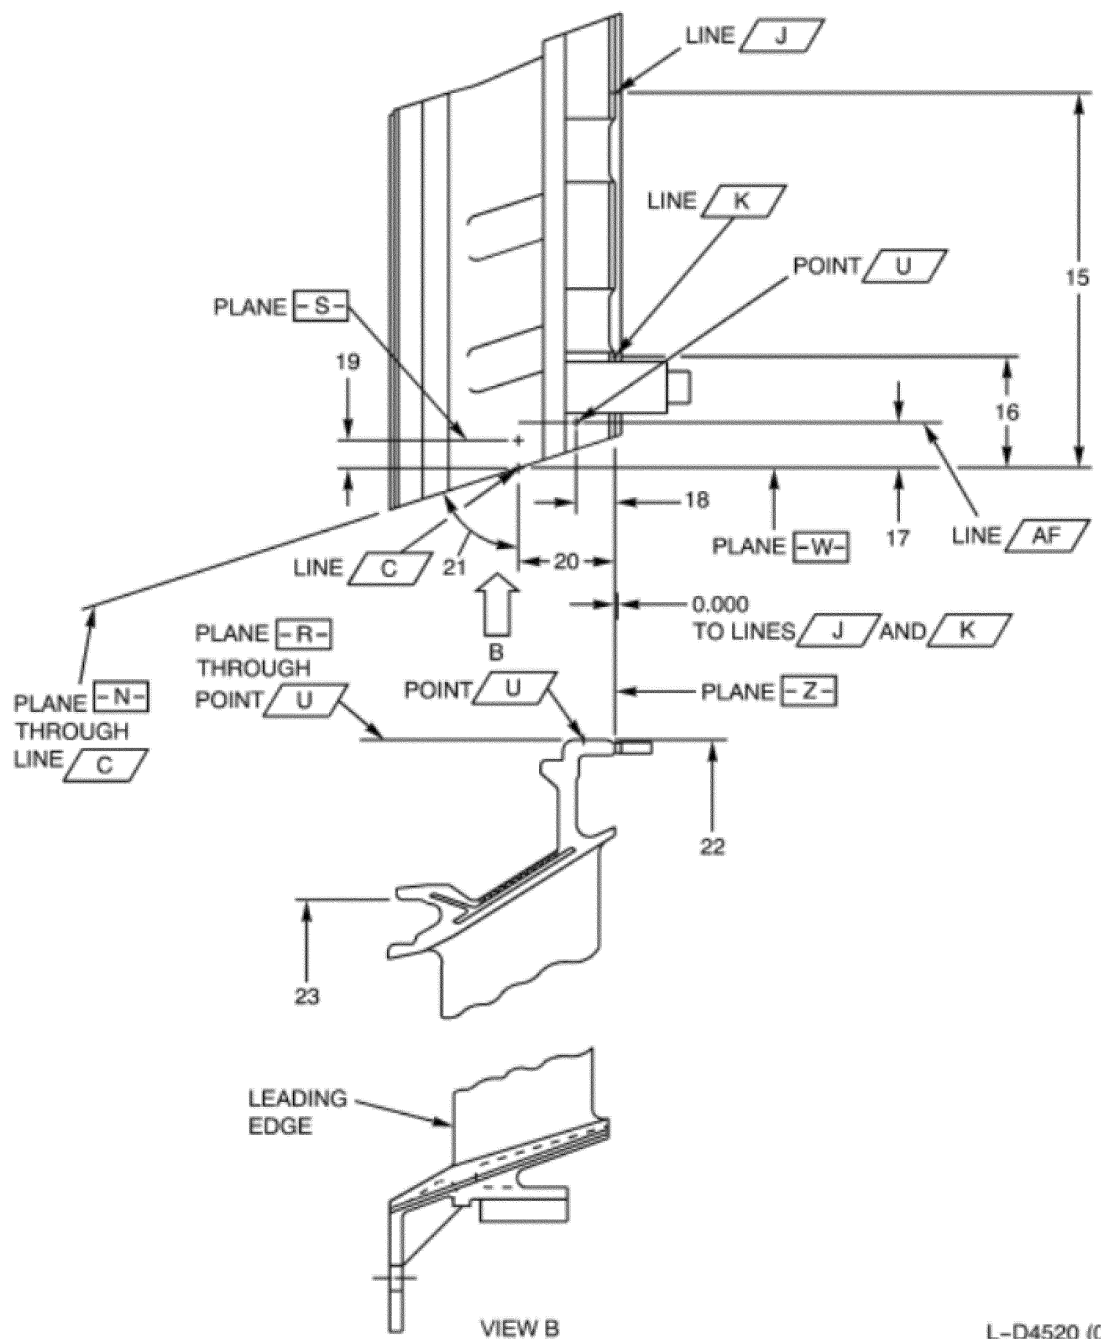
Figure 2 to Paragraph (e) - Determination of Vane Eligibility

Inspect:	Eligible for installation limits:
For Section E–E:	3.181 inches (80.797 mm).
For Section J–J:	1.935 inches (49.149 mm).
28: Airfoil chord at Section J–J (1.935 inches (49.149 mm) from rear foot outer diameter surface at Planes S, SL, and SM).	1.346 inches (34.188 mm) minimum.
At Section E–E (3.181 inches (80.797 mm) from rear foot outer diameter surface at Planes S, SL, and SM).	1.314 inches (33.376 mm) minimum.
At Section B–B (5.241 inches (133.121 mm) from rear foot outer diameter surface at Planes S, SL, and SM).	1.188 inches (30.175 mm) minimum.

29: Airfoil thickness at Section J–J (1.935 inches (49.149 mm) from rear foot outer diameter surface at Planes S, SL, and SM).	0.239 inch (6.071 mm) minimum.
At Section E–E (3.181 inches (80.797 mm) from rear foot outer diameter surface at Planes S, SL, and SM).	0.183 inch (4.648 mm) minimum.
At Section B–B (5.241 inches (133.121 mm) from rear foot outer diameter surface at Planes S, SL, and SM).	0.139 inch (3.531 mm) minimum.

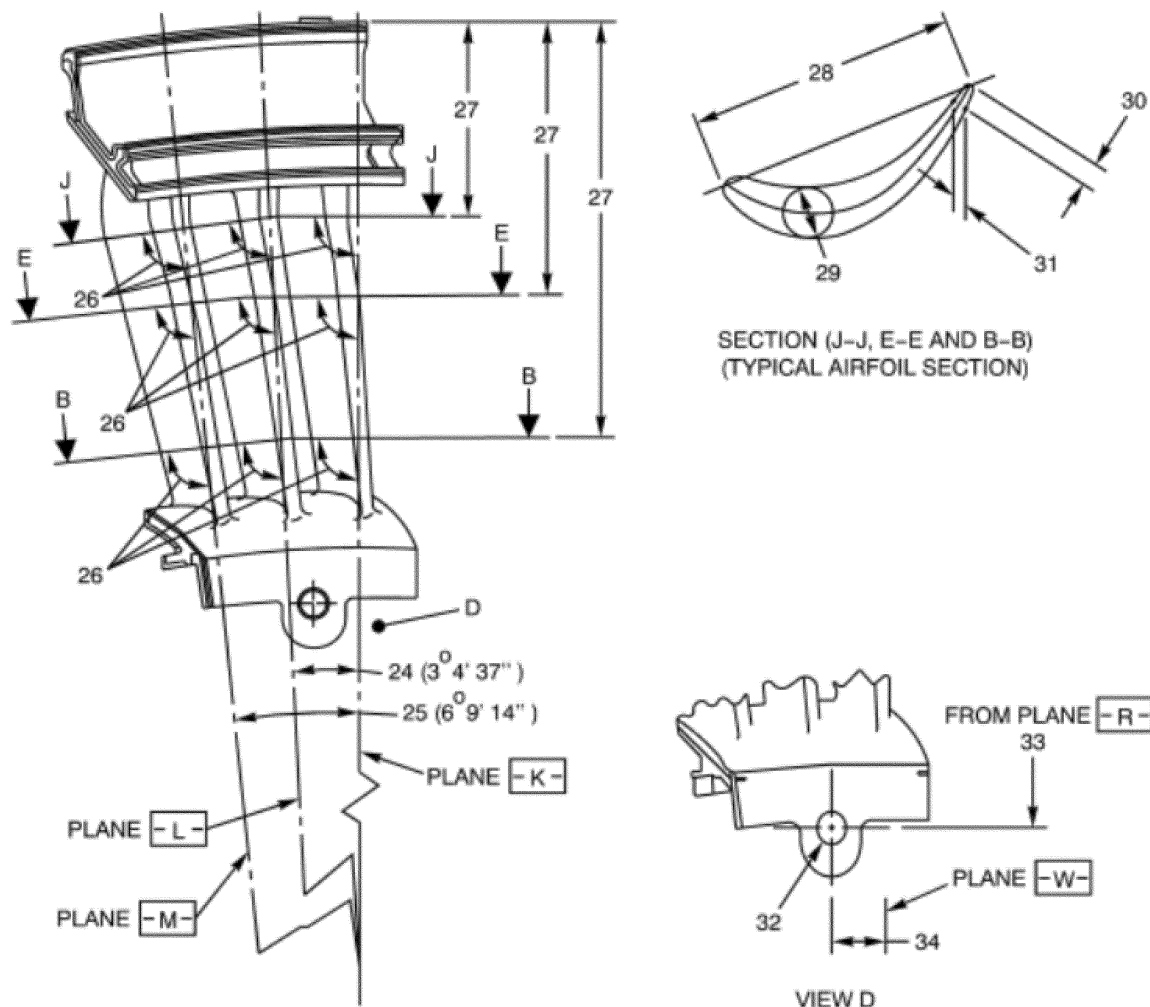
Figure 3 to Paragraph (e) - Determination of Vane Eligibility

30: Distance to trailing edge measurement	0.062 inch (1.575 mm).
31: Airfoil trailing edge thickness	0.030 inch (0.762 mm) minimum.
32: Dimension	0.315–0.324 inch (8.001–8.230 mm) diameter.

33: Dimension	6.785–6.795 inches (172.34–172.59 mm).
34: Dimension	0.692–0.714 inch (17.58–18.14 mm).
