[Docket No. FAA-2013-0019; Directorate Identifier 2010-SW-051-AD]

Airworthiness Directives; Bell Helicopter Textron Canada Helicopters

ACTION: Notice of proposed rulemaking (NPRM).

Bell Helicopter Textron Canada (BHTC):

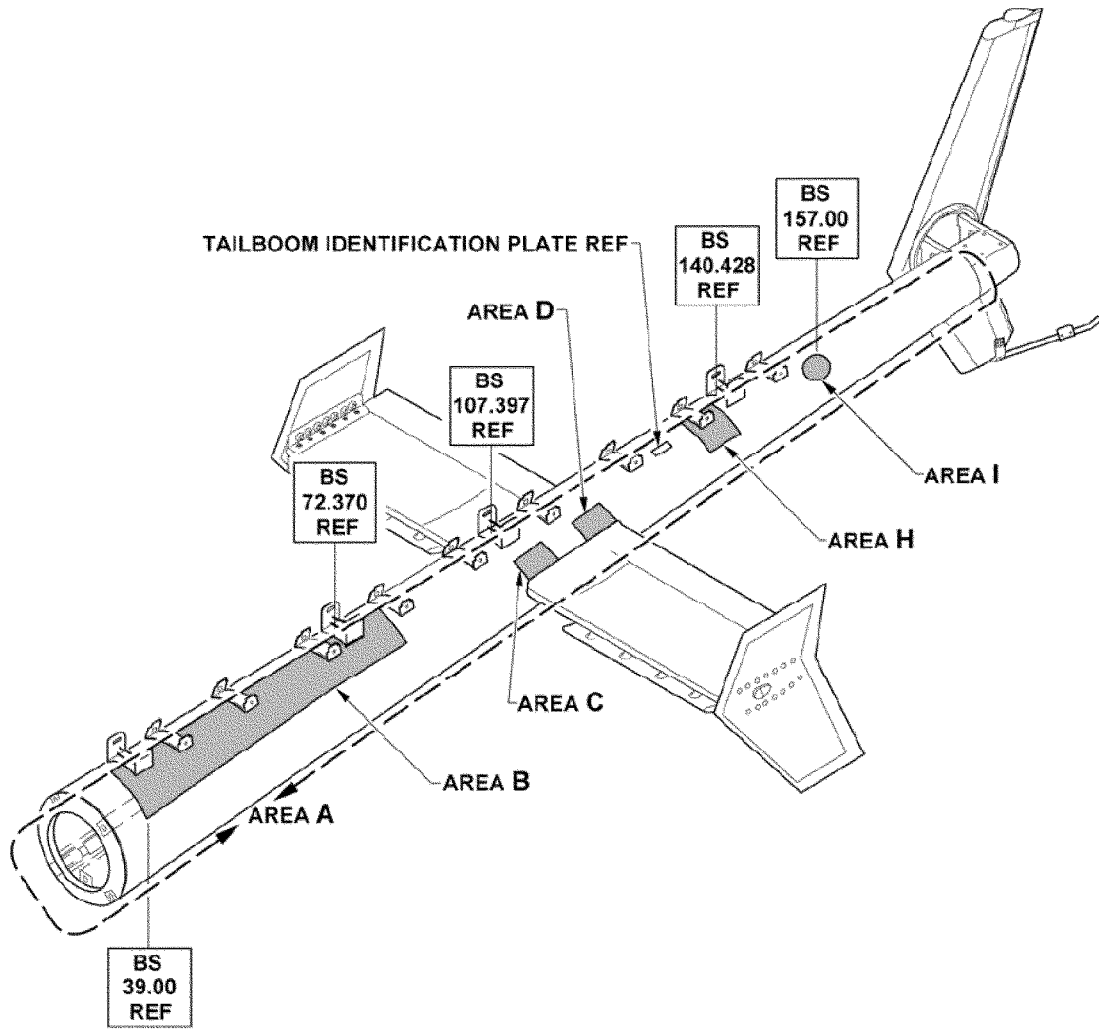
Figure 1 to Paragraph (d)

This AD defines the unsafe condition as high-stress-concentration areas in the tailboom skin that are at risk of cracking. This condition could result in a crack in the tailboom assembly, failure of the tailboom, and subsequent loss of helicopter control.

(A) Before the first flight of each day, visually check for a crack in the "C" and "D" areas depicted in Figures 1 and 2 to Paragraph (d) of this AD. The actions required by this paragraph may be performed by the owner/operator (pilot) holding at least a private pilot certificate, and must be entered into the aircraft records showing compliance with this AD in accordance with 14 CFR 43.9 (a)(1)-(4) and 14 CFR 91.417(a)(2)(v). The record must be maintained as required by 14 CFR 91.417, 121.380, or 135.439; or

(5) If there is a crack in the tailboom assembly, before further flight, replace it with an airworthy tailboom assembly.

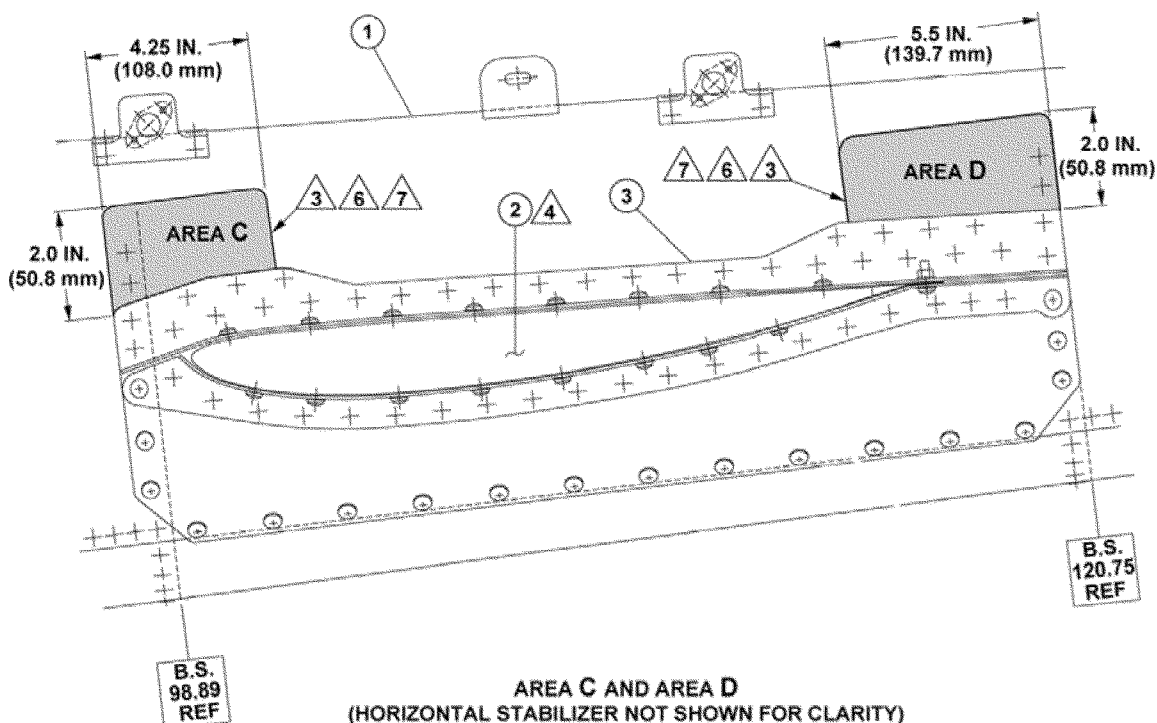
(B) Within 25 hours TIS, or 30 days, whichever comes first, and thereafter at intervals not to exceed 50 hours TIS, clean and inspect for a crack around each fastener and just above the edge of the upper stabilizer support in the "C" and "D" areas on the left side of the tailboom assembly, as depicted in Figure 2 to Paragraph (d) of this AD, using a 10X or higher power magnifying glass.
