Airworthiness Directives; Agusta S.p.A. Helicopters

ACTION: Notice of proposed rulemaking (NPRM).

AGUSTA S.p.A. (Agusta); Docket No. FAA–2013–0146; Directorate Identifier 2012–SW–060–AD.

This AD defines the unsafe condition as a fatigue crack in a T/R blade. This condition could result in failure of the T/R blade and subsequent loss of control of the helicopter.

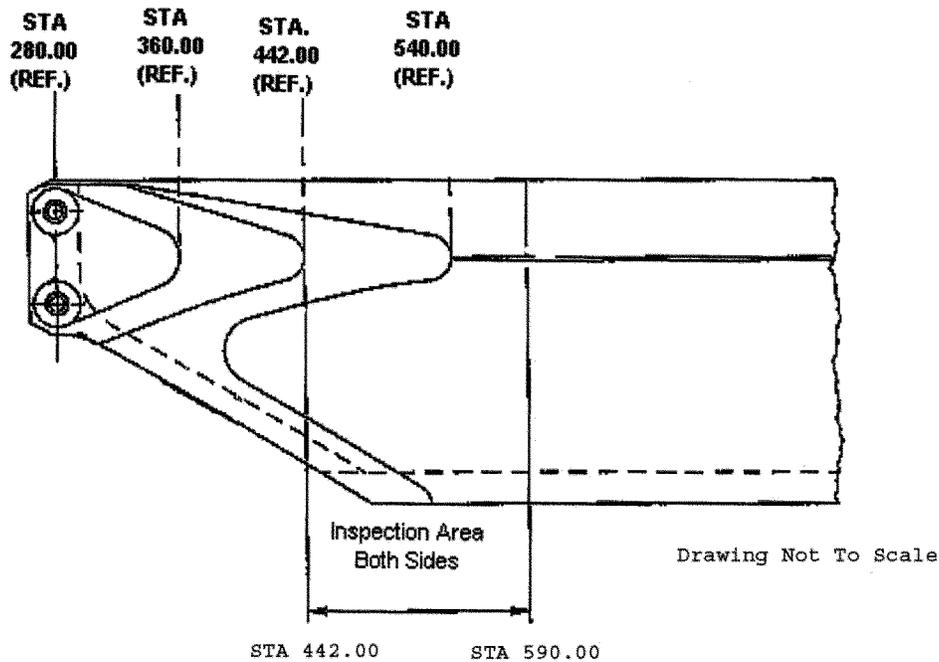
(1) Before each start of the helicopter engines, visually check both sides of each T/R blade for a crack in the inspection area depicted in Figure 1 to paragraph (f) of this AD. This action may be performed by the owner/operator (pilot) holding at least a private pilot certificate, and must be entered into the aircraft records showing compliance with this AD in accordance with 14 CFR 43.9 (a)(1)–(4) and 14 CFR 91.417(a)(2)(v). The record must be maintained as required by 14 CFR 91.173, 121.380, or 135.439.

Part Number 109-8132-01-111 Tail Rotor Blade

(5) If there is a crack in a T/R blade, before further flight, replace the cracked T/R blade.
