Airworthiness Directives; Eurocopter France Helicopters

2013-07-05 Eurocopter France:

Amendment 39–17409; Docket No. FAA–2012–0630; Directorate Identifier 2011–SW–010–AD.

This AD applies to Eurocopter France EC130B4 helicopters with center windscreens (center windscreens), part number (P/N) 350A25–9004–00, 350A25–9025–00, or 350A25–9041–20, certificated in any category.

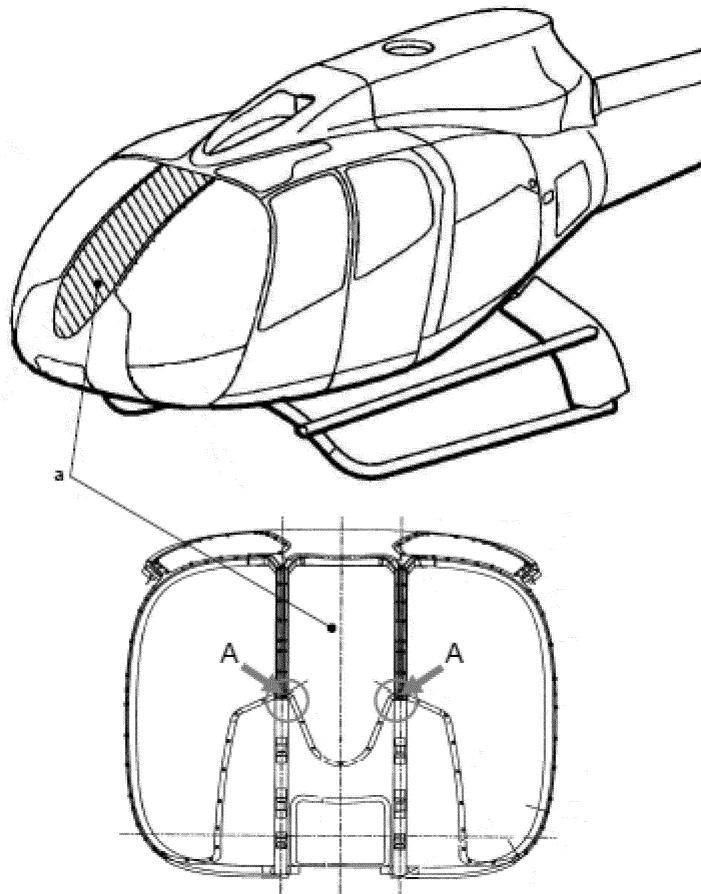
Figure 1 to Paragraph (e)(1)

This AD defines the unsafe condition as a crack in the blending radii of the center windscreens, which could lead to failure of the center windscreens, injury to the flight crew, and subsequent loss of control of the helicopter.

- (1) Until the center windscreens are replaced with center windscreens P/N 350A25–9045–20, before each flight, visually check the center windscreens for a crack in the area of the blending radii where the front-lower part of the center windscreens joins the front fuselage as depicted in Figure 1 to paragraph (e)(1) of this AD. This visual check may be performed by the owner/operator (pilot) holding at least a private pilot certificate, and must be entered into the aircraft records showing compliance with this AD in accordance with Title 14 Code of Federal Regulations (14 CFR) 43.9 (a)(1)–(4) and 14 CFR 91.417(a)(2)(v). The record must be maintained as required by 14 CFR 91.417, 121.380, or 135.439.

(2) If there is a crack or if a pilot indicates that the center windscreens distorted during flight, before further flight, replace the center windscreens with an airworthy center windscreens, P/N 350A25-9045-20, in accordance with the Accomplishment Instructions, paragraphs 2.B.2.b. through 2.B.2.b.4., of Eurocopter Service Bulletin No. 56-003, Revision 0, dated November 16, 2010.

(3) Within 12 months, replace the center windscreens with an airworthy center windscreens, P/N 350A25-9045-20, in accordance with the instructions contained in paragraph (e)(2) of this AD.
