[Docket No. FAA-2013-0340; Directorate Identifier 2010-SW-081-AD]

Airworthiness Directives; Eurocopter Deutschland GmbH Helicopters

ACTION: Notice of proposed rulemaking
(NPRM).

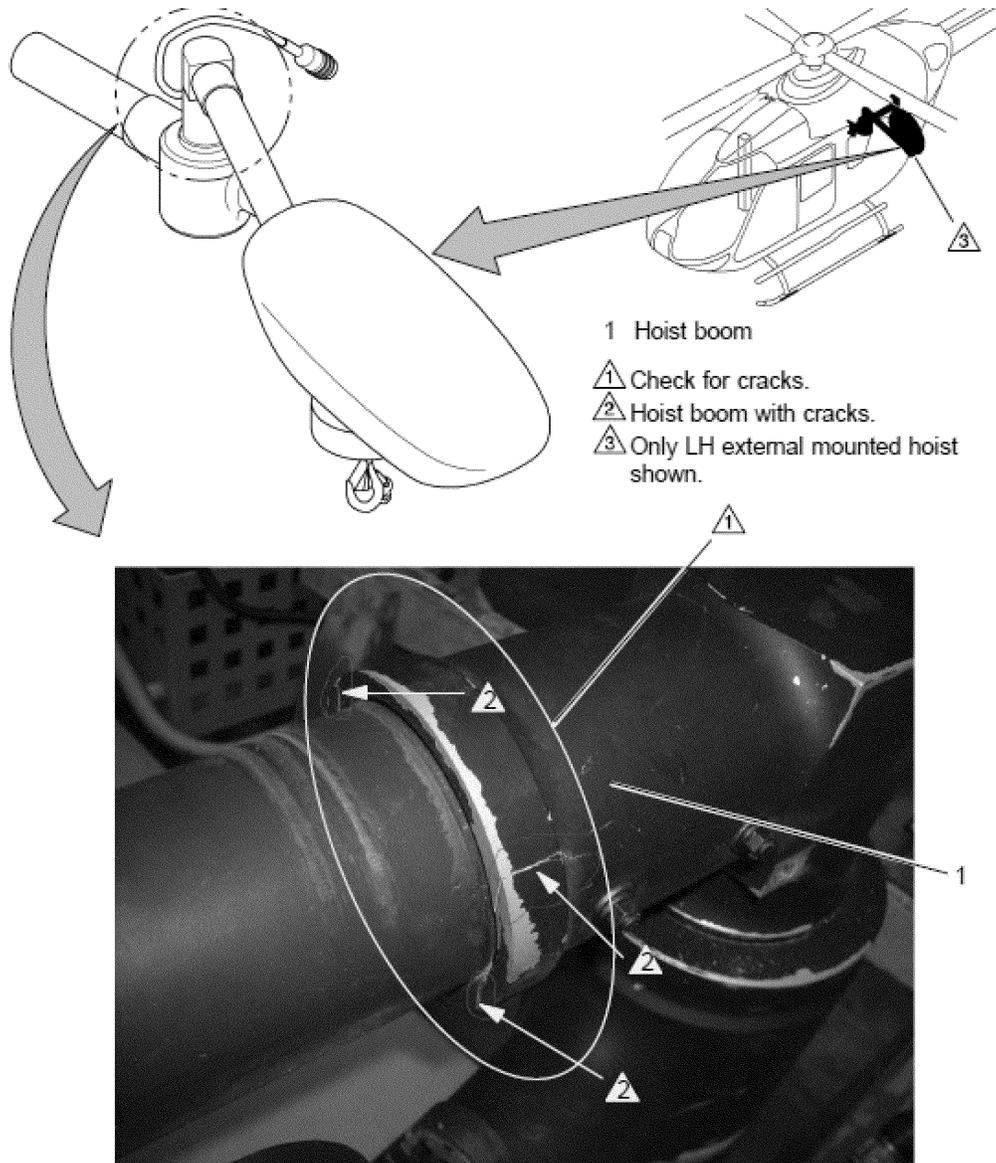
This AD defines the unsafe condition as a crack in the boom. This condition could result in loss of the boom and attached loads, and subsequent loss of helicopter control.

(1) Before further flight, and thereafter before the first flight of each day until you have performed the inspection required by paragraph (e)(2) of this AD, clean the hoist and visually check for a crack, paying particular attention to the areas that are circled as depicted in Figure 1 to paragraph (e) of this AD. The actions required by this paragraph may be performed by the owner/operator (pilot) holding at least a private pilot certificate, and must be entered into the aircraft records showing compliance with this AD in accordance with 14 CFR 43.9 (a)(1)-(4) and 14 CFR 91.417 (a)(2)(v). The record must be maintained as required by 14 CFR 91.417, 121.380, or 135.439.

(2) Within 30 days, perform a dye penetrant inspection of the boom in accordance with the Accomplishment Instructions, Section 2.D, of the Goodrich Service Bulletin 44307-500-03, Revision 2, dated April 30, 2010 (SB).

(3) If a crack exists in the boom, replace the cracked boom with an airworthy boom before further flight.
