[Docket No. FAA-2012-1297; Directorate Identifier 2012-SW-100-AD; Amendment 39-17285; AD 2012-25-04]

**Airworthiness Directives; Eurocopter France Helicopters**

#### 2012–25–04 Eurocopter France:

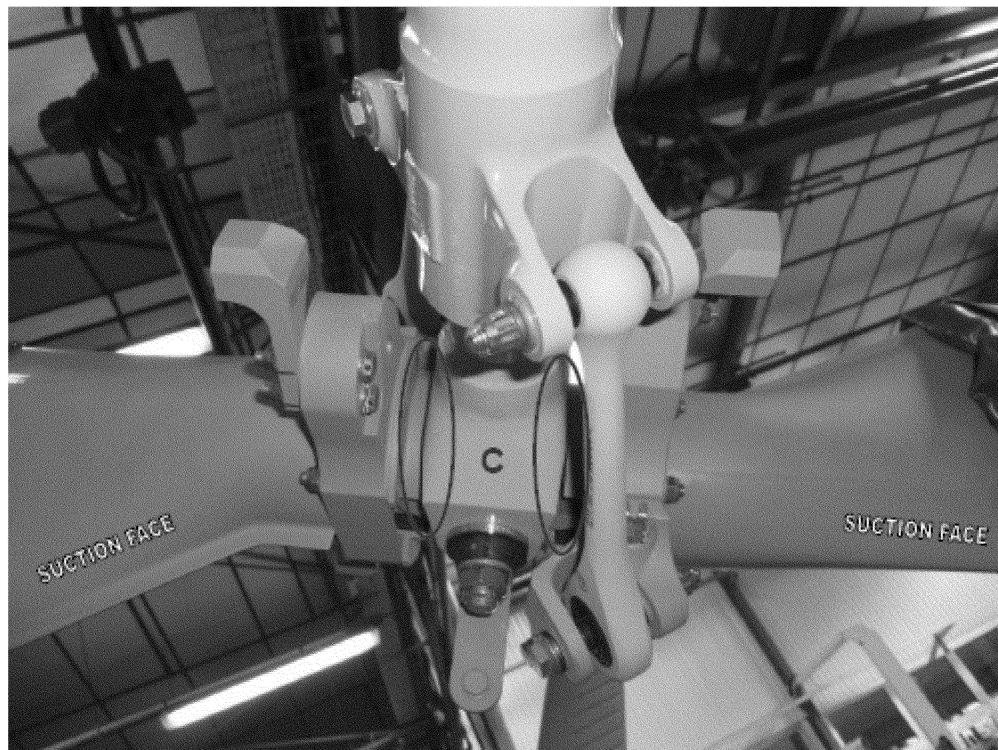
(v) Apply load (G) by hand perpendicular to the suction face of one tail rotor blade as shown in Figure 3 to paragraph (f) of this AD.

The load will deflect the tail rotor blade away from the tail boom.

(vi) While maintaining the load, check visible faces of Area C as shown in Figure 3 to paragraph (f) of this AD for any extrusion. A flashlight may be used to enhance the check.
