[Docket No. FAA-2011-1231; Directorate Identifier 2011-NM-088-AD; Amendment 39-17418; AD 2013-08-01]

#### Airworthiness Directives; The Boeing Company Airplanes

**SUMMARY:** We are adopting a new airworthiness directive (AD) for certain The Boeing Company Model 737-600, -700, -700C, -800, -900, and -900ER series airplanes. This AD was prompted by reports of damaged fire seals on the forward edge of the thrust reverser. This AD requires inspecting to detect damage to the upper fire seals on the forward edge of the thrust reverser, where the fire seal contacts the 12-o'clock engine strut, and for correct stiffness and vent holes, and doing corrective actions if necessary; and installing a bracket for the fire seal. We are issuing this AD to detect and correct damage to the fire seals, which could allow airflow into the engine fire zone and could degrade the ability to extinguish an engine fire.

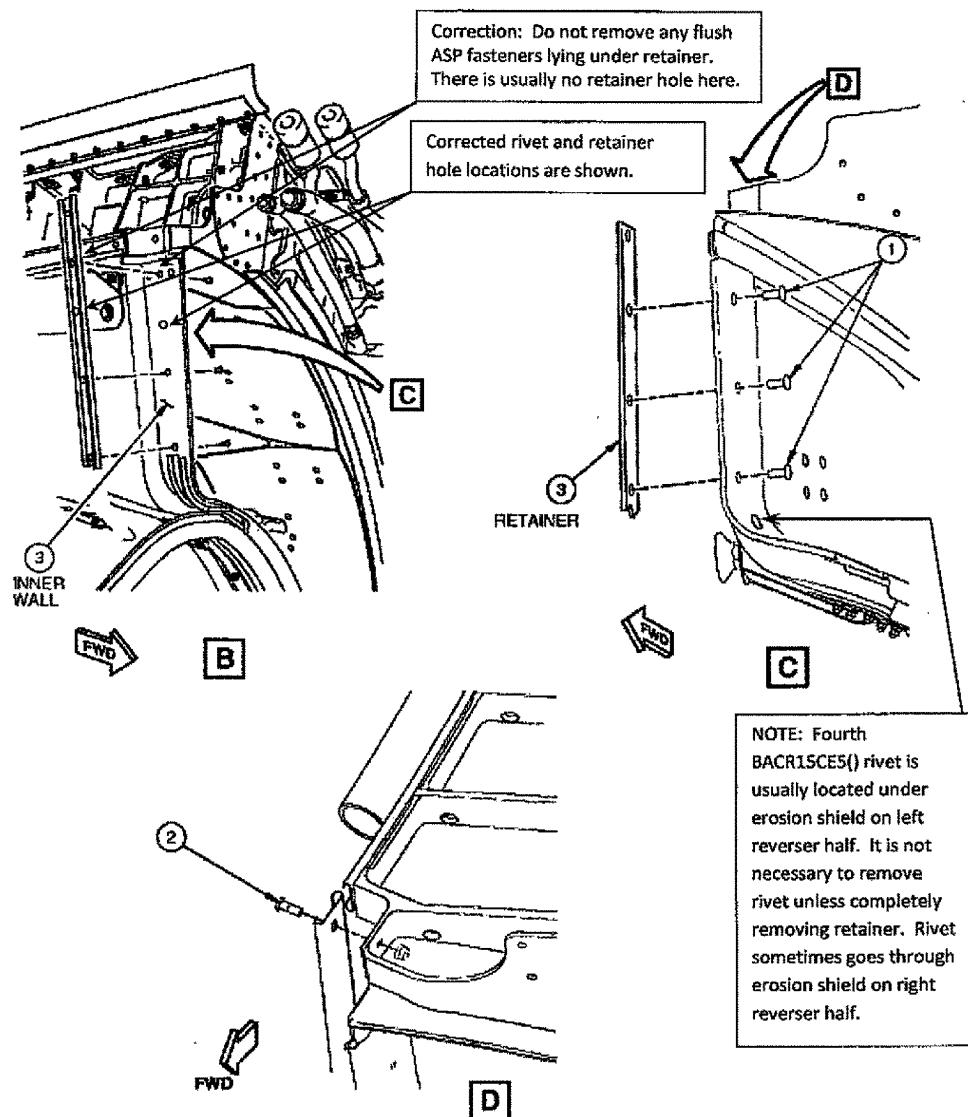
Figure 1, Fastener Removal of the Retainer Support on the Left Thrust Reverser Half

- Figures 6, 7, 15, and 16, all Sheet 2 of 3, all View B: These illustrations show the top fastener to be removed in the center of three fasteners in order to remove the retainer. However, these three fasteners are adjustable sustained preload (ASP) fasteners that do not require removal for this action. View B also incorrectly shows the location of the top rivet hole, which is actually below the row of ASP fasteners. These errors in those figures affect the actions specified in paragraph (g)(2) of this AD. The other instructions in the figures are correct.

(2) Figures 1 and 3 of this AD, titled "Fastener Removal of the Retainer Support on the Left (Right) Thrust Reverser Half," have View B showing the top fastener in the center of three adjustable sustained preload (ASP) fasteners. That top fastener does not require removal in order to remove the retainer. The figures in this AD point to the correct information for those fasteners.

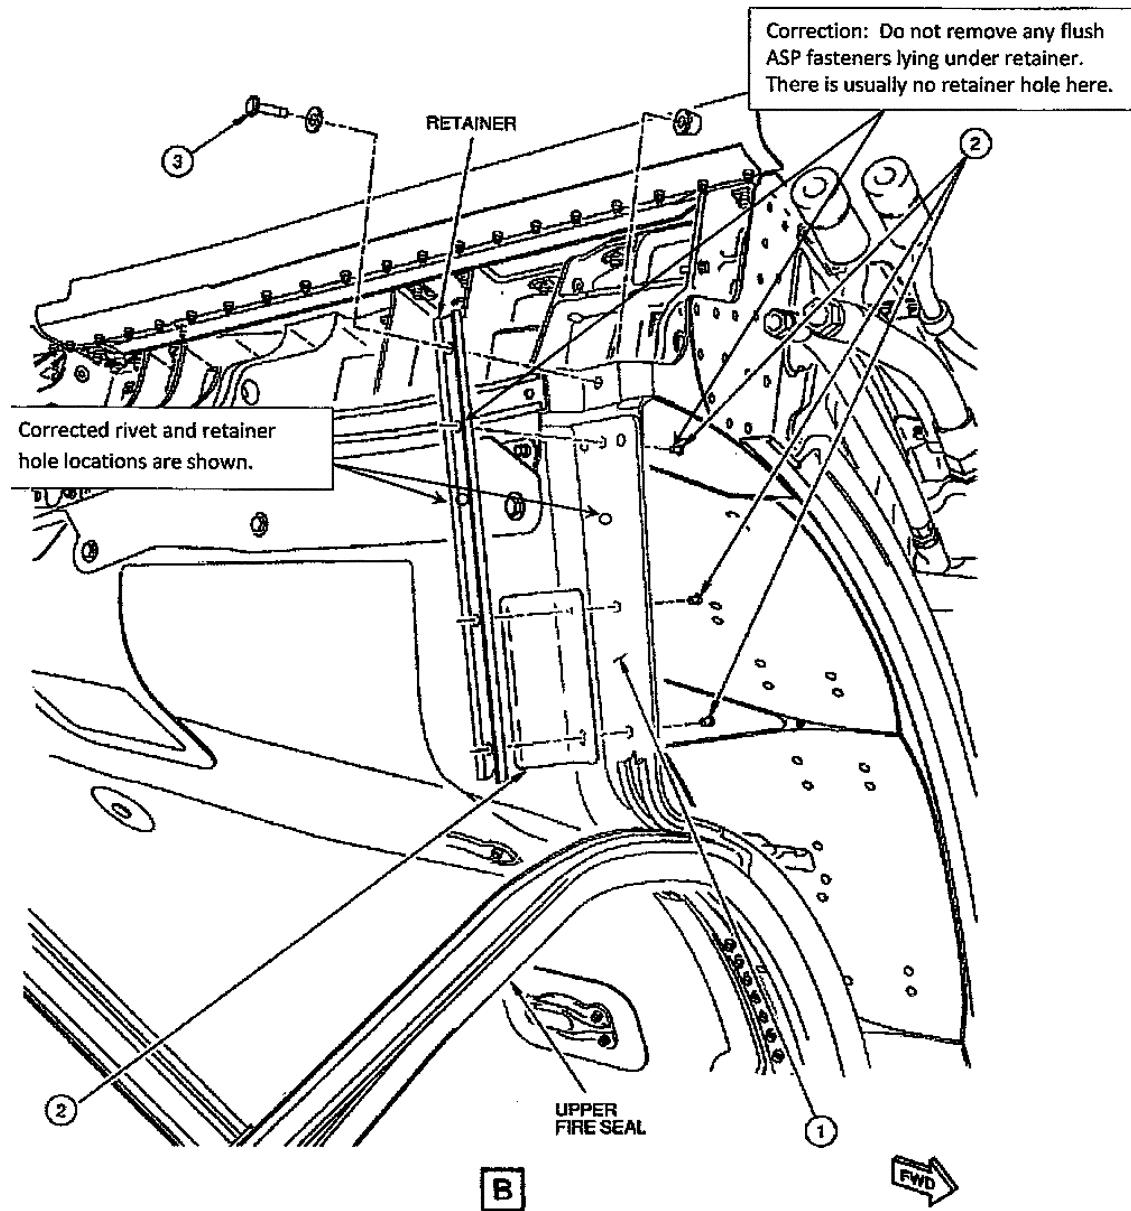
Figure 2, Installation of the New Bracket behind the Retainer Support on the Left Thrust Reverser Half

(3) Figures 2 and 4 of this AD, titled "Installation of the New Bracket behind the Retainer Support on the Left (Right) Thrust Reverser Half," have View B showing the top rivet hole. That rivet hole is actually below the row of three ASP fasteners. The figures in this AD point to the correct information for those rivet holes.
