[Docket No. FAA-2013-0486; Directorate Identifier 2010-SW-031-AD]

#### Airworthiness Directives; MD Helicopters, Inc. (MDHI), Helicopters

**ACTION:** Notice of proposed rulemaking (NPRM).

This AD applies to Model MD 900 helicopters with a main rotor blade retention bolt (bolt), part number (P/N) 900R3100001–103 or 900R3100001–105, installed; certificated in any category.

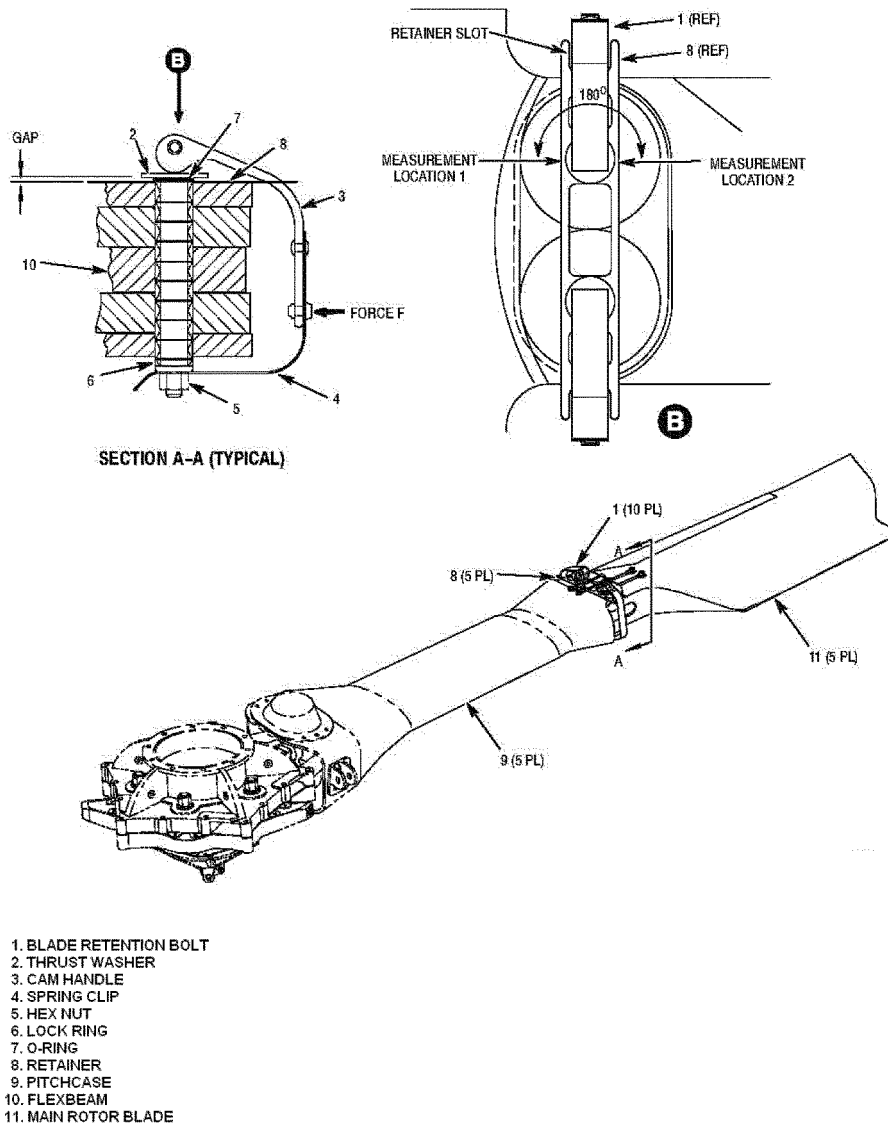
Figure 1 to paragraph (e) of this AD

- (1) Before the first flight of each day:
  - (i) Visually check each bolt for failure. Failure of a bolt may be indicated by movement of the bolt out of the bolt hole or by inconsistent extension of the bolt above or below the other bolts being inspected (a failed bolt migrates out of the bolt hole).
  - (ii) Visually check for a gap between the thrust washer and the retainer, P/N 900R2100009–101 or –103. The thrust washer is depicted as item 2 and the retainer is depicted as item 8 in Figure 1 to paragraph (e) of this AD.

(iv) If there is any indication of bolt failure or if there is no gap between the thrust washer and retainer, before further flight, remove and inspect the bolt for a crack.

Replace any cracked bolt with an airworthy bolt.

(iii) If there is a gap between the thrust washer and retainer, measure the gap in two locations, 180 degrees apart, with a feeler gage. If the gap is more than 0.100 inch (2.54 mm) at either location, before further flight, remove and inspect the bolt for a crack. Replace any cracked bolt with an airworthy bolt.
