[Docket No. FAA-2013-0019; Directorate Identifier 2010-SW-051-AD; Amendment 39-17485; AD 2013-12-07]

Airworthiness Directives; Bell Helicopter Textron Canada Helicopters

2013-12-07 Bell Helicopter Textron

Canada (BHTC): Amendment 39-17485; Docket No. FAA-2013-0019; Directorate Identifier 2010-SW-051-AD.

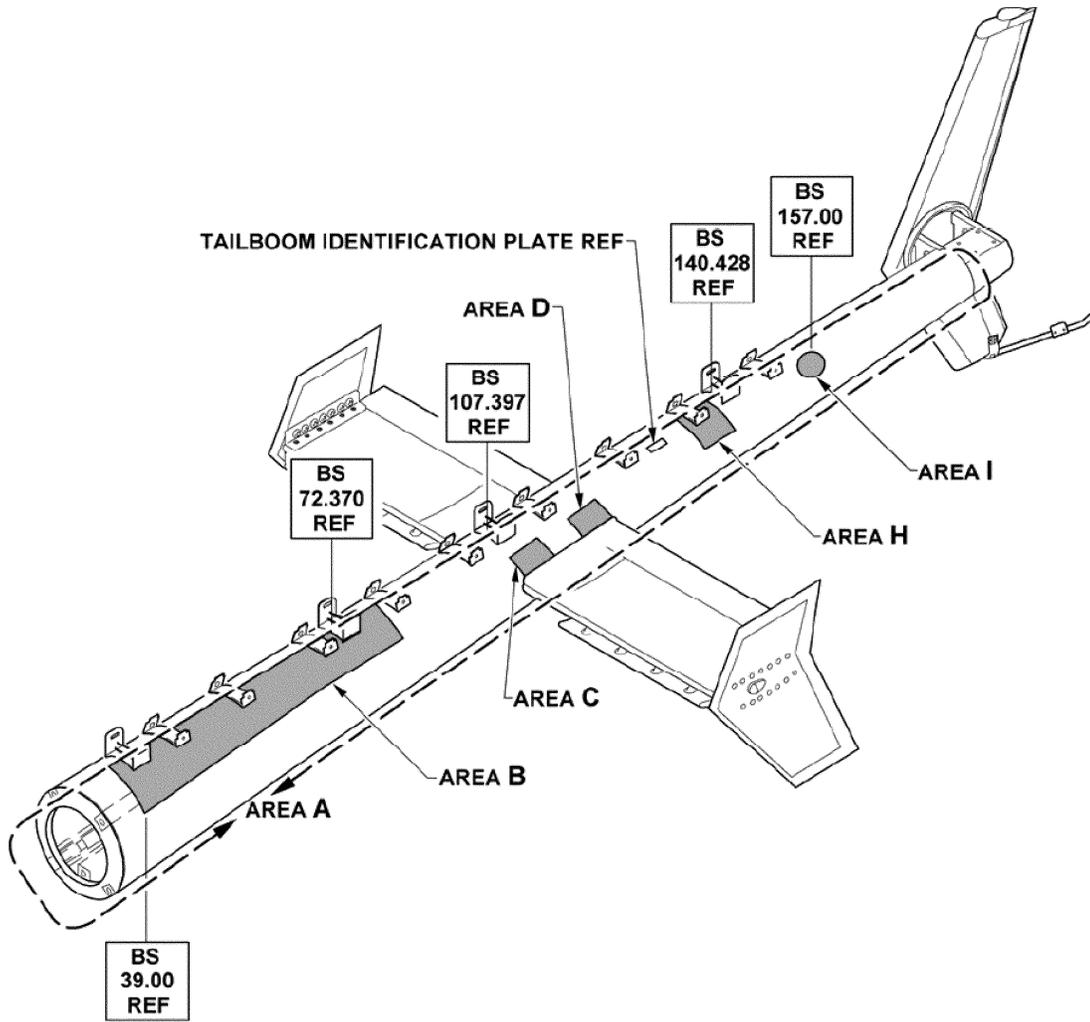
Figure 1 to Paragraph (e)

This AD defines the unsafe condition as high-stress-concentration areas in the tailboom skin that are at risk of cracking. This condition could result in a crack in the tailboom assembly, failure of the tailboom, and subsequent loss of helicopter control.

(A) Before the first flight of each day, visually check for a crack in the "C" and "D" areas depicted in Figures 1 and 2 to Paragraph (e) of this AD. The actions required by this paragraph may be performed by the owner/operator (pilot) holding at least a private pilot certificate, and must be entered into the aircraft records showing compliance with this AD in accordance with 14 CFR 43.9 (a)(1)-(4) and 14 CFR § 91.417(a)(2)(v). The record must be maintained as required by 14 CFR 91.417, 121.380, or 135.439; or

(5) If there is a crack in the tailboom assembly, before further flight, replace it with an airworthy tailboom assembly.

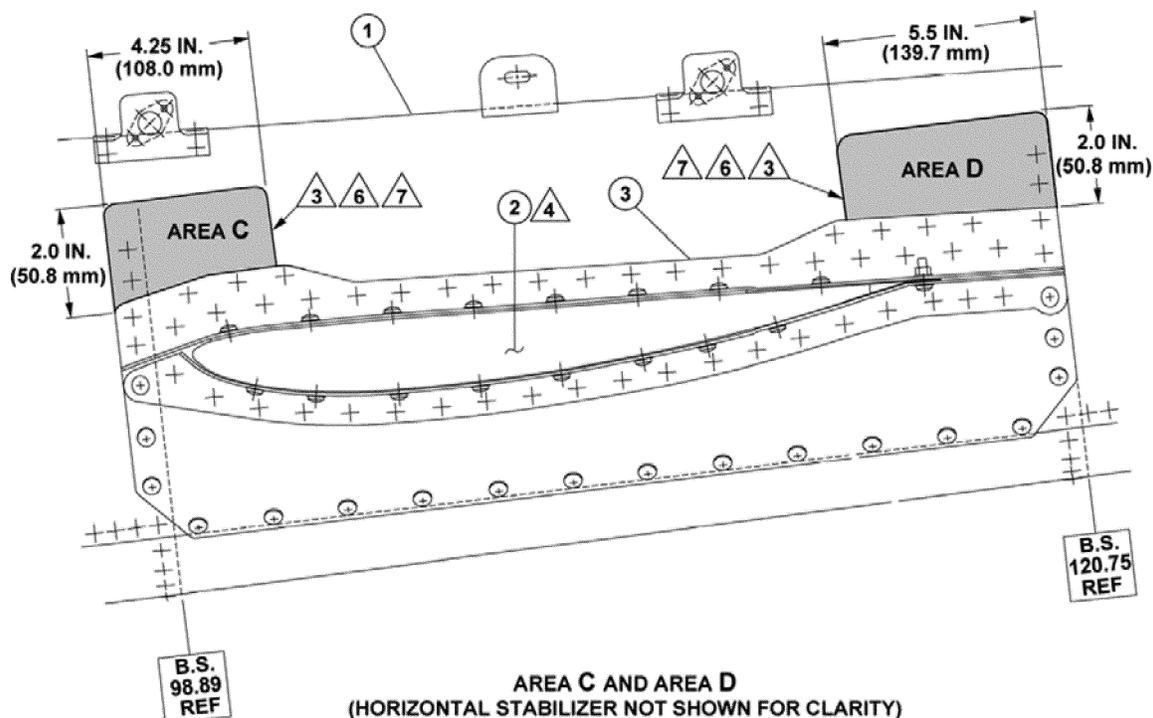
(B) Within 25 hours TIS, or 30 days, whichever comes first, and thereafter at intervals not to exceed 50 hours TIS, clean and inspect for a crack around each fastener and just above the edge of the upper stabilizer support in the "C" and "D" areas on the left side of the tailboom assembly, as depicted in Figure 2 to Paragraph (e) of this AD, using a 10X or higher power magnifying glass.
