[Docket No. FAA-2013-0019; Directorate Identifier 2010-SW-051-AD; Amendment 39-17485; AD 2013-12-07]

Airworthiness Directives; Bell Helicopter Textron Canada Helicopters

SUMMARY: We are adopting a new airworthiness directive (AD) for Bell

Helicopter Textron Canada (BHTC) Model 407 helicopters with certain tailboom assemblies installed. This AD requires, at specified intervals, inspecting the tailboom assembly for a crack, loose rivet, or other damage. This AD was prompted by a stress analysis of the tailboom skin that revealed that high-stress-concentration areas are susceptible to skin cracking. This condition, if not detected, could result in a crack in the tailboom assembly, failure of the tailboom, and subsequent loss of control of the helicopter.

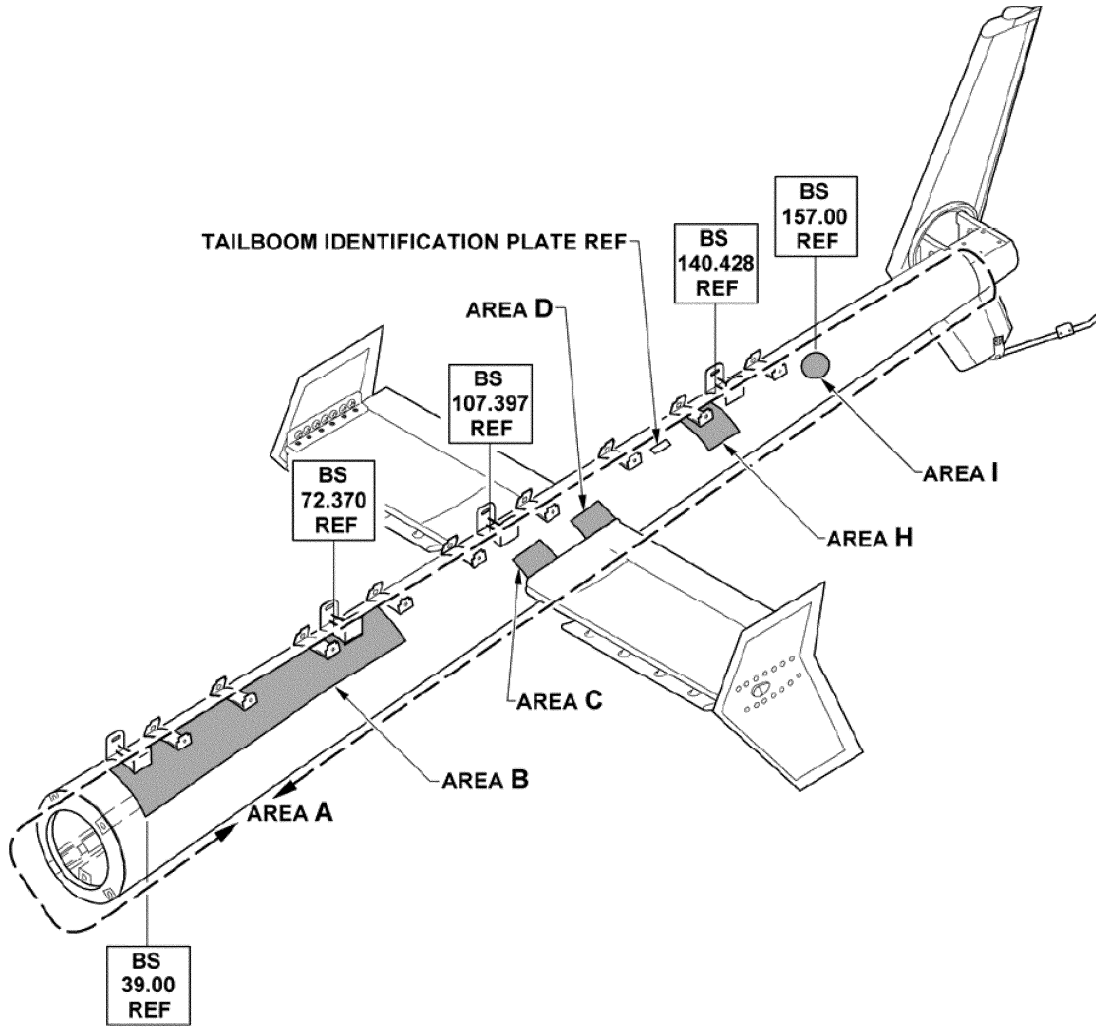
Figure 1 to Paragraph (e)

This AD defines the unsafe condition as high-stress-concentration areas in the tailboom skin that are at risk of cracking. This condition could result in a crack in the tailboom assembly, failure of the tailboom, and subsequent loss of helicopter control.

(A) Before the first flight of each day, visually check for a crack in the "C" and "D" areas depicted in Figures 1 and 2 to Paragraph (e) of this AD. The actions required by this paragraph may be performed by the owner/operator (pilot) holding at least a private pilot certificate, and must be entered into the aircraft records showing compliance with this AD in accordance with 14 CFR 43.9 (a)(1)-(4) and 14 CFR § 91.417(a)(2)(v). The record must be maintained as required by 14 CFR 91.417, 121.380, or 135.439; or

(5) If there is a crack in the tailboom assembly, before further flight, replace it with an airworthy tailboom assembly.
