## **DEPARTMENT OF TRANSPORTATION**

**[Docket No. FAA-2013-0574; Directorate Identifier 2008-SW-22-AD]**

#### **Airworthiness Directives; Bell Helicopter Textron Canada (Bell) Helicopters**

**ACTION:** Notice of proposed rulemaking (NPRM).

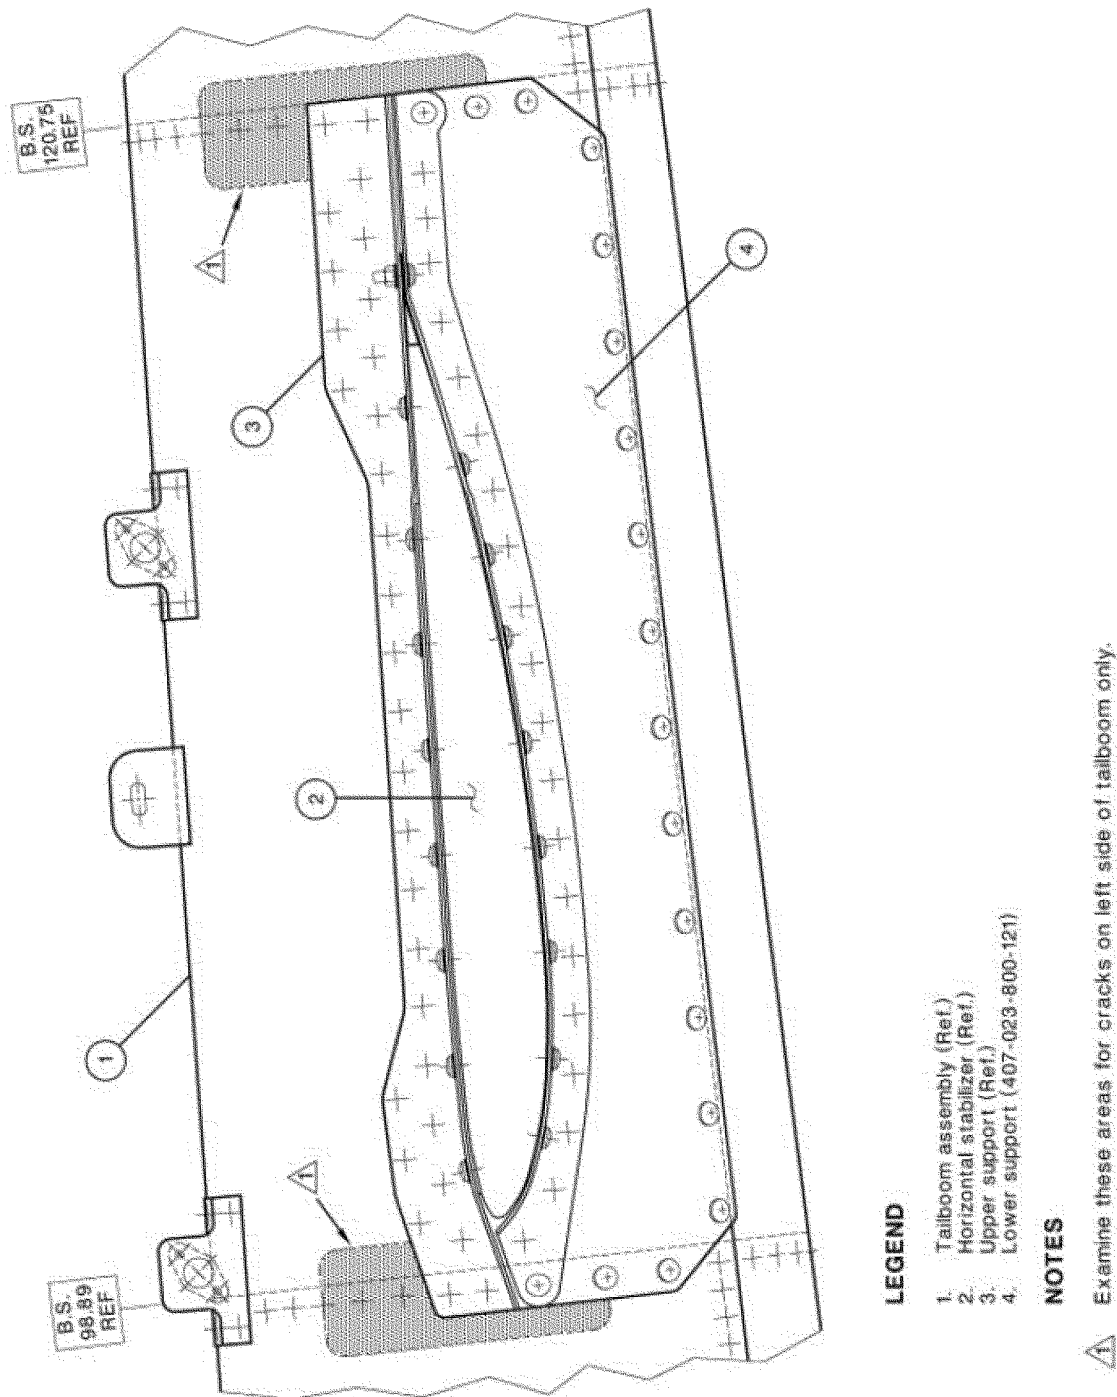
Figure 1 to Paragraph (f)(1)(i)(A)

This AD defines the unsafe condition as cracks in the tailboom skin on the left side in the area of horizontal stabilizer, which could result in separation of the tailboom and subsequent loss of control of the helicopter.

(A) Before the first flight of each day, visually check the tailboom for a crack, as depicted in Figure 1 to paragraph (f)(1)(i)(A) of this AD.

(B) For a tailboom with 600 or more hours time-in-service (TIS), within 25 hours TIS and thereafter at intervals not to exceed 50 hours TIS, visually inspect the tailboom for a crack using a 10X or higher magnifying glass by following the Accomplishment Instructions, Part II, of Bell ASB 407-99-26, Revision C, dated February 28, 2002, except this AD does not require you to contact Bell.
