[Docket No. FAA-2013-0695; Directorate
Identifier 2011-NM-264-AD]

Airworthiness Directives; Saab AB, Saab Aerosystems Airplanes

ACTION: Notice of proposed rulemaking
(NPRM).

SUMMARY: We propose to adopt a new airworthiness directive (AD) for certain Saab AB, Saab Aerosystems Model 340A (SAAB/SF340A) and SAAB 340B airplanes modified by Supplemental Type Certificate SA7971SW. This proposed AD was prompted by reports of smoke, a burning odor, and possible fire in the flight deck and cabin of the airplane, which was caused by brushes wearing beyond their limits, in the air conditioning motor. This proposed AD would require an inspection to determine if a certain air compressor motor is installed, an inspection to determine the age of a certain compressor hour meter since new or overhauled, and repetitive replacement of the brushes on affected air conditioning compressor motor units. As an option to the replacement, this proposed AD allows pulling the air conditioning circuit breaker and adding a placard. We are proposing this AD to detect and correct worn brushes contacting the commutator, which could result in a fire under the cabin floor with no means to detect or extinguish the f

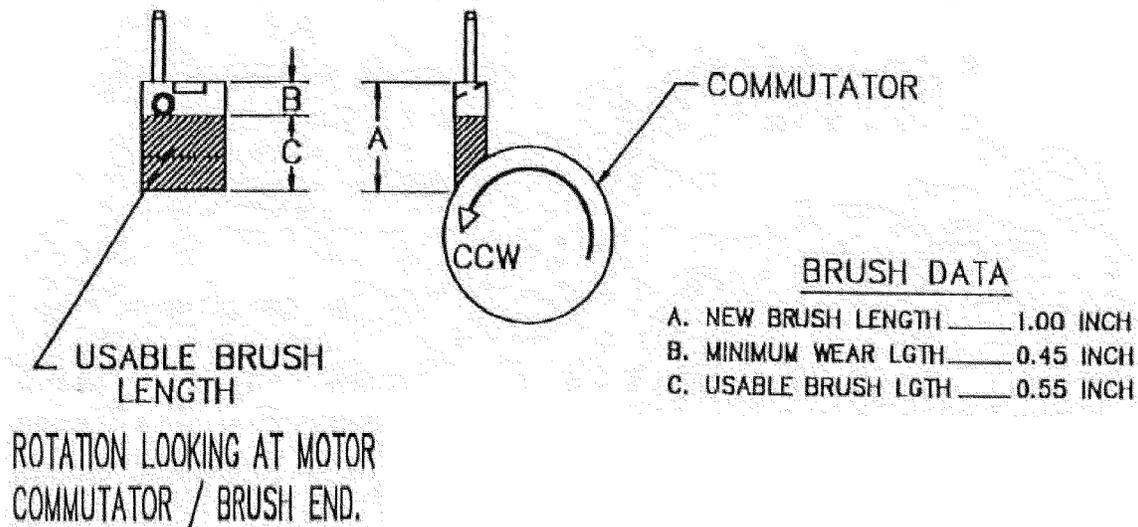
Figure 1 to paragraph (m)(2)(vii) of this AD – Measuring the Brush

(vii) Measure each brush as shown in figure below and record values.

(viii) Using the brush with the shortest measured length calculate the wear by subtracting the measured value from 1.000 inch.

(11) Install each new brush set by lifting brush springs, sliding brush into holder (with brush leading edge in direction of motor rotation) and lightly releasing the brush spring on the brush. (See Figure 1 to paragraph (m)(2)(vii) of this AD). CAUTION: Do not allow brush spring to strike hard into place or damage to brush may result.
