[Docket No. FAA-2013-0822; Directorate Identifier 2013-SW-004-AD]

Airworthiness Directives; Eurocopter France Helicopters

ACTION: Notice of proposed rulemaking (NPRM).

Eurocopter France: Docket No. FAA–2013–0822; Directorate Identifier 2013–SW–004–AD.

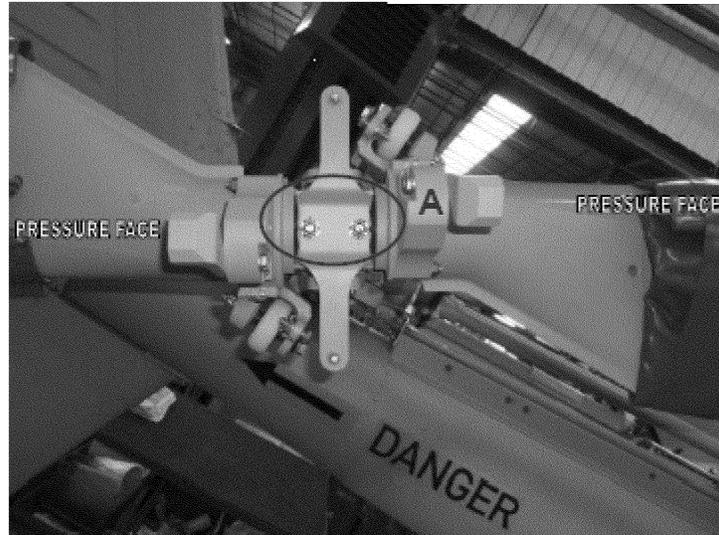
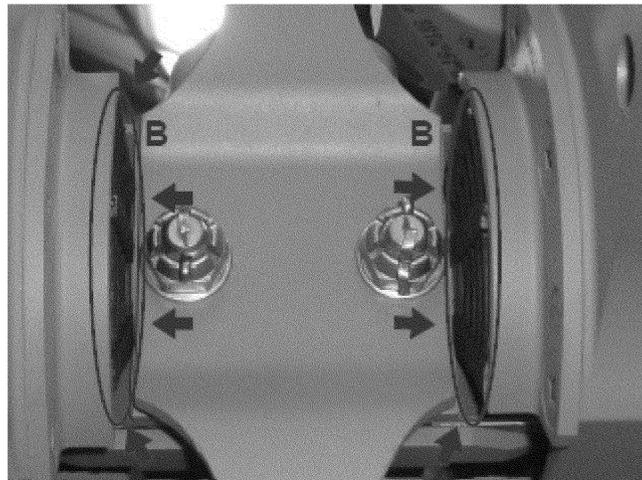
(B) Apply load (F) by hand, perpendicular to the pressure face of one tail rotor blade (a), as shown in Figure 1 to paragraph (f) of this AD, taking care not to reach the extreme position against the tail rotor hub. The load will deflect the tail rotor blade towards the tail boom.

(C) While maintaining the load, check all the visible faces of the bearings (front and side faces) in area B of DETAIL A of Figure 1 to paragraph (f) of this AD for separation between the elastomer and metal parts, a crack in the elastomer, or an extrusion (see example in Figure 2 to paragraph (f) of this AD). A flashlight may be used to enhance the check.

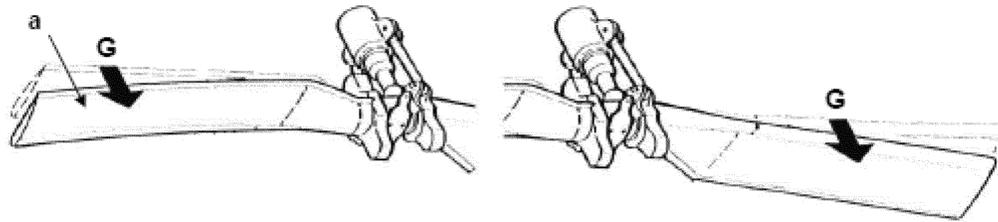
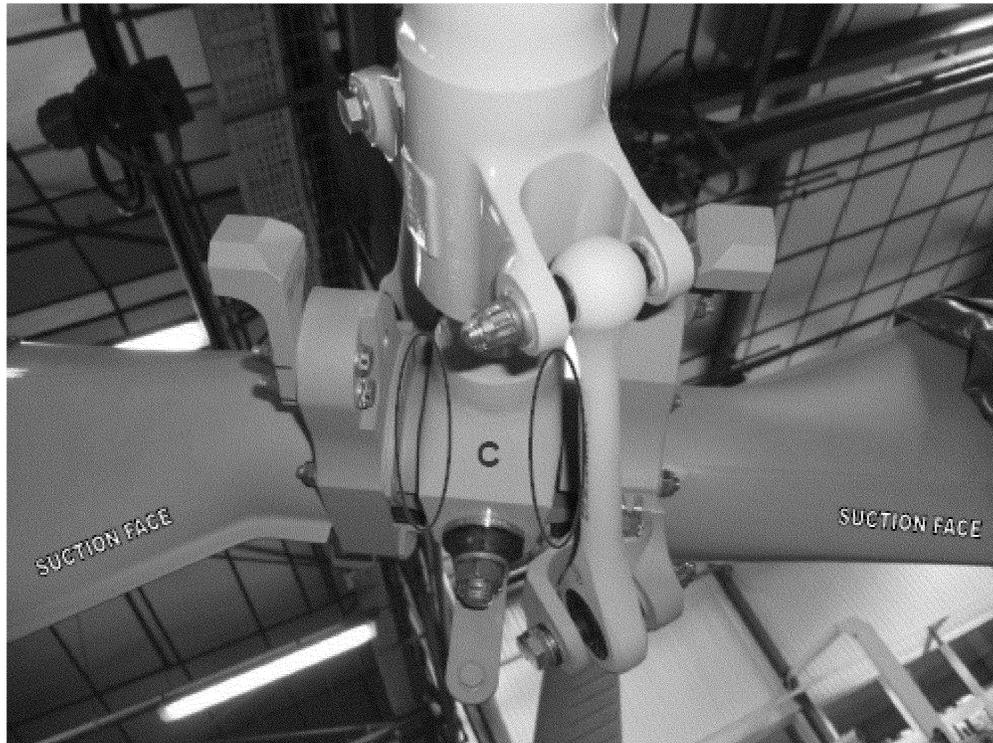
(E) Apply load (G) by hand perpendicular to the suction face of one tail rotor blade as shown in Figure 3 to paragraph (f) of this AD.

(F) While maintaining the load, check visible faces of Area C as shown in Figure 3 to paragraph (f) of this AD for any extrusion. A flashlight may be used to enhance the check.

(v) If there is an extrusion on any bearing, before further flight, replace the four bearings with airworthy bearings.

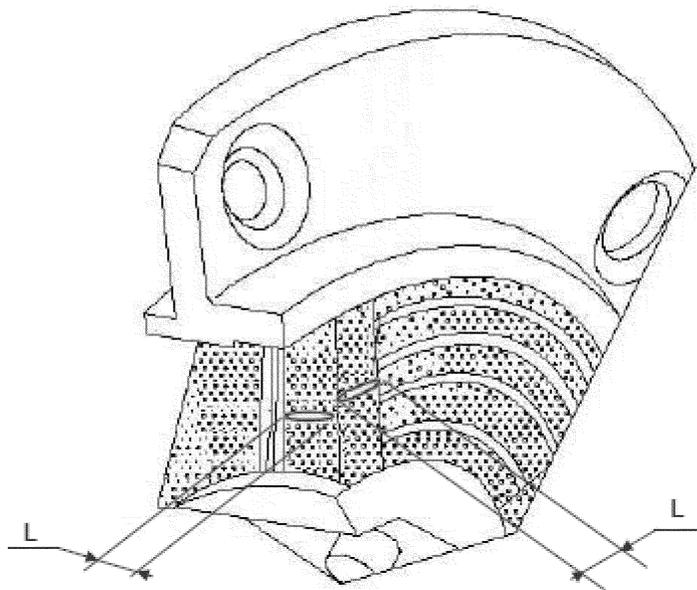
(vi) If there is a separation or a crack on the pressure side bearing, measure the separation or the crack. If the separation or crack is greater than 5 millimeters (.196 inches) as indicated by dimension “L” in Figure 4 to paragraph (f) of this AD, before further flight, replace the four bearings with airworthy bearings.
