[Docket No. FAA-2013-0146; Directorate Identifier 2012-SW-060-AD; Amendment 39-17559; AD 2013-16-21]

#### **Airworthiness Directives; Agusta S.p.A. (Type Certificate Currently Held by Agusta Westland S.p.A) (Agusta) Helicopters**

**ACTION:** Final rule.

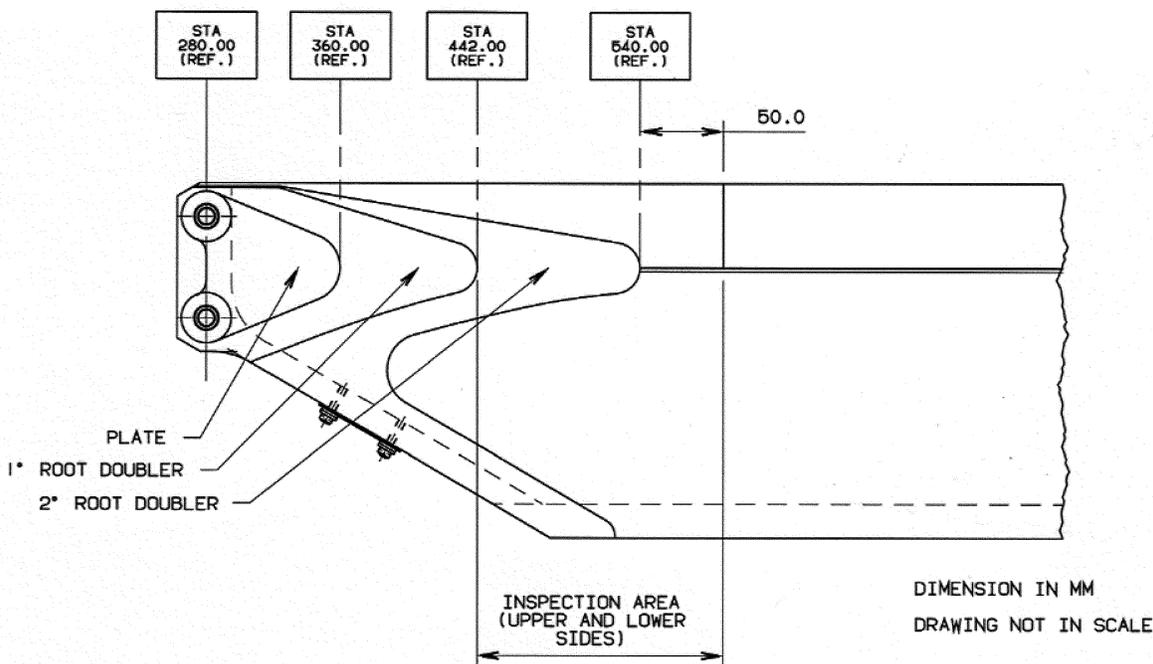
Figure 1 to Paragraph (f)(1), T/R Blade, P/N 109-8132-01-111

This AD defines the unsafe condition as a fatigue crack in a T/R blade. This condition could result in failure of the T/R blade and subsequent loss of control of the helicopter.

(1) Before each start of the helicopter engines, visually check both sides of each T/R blade for a crack in the inspection area depicted in Figure 1 to paragraph (f)(1) of this AD. This action may be performed by the owner/operator (pilot) holding at least a private pilot certificate, and must be entered into the aircraft records showing compliance with this AD in accordance with 14 CFR 43.9 (a)(1)-(4) and 14 CFR 91.417(a)(2)(v). The record must be maintained as required by 14 CFR 91.417, 121.380, or 135.439.

(5) If there is a crack in a T/R blade, before further flight, replace the cracked T/R blade.
