#### Airworthiness Directives; Eurocopter France Helicopters

**ACTION:** Notice of proposed rulemaking (NPRM).

**Eurocopter France:** Docket No. FAA–2011–1158; Directorate Identifier 2010–SW–018–AD.

This AD defines the unsafe condition as excessive play in the control rod. This condition could result in failure of a T/R control rod, loss of T/R control, and subsequent loss of control of the helicopter.

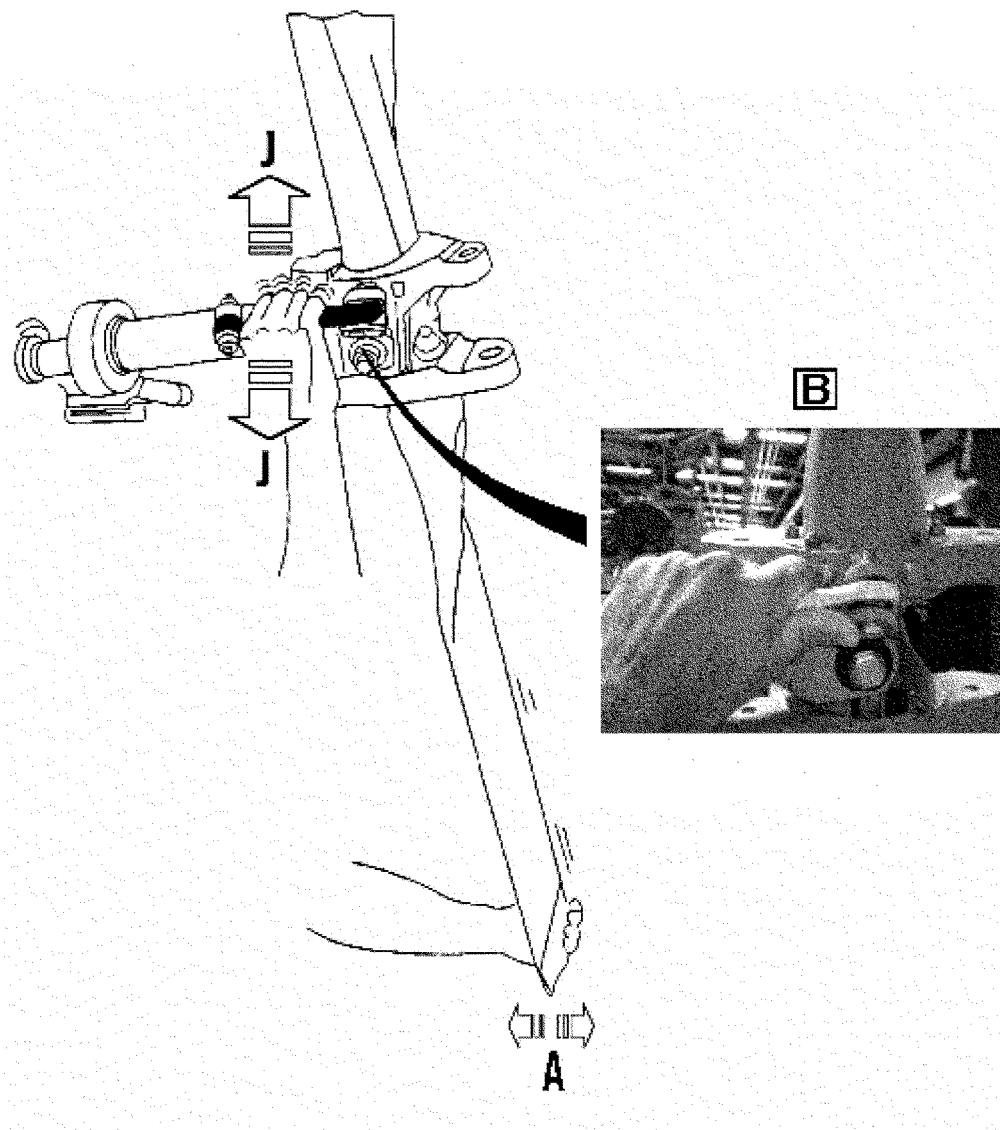
Manual Check for Play of the Tail Rotor Pitch Control Rod  
Figure 1 to Paragraph (f)

(1) Within 30 hours time-in-service (TIS) and, if no bearing play is detected, thereafter at intervals not to exceed 30 hours TIS, place the T/R pedals in the neutral position. If the helicopter is fitted with a T/R load compensator, discharge the accumulator as described in the rotorcraft flight manual. Check the control rod bearing (bearing) for play on the helicopter, by observation and feel, by slightly moving the T/R blade in the flapping axis while monitoring the bearing for movement. See the following Figure 1 to Paragraph (f) of this AD. The actions required by this paragraph may be performed by the owner/operator (pilot) holding at least a private pilot certificate, and must be entered into the helicopter maintenance records showing compliance with this AD in accordance with 14 CFR 43.9(a)(1)–(4) and 14 CFR 91.417(a)(2)(v). The record must be maintained as required by 14 CFR 91.417, 121.380, or 135.439.

(2) If a pilot or mechanic detects play in the bearing, before the next flight, a mechanic must remove the control rod from the

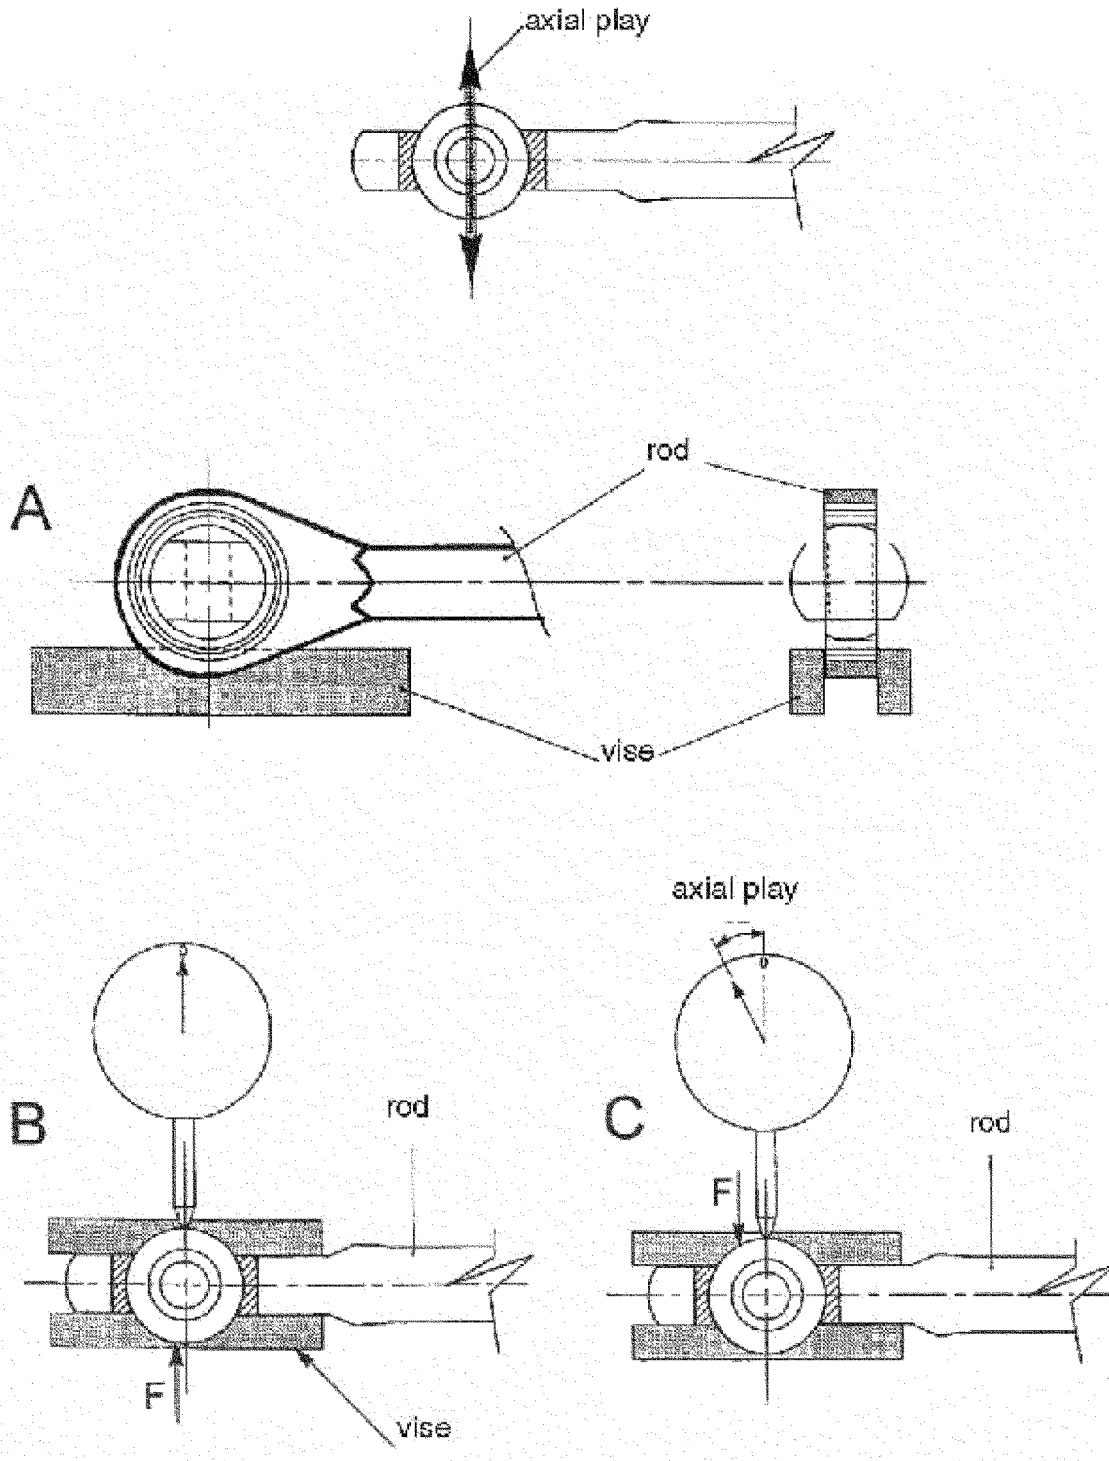
Measurement of the Axial Play (A) of the Bearing

(ii) Mount the control rod in a vise as shown in Figure 2 to Paragraph (f) of this AD.

(iii) Using a dial indicator, take axial play readings by moving the spherical bearing in the direction F (up and down) as shown in Figure 2 to Paragraph (f) of this AD.

(viii) If the radial play exceeds 0.008 inch or axial play exceeds 0.016 inch, replace the control rod with an airworthy control rod before further flight.
