#### Airworthiness Directives; Eurocopter France Helicopters

**ACTION:** Notice of proposed rulemaking (NPRM).

**Eurocopter France:** Docket No. FAA-2011-1158; Directorate Identifier 2010-SW-018-AD.

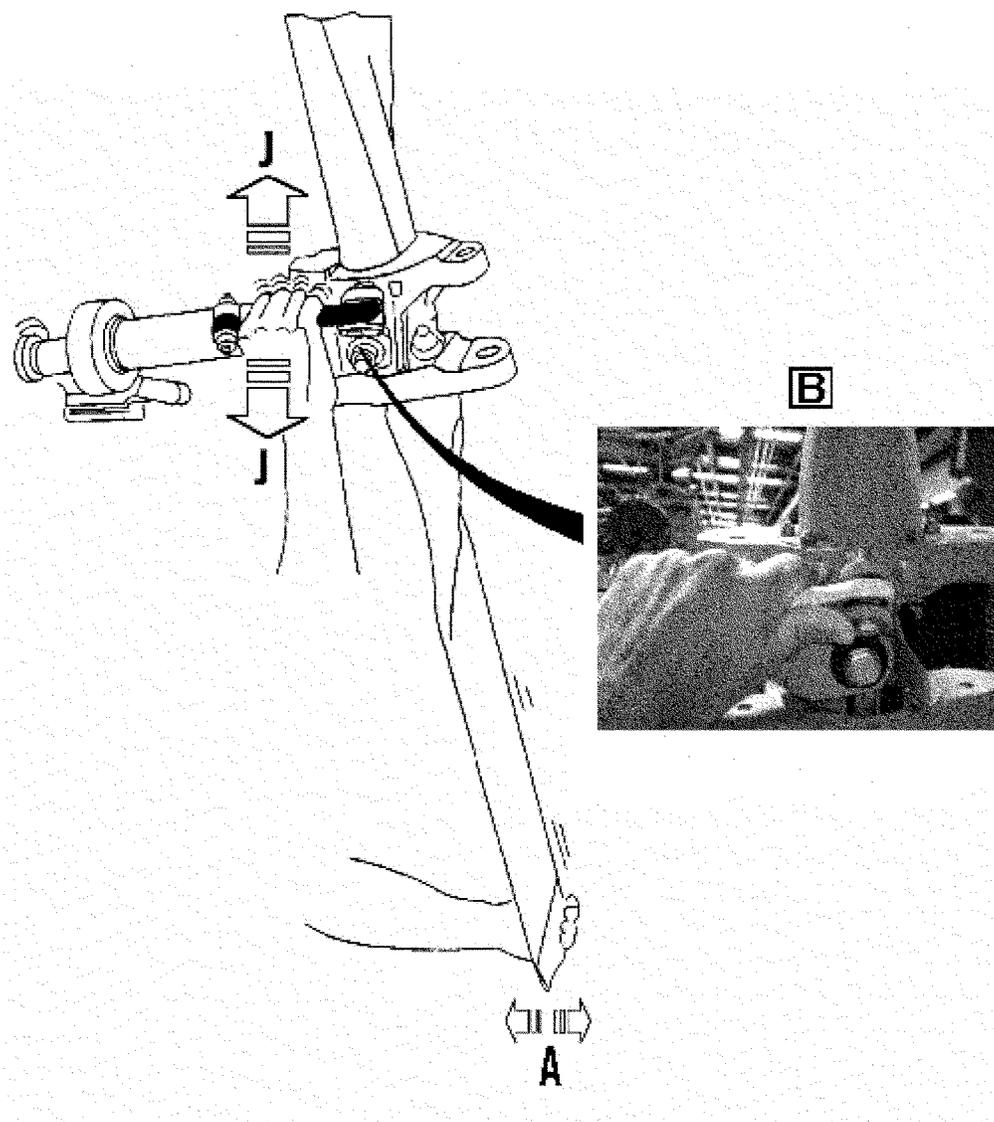
Manual Check for Play of the Tail Rotor Pitch Control Rod  
Figure 1 to Paragraph (f)

(1) Within 30 hours time-in-service (TIS) and, if no bearing play is detected, thereafter at intervals not to exceed 30 hours TIS, place the T/R pedals in the neutral position. If the helicopter is fitted with a T/R load compensator, discharge the accumulator as described in the rotorcraft flight manual. Check the control rod bearing (bearing) for play on the helicopter, by observation and feel, by slightly moving the T/R blade in the flapping axis while monitoring the bearing for movement. See the following Figure 1 to Paragraph (f) of this AD. The actions required by this paragraph may be performed by the owner/operator (pilot) holding at least a private pilot certificate, and must be entered into the helicopter maintenance records showing compliance with this AD in accordance with 14 CFR 43.9(a)(1)-(4) and 14 CFR 91.417(a)(2)(v). The record must be maintained as required by 14 CFR 91.417, 121.380, or 135.439.

(2) If a pilot or mechanic detects play in the bearing, before the next flight, a mechanic must remove the control rod from the

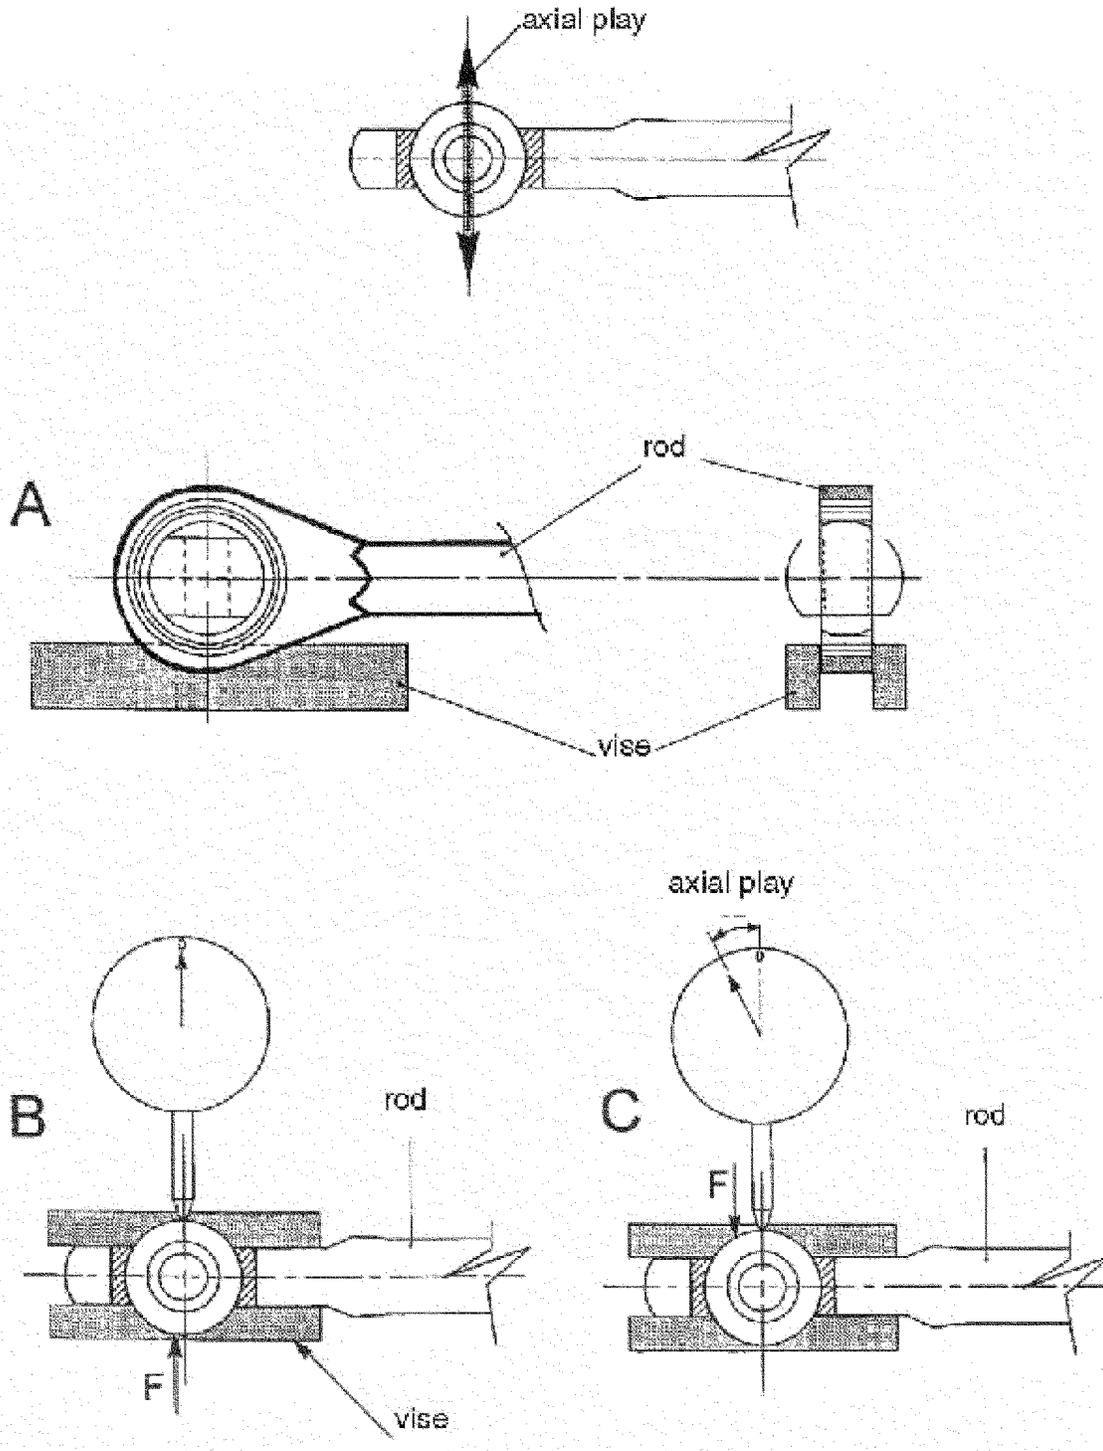
Measurement of the Axial Play (A) of the Bearing

(iii) Using a dial indicator, take axial play readings by moving the spherical bearing in the direction F (up and down) as shown in Figure 2 to Paragraph (f) of this AD.

(viii) If the radial play exceeds 0.008 inch or axial play exceeds 0.016 inch, replace the control rod with an airworthy control rod before further flight.

(ii) Mount the control rod in a vise as shown in Figure 2 to Paragraph (f) of this AD.

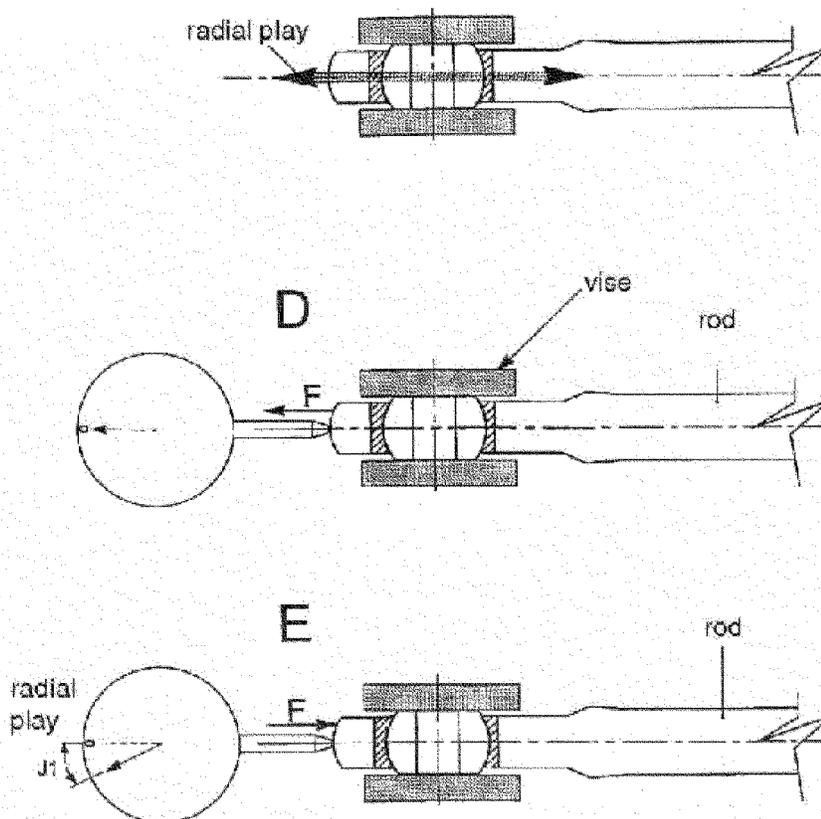
Figure (3) to Paragraph (f)

Measurement of the Radial Play (R) of the Bearing

(vi) Using a dial indicator, take radial play measurements by moving the control rod in the direction F as shown in Figure 3 to Paragraph (f) of this AD.

(v) Mount the control rod and bearing in a vise as shown in Figure 3 to Paragraph (f) of this AD.
