[Docket No. FAA-2011-1158; Directorate Identifier 2010-SW-018-AD]

#### Airworthiness Directives; Eurocopter France Helicopters

**SUMMARY:** We propose to revise airworthiness directive (AD) 2011-22-05 for Eurocopter France (Eurocopter) Model AS350B, B1, B2, B3, BA, C, D, D1, AS355E, F, F1, F2, N, and NP helicopters with certain tail rotor pitch control rods installed. AD 2011-22-05 currently requires, before the first flight of each day, checking the tail rotor (T/R) pitch control rod (control rod) outboard spherical bearing (bearing) for play. If play exists, AD 2011-22-05 requires measuring the bearing's radial and axial play. Since we issued AD 2011-22-05, we have determined that we can safely extend the compliance time to perform the initial and recurring checks for bearing play. The proposed actions are intended to prevent failure of a control rod, loss of T/R control, and subsequent loss of control of the helicopter.

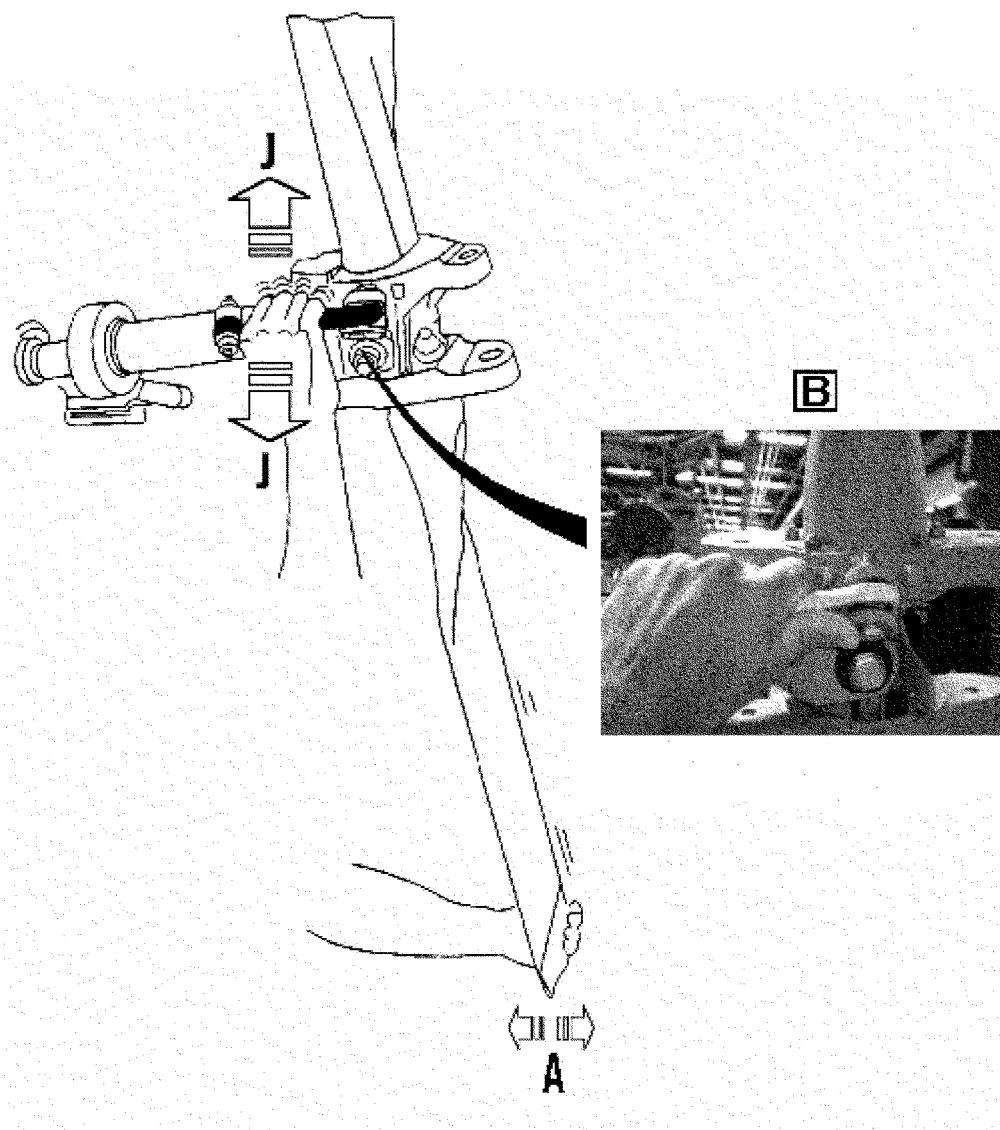
Manual Check for Play of the Tail Rotor Pitch Control Rod  
Figure 1 to Paragraph (f)

This AD defines the unsafe condition as excessive play in the control rod. This condition could result in failure of a T/R control rod, loss of T/R control, and subsequent loss of control of the helicopter.

(1) Within 30 hours time-in-service (TIS) and, if no bearing play is detected, thereafter at intervals not to exceed 30 hours TIS, place the T/R pedals in the neutral position. If the helicopter is fitted with a T/R load compensator, discharge the accumulator as described in the rotorcraft flight manual. Check the control rod bearing (bearing) for play on the helicopter, by observation and feel, by slightly moving the T/R blade in the flapping axis while monitoring the bearing for movement. See the following Figure 1 to Paragraph (f) of this AD. The actions required by this paragraph may be performed by the owner/operator (pilot) holding at least a private pilot certificate, and must be entered into the helicopter maintenance records showing compliance with this AD in accordance with 14 CFR 43.9(a)(1)-(4) and 14 CFR 91.417(a)(2)(v). The record must be maintained as required by 14 CFR 91.417, 121.380, or 135.439.

(2) If a pilot or mechanic detects play in the bearing, before the next flight, a mechanic must remove the control rod from the

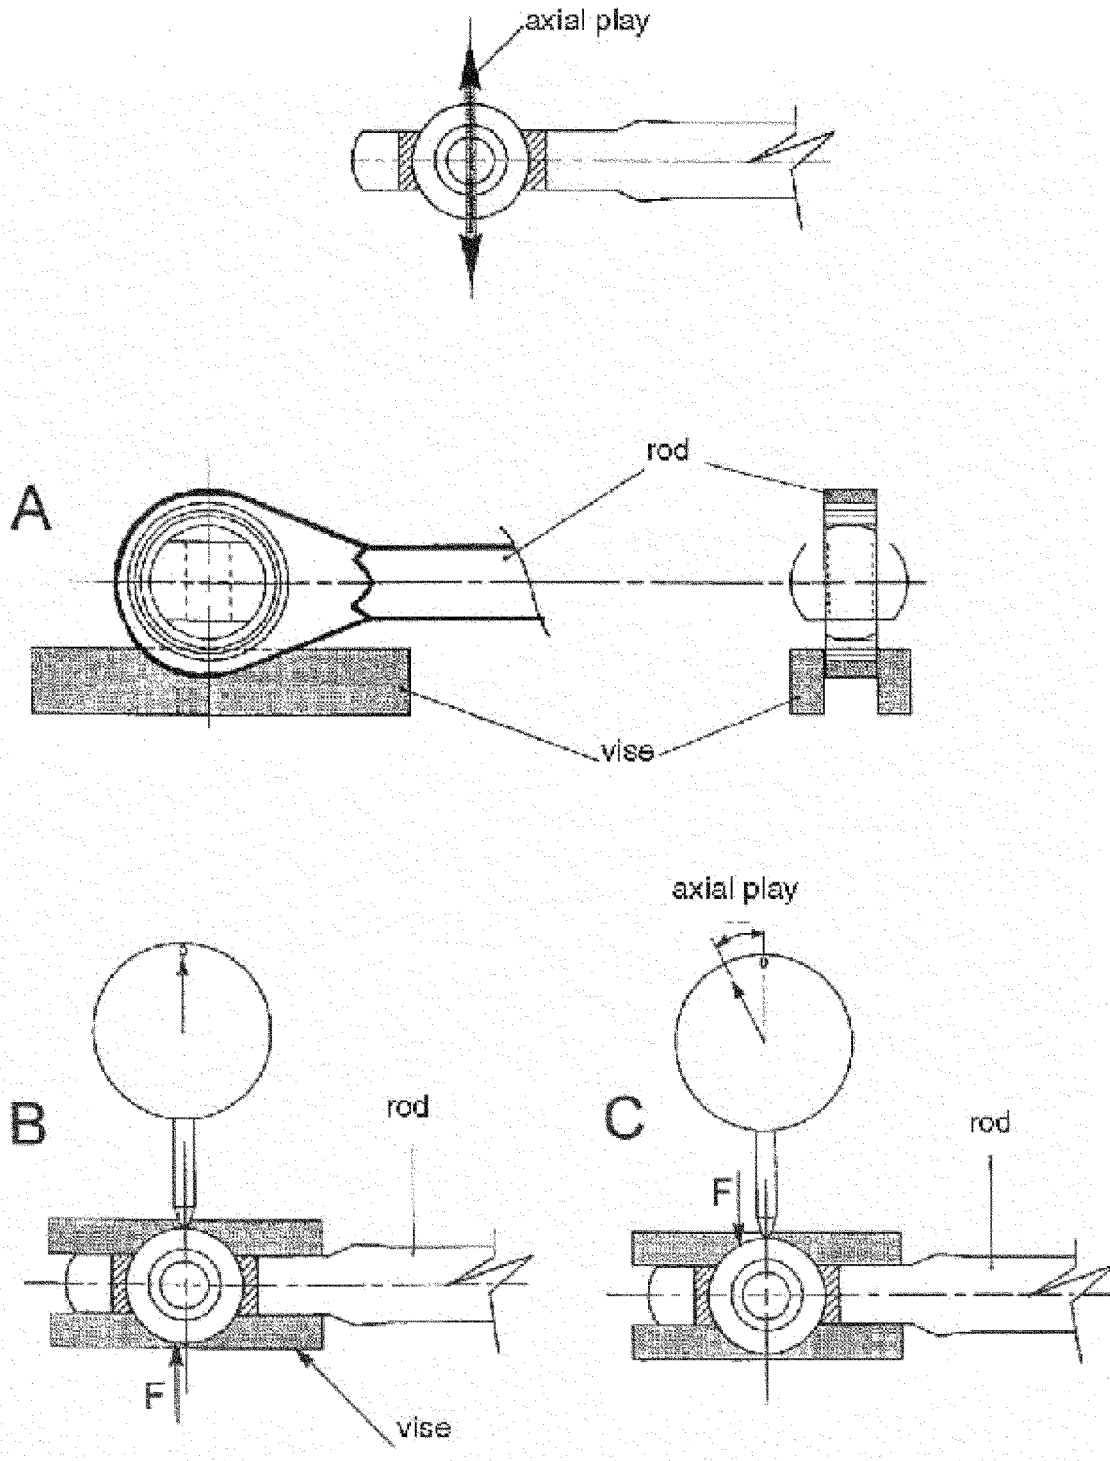
Measurement of the Axial Play (A) of the Bearing

(iii) Using a dial indicator, take axial play readings by moving the spherical bearing in the direction F (up and down) as shown in Figure 2 to Paragraph (f) of this AD.

(viii) If the radial play exceeds 0.008 inch or axial play exceeds 0.016 inch, replace the control rod with an airworthy control rod before further flight.

(ii) Mount the control rod in a vise as shown in Figure 2 to Paragraph (f) of this AD.

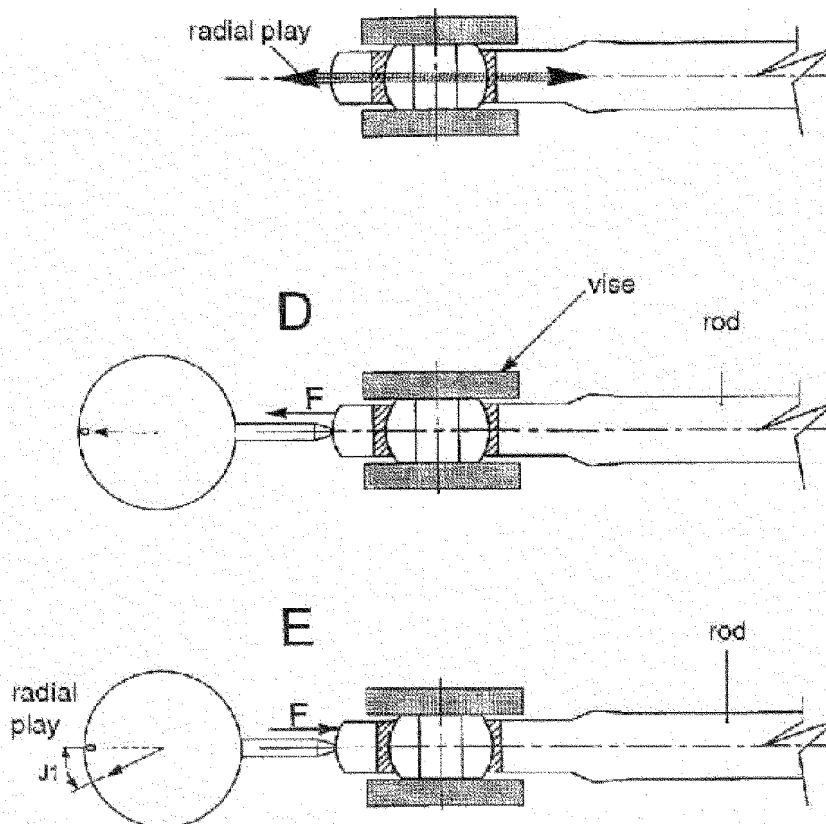
Figure (3) to Paragraph (f)

Measurement of the Radial Play (R) of the Bearing

(vi) Using a dial indicator, take radial play measurements by moving the control rod in the direction F as shown in Figure 3 to Paragraph (f) of this AD.

(v) Mount the control rod and bearing in a vise as shown in Figure 3 to Paragraph (f) of this AD.
