[Docket No. FAA-2013-0486; Directorate Identifier 2010-SW-031-AD; Amendment 39-17622; AD 2013-20-16]

Airworthiness Directives; MD Helicopters, Inc. (MDHI) Helicopters

2013–20–16 MD Helicopters, Inc. (MDHI):
Amendment 39–17622; Docket No. FAA–2013–0486; Directorate Identifier 2010–SW–031–AD.

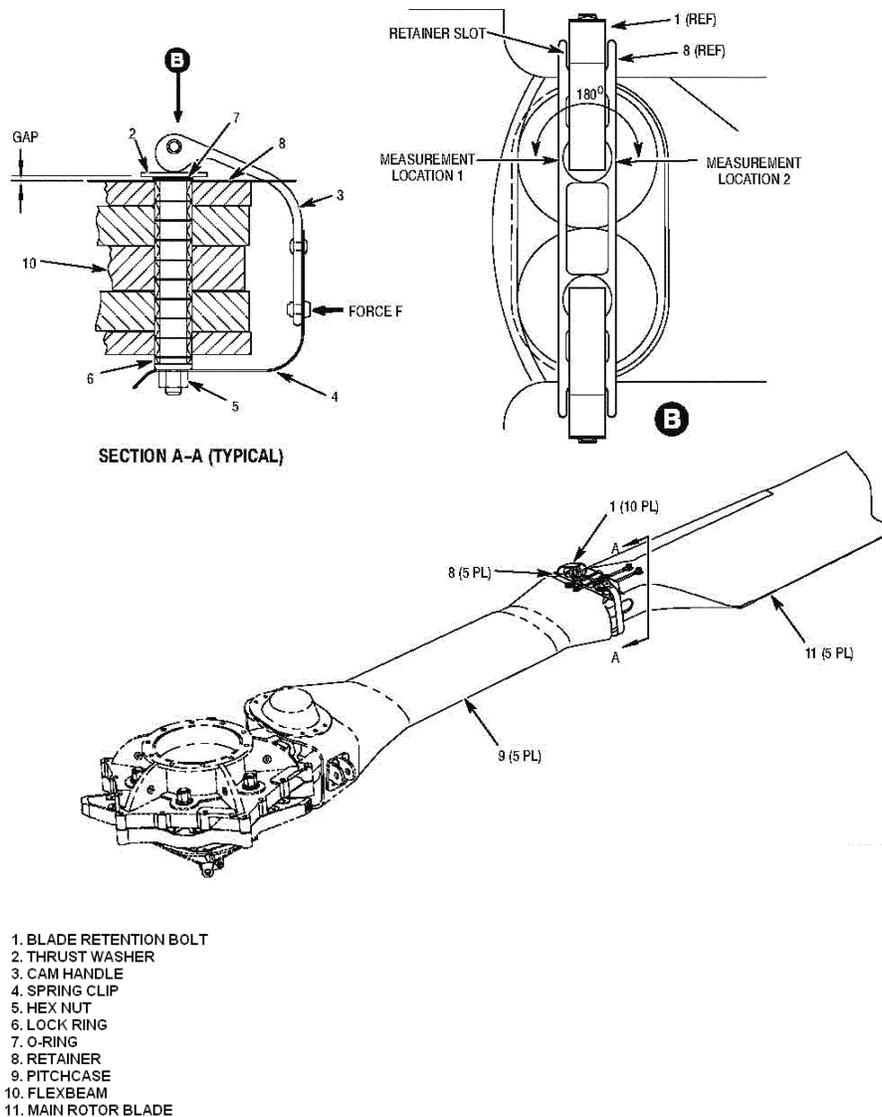
Figure 1 to Paragraph (e)
Gap and Force Check of the Blade Retention Bolts

- (1) Before the first flight of each day:
 - (i) Visually check each bolt for failure. Failure of a bolt may be indicated by movement of the bolt out of the bolt hole or by inconsistent extension of the bolt above or below the other bolts being inspected (a failed bolt migrates out of the bolt hole).
 - (ii) Visually check for a gap between the thrust washer and the retainer, P/N 900R2100009–101 or –103. The thrust washer is depicted as item 2 and the retainer is depicted as item 8 in Figure 1 to paragraph (e) of this AD.

(iv) If there is any indication of bolt failure or if there is no gap between the thrust washer and retainer, before further flight, remove and inspect the bolt for a crack. Replace any cracked bolt with an airworthy bolt.

(iii) If there is a gap between the thrust washer and retainer, measure the gap in two locations, 180 degrees apart, with a feeler gage. If the gap is more than 0.100 inch (2.54 mm) at either location, before further flight,

remove and inspect the bolt for a crack. Replace any cracked bolt with an airworthy bolt.
