[Docket No. FAA-2013-0879; Directorate Identifier 2013-NE-30-AD; Amendment 39-17694; AD 2013-24-17]

Airworthiness Directives; General Electric Company Turbofan Engines

Airworthiness Directives; The Boeing Company Airplanes

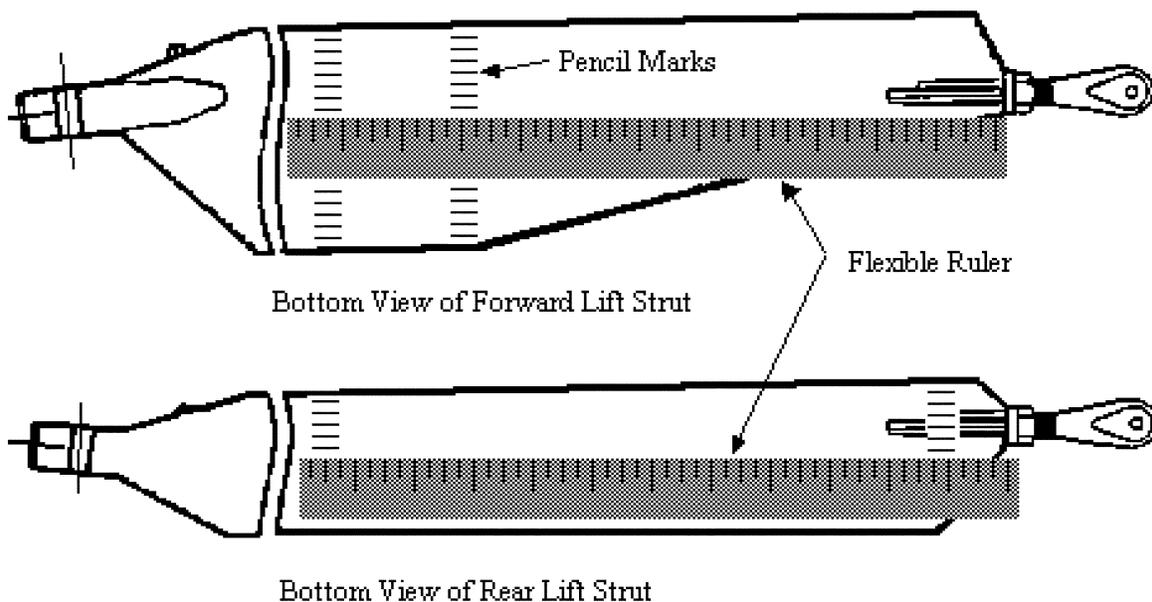
Figure 1

• NOTE: The strut wall contains a fabrication bead at approximately 40% of the strut chord. The bead may interfere with accurate measurements in that specific location.

8. A measurement of 0.024-inch or less shall require replacement of the strut prior to further flight.
