Airworthiness Directives; Eurocopter Deutschland GmbH Helicopters

ACTION: Notice of proposed rulemaking (NPRM).

Eurocopter Deutschland GmbH (ECD):

Docket No. FAA–2014–0034; Directorate Identifier 2013–SW–006–AD.

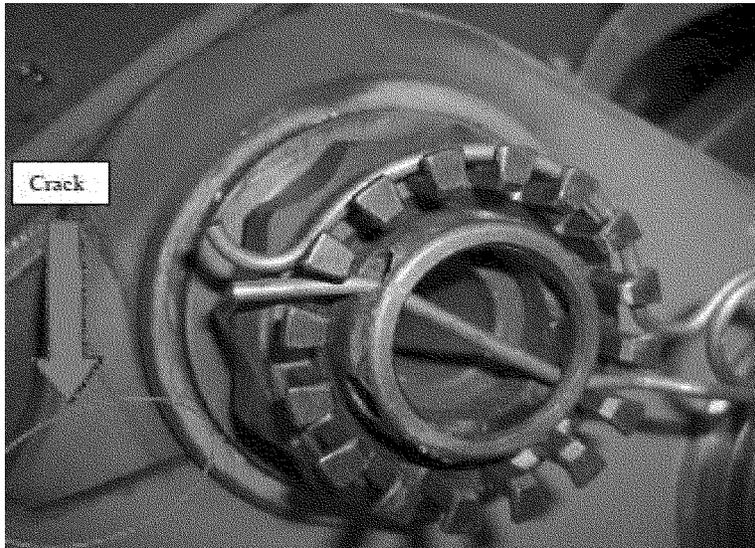
Figure 1 to Paragraph (f)(1)

This AD defines the unsafe condition as a crack in the MRH shaft flange, which could result in failure of the MRH and subsequent loss of control of the helicopter.

(1) Before further flight, and thereafter at intervals not to exceed 6 hours time-in-service (TIS), check the MRH shaft lower flange and the visible area of the MRH shaft upper flange for a crack. Figures 1 and 2 to Paragraph (f)(1) of this AD are examples of cracks that have been discovered in the MRH shaft lower flange. The actions required by this paragraph may be performed by the owner/operator (pilot) holding at least a private pilot certificate, and must be entered into the aircraft records showing compliance with this AD in accordance with 14 CFR 43.9 (a)(1)-(4) and 14 CFR 91.417(a)(2)(v). The record must be maintained as required by 14 CFR 91.417, 121.380, or 135.439.

(3) If there is a crack in the upper or lower MRH shaft flange, before further flight, replace that MRH shaft with an airworthy MRH shaft. Replacing the MRH shaft with an MRH shaft having a P/N listed in the applicability of this AD does not constitute
