[Docket No. FAA-2014-0034; Directorate Identifier 2013-SW-006-AD]

Airworthiness Directives; Eurocopter Deutschland GmbH Helicopters

ACTION: Notice of proposed rulemaking (NPRM).

Eurocopter Deutschland GmbH (ECD):

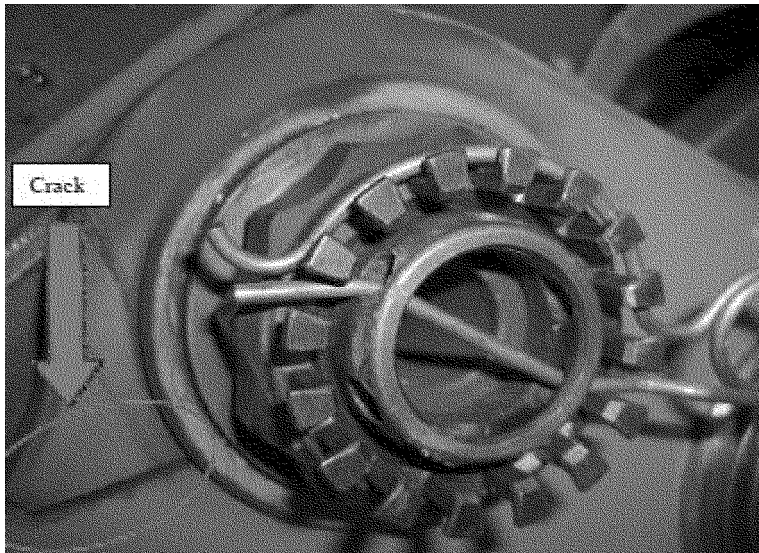
Figure 1 to Paragraph (f)(1)

This AD defines the unsafe condition as a crack in the MRH shaft flange, which could result in failure of the MRH and subsequent loss of control of the helicopter.

(1) Before further flight, and thereafter at intervals not to exceed 6 hours time-in-service (TIS), check the MRH shaft lower flange and the visible area of the MRH shaft upper flange for a crack. Figures 1 and 2 to Paragraph (f)(1) of this AD are examples of cracks that have been discovered in the MRH shaft lower flange. The actions required by this paragraph may be performed by the owner/operator (pilot) holding at least a private pilot certificate, and must be entered into the aircraft records showing compliance with this AD in accordance with 14 CFR 43.9 (a)(1)-(4) and 14 CFR 91.417(a)(2)(v). The record must be maintained as required by 14 CFR 91.417, 121.380, or 135.439.

(3) If there is a crack in the upper or lower MRH shaft flange, before further flight, replace that MRH shaft with an airworthy MRH shaft. Replacing the MRH shaft with an MRH shaft having a P/N listed in the applicability of this AD does not constitute
