#### Airworthiness Directives; Airbus Airplanes

**Airbus:** Docket No. FAA–2012–0807; Directorate Identifier 2011–NM–191–AD.

Air Transport Association (ATA) of America Code 35, Oxygen.

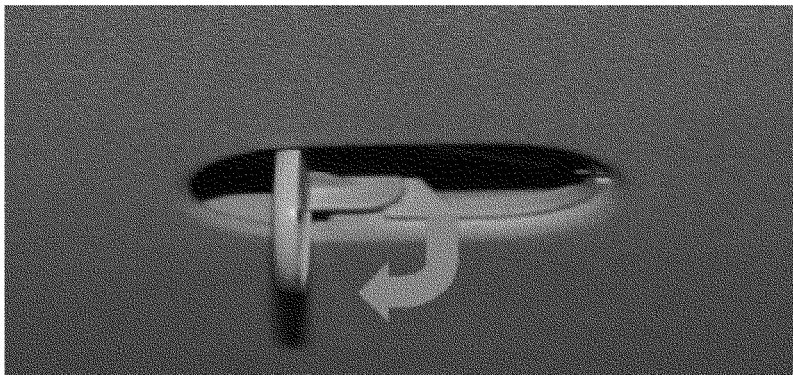
**Picture B:**

(7) The requirements of paragraphs (g) and (h) of this AD apply only to passenger oxygen containers that are Design A, as defined in figure 1 to paragraph (i)(7) of this AD.
