[Docket No. FAA-2012-0807; Directorate Identifier 2011-NM-191-AD]

Airworthiness Directives; Airbus Airplanes

Airbus: Docket No. FAA–2012–0807; Directorate Identifier 2011–NM–191–AD.

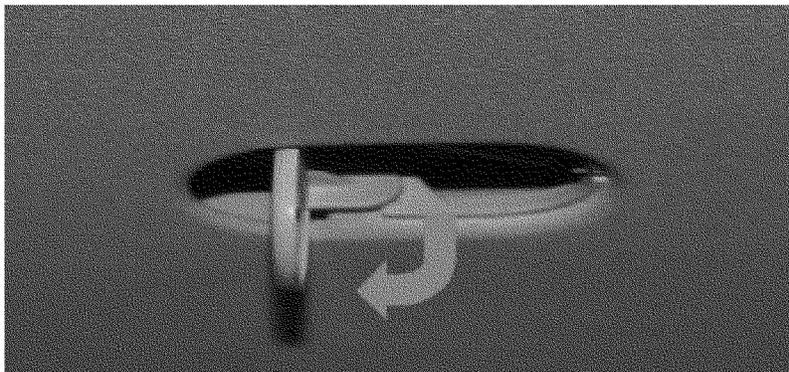
Picture B:

Design A: The placard on the passenger oxygen container test button is as described in Picture A of Appendix 1 of this AD. The Mask configuration ("ZZ" in Picture A) is a number and the test button is as shown in Picture B.
