[Docket No. FAA-2013-0695; Directorate Identifier 2011-NM-264-AD; Amendment 39-17726; AD 2014-01-03]

#### Airworthiness Directives; Saab AB, Saab Aerosystems Airplanes

**ACTION:** Final rule.

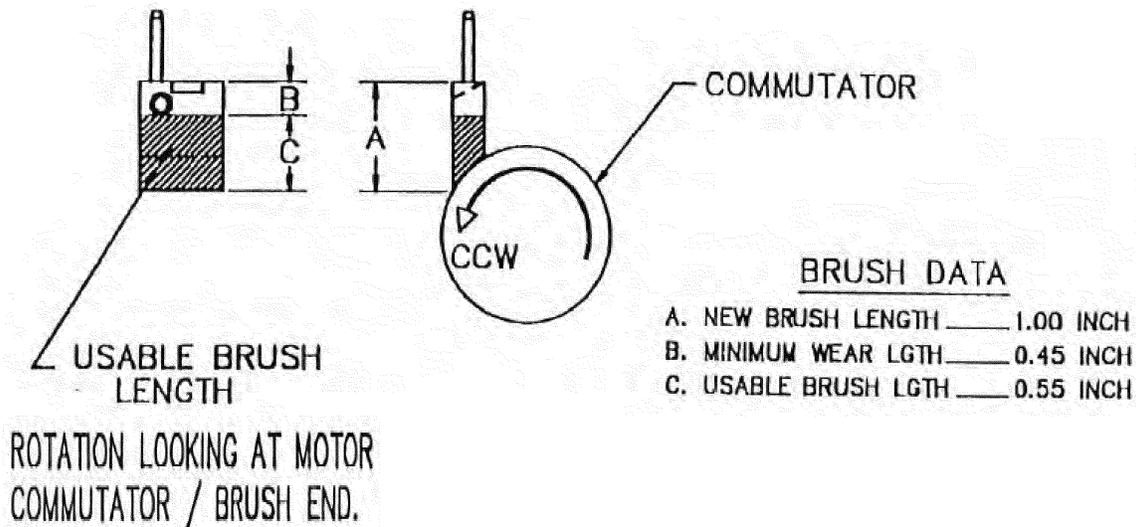
Figure 1 to paragraph (m)(4)(vii) of this AD – Measuring the Brush

This AD was prompted by reports of smoke, a burning odor, and possible fire in the flight deck and cabin of the airplane, which were caused by brushes wearing beyond their limits in the air conditioning motor. We are issuing this AD to detect and correct worn brushes contacting the commutator, which could result in a fire under the cabin floor with no means to detect or extinguish the fire.

- (i) Verify all electrical power is off to the system.
- (ii) Remove all access panels and exhaust ducts to gain access to the drive motor.
- (iii) Disconnect power leads from motor terminals (1/4-28). Tag positive lead.
- (iv) Remove condenser support bracket to provide access to brush cover fasteners and remove motor cuff shroud.
- (v) Loosen and unsnap brush cover assembly. Remove from motor.
- (vi) Lift brush spring and remove brush with wire hook or scribe.
- (vii) Measure each brush as shown in figure below and record values.

(11) Install each new brush set by lifting brush springs, sliding brush into holder (with brush leading edge in direction of motor rotation) and lightly releasing the brush spring on the brush. (See Figure 1 to paragraph (m)(4)(vii) of this AD.) CAUTION: Do not allow brush spring to strike hard into place or damage to brush may result.

(viii) Using the brush with the shortest measured length, calculate the wear by subtracting the measured value from 1.000 inch.

(ix) Replace brushes in accordance with the instructions specified in paragraphs (j)(9) through (j)(23) of this AD.
