[Docket No. FAA-2013-0695; Directorate Identifier 2011-NM-264-AD; Amendment 39-17726; AD 2014-01-03]

#### Airworthiness Directives; Saab AB, Saab Aerosystems Airplanes

**2014-01-03 Saab AB, Saab Aerosystems:**  
Amendment 39-17726; Docket No. FAA-2013-0695; Directorate Identifier 2011-NM-264-AD.

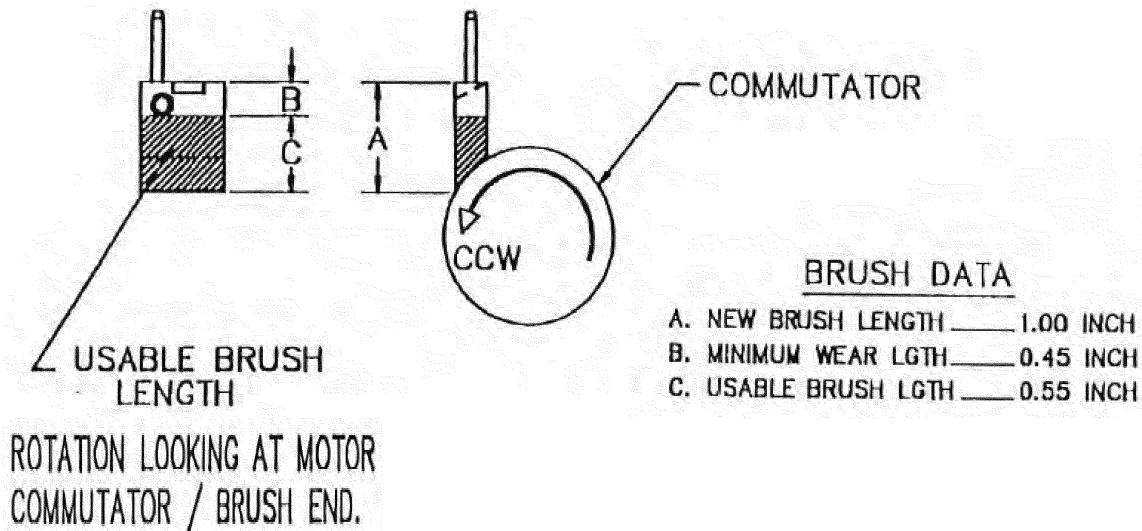
Figure 1 to paragraph (m)(4)(vii) of this AD – Measuring the Brush

- (i) Verify all electrical power is off to the system.
- (ii) Remove all access panels and exhaust ducts to gain access to the drive motor.
- (iii) Disconnect power leads from motor terminals (1/4-28). Tag positive lead.
- (iv) Remove condenser support bracket to provide access to brush cover fasteners and remove motor cuff shroud.
- (v) Loosen and unsnap brush cover assembly. Remove from motor.
- (vi) Lift brush spring and remove brush with wire hook or scribe.
- (vii) Measure each brush as shown in figure below and record values.

(viii) Using the brush with the shortest measured length, calculate the wear by subtracting the measured value from 1.000 inch.

(11) Install each new brush set by lifting brush springs, sliding brush into holder (with brush leading edge in direction of motor rotation) and lightly releasing the brush spring on the brush. (See Figure 1 to paragraph (m)(4)(vii) of this AD.) CAUTION: Do not allow brush spring to strike hard into place or damage to brush may result.
