[Docket No. FAA-2014-0337; Directorate Identifier 2013-SW-029-AD]

Airworthiness Directives; Various Restricted Category Helicopters

ACTION: Notice of proposed rulemaking (NPRM).

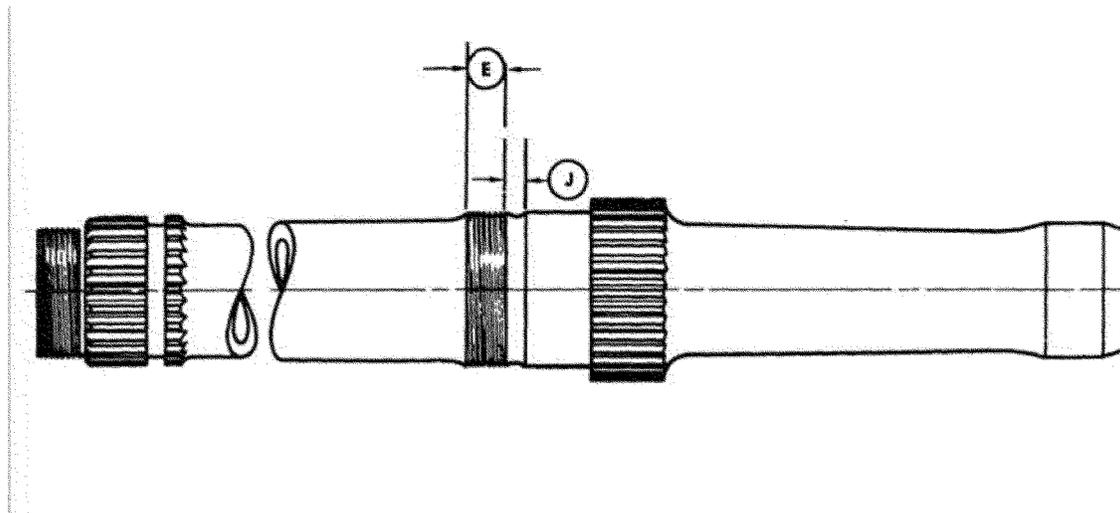
This AD defines the unsafe condition as a crack in the main rotor mast, which could result in failure of the mast and subsequent loss of control of the helicopter.

- (i) Remove any surface rust with a wire brush or steel wool and, using a 10X or higher power magnifying glass, inspect the areas of the mast as shown in area E and area J of Figure 1 to Paragraph (f) of this AD for pitting, corrosion, or a crack.
- (ii) Overhaul the main rotor mast assembly and magnetic particle inspect the mast; mast bearing nut; plate, mast and seal; and bearing liner for a crack.
- (iii) Fluorescent penetrant inspect the locking plate for a crack.

(2) If there is a crack, pitting, or corrosion, before further flight, replace the mast with an airworthy mast.
