**[Docket No. FAA-2014-0337; Directorate Identifier 2013-SW-029-AD]**

**Airworthiness Directives; Various Restricted Category Helicopters**

**ACTION:** Notice of proposed rulemaking (NPRM).

#### Various Restricted Category Helicopters:

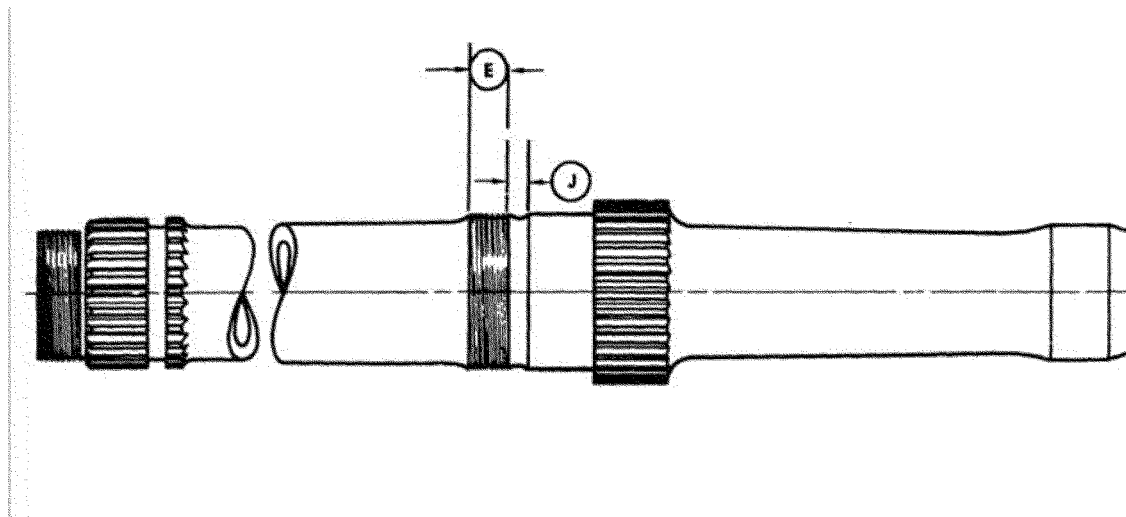
This AD defines the unsafe condition as a crack in the main rotor mast, which could result in failure of the mast and subsequent loss of control of the helicopter.

- (i) Remove any surface rust with a wire brush or steel wool and, using a 10X or higher power magnifying glass, inspect the areas of the mast as shown in area E and area J of Figure 1 to Paragraph (f) of this AD for pitting, corrosion, or a crack.
- (ii) Overhaul the main rotor mast assembly and magnetic particle inspect the mast; mast bearing nut; plate, mast and seal; and bearing liner for a crack.
- (iii) Fluorescent penetrant inspect the locking plate for a crack.

(2) If there is a crack, pitting, or corrosion, before further flight, replace the mast with an airworthy mast.
