[Docket No. FAA-2012-0415; Directorate Identifier 2008-SW-065-AD; Amendment 39-17865; AD 2014-12-04]

**Airworthiness Directives; Bell Helicopter Textron, Inc. (BHTI) Helicopters**

**2014-12-04 Bell Helicopter Textron, Inc. (BHTI):** Amendment 39-17865; Docket No. FAA-2012-0415; Directorate Identifier 2008-SW-065-AD.

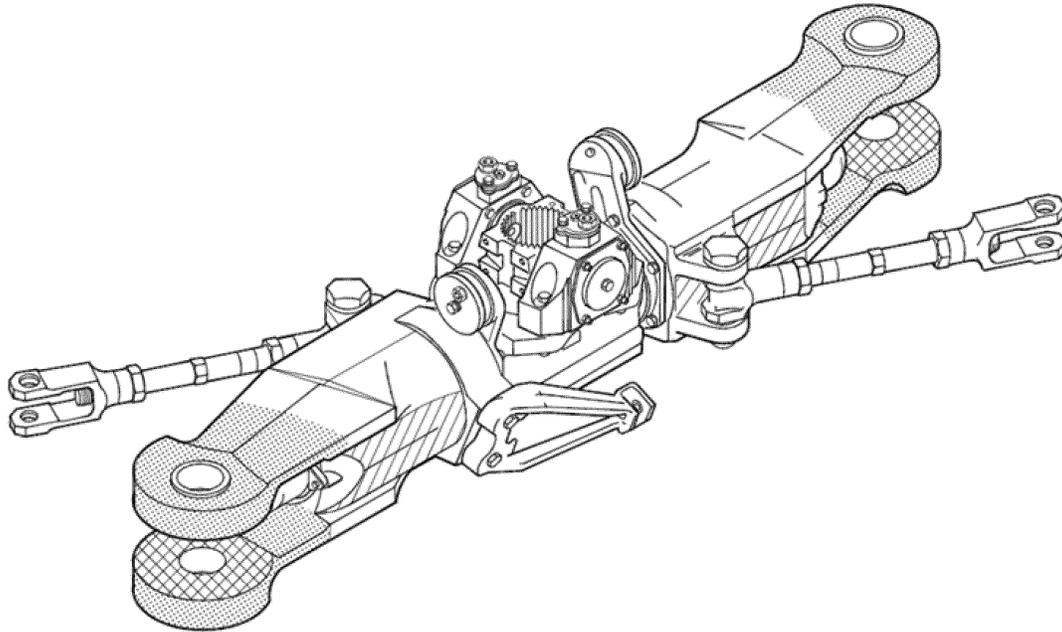
Figure 1 to Paragraphs (f)(2)(ii) and (f)(4)(ii)  
Inspection of Main Rotor Hub Grip Tangs

- (i) Clean the exposed surfaces of the upper and lower tangs of each grip with denatured alcohol, and wipe dry.
- (ii) Using a 10-power or higher magnifying glass, visually inspect the exposed surfaces of the upper and lower tangs of each grip for a crack. Pay particular attention to the lower surface of each lower grip tang from the main rotor blade bolt-bushing flange to the leading and trailing edge of each grip tang as depicted in Figure 1 to Paragraphs (f)(2)(i) and (f)(4)(ii) of this AD.

INSPECT BUFFER PAD FOR DELAMINATION (IF INSTALLED)

AREA TO BE INSPECTED UPPER AND LOWER TANGS ALL EXPOSED SURFACES

(ii) Inspect each grip buffer pad on the inner surfaces of each grip tang for delamination as depicted in Figure 1 to Paragraphs (f)(2)(ii) and (f)(4)(ii) of this AD. If there is any delamination, remove the buffer pad and inspect the grip surface for corrosion or other damage.

(i) Replace any cracked grip with an airworthy grip.

(ii) Replace any grip with any corrosion or other damage with an airworthy grip, or repair the grip if the corrosion or other damage is within maximum repair damage limitations.
