[Docket No. FAA-2013-0574; Directorate Identifier 2008-SW-22-AD; Amendment 39-17766; AD 2014-04-07]

**Airworthiness Directives; Bell Helicopter Textron Canada (Bell) Helicopters**

**2014–04–07 Bell Helicopter Textron Canada:** Amendment 39–17766; Docket No. FAA–2013–0574; Directorate Identifier 2008–SW–22–AD.

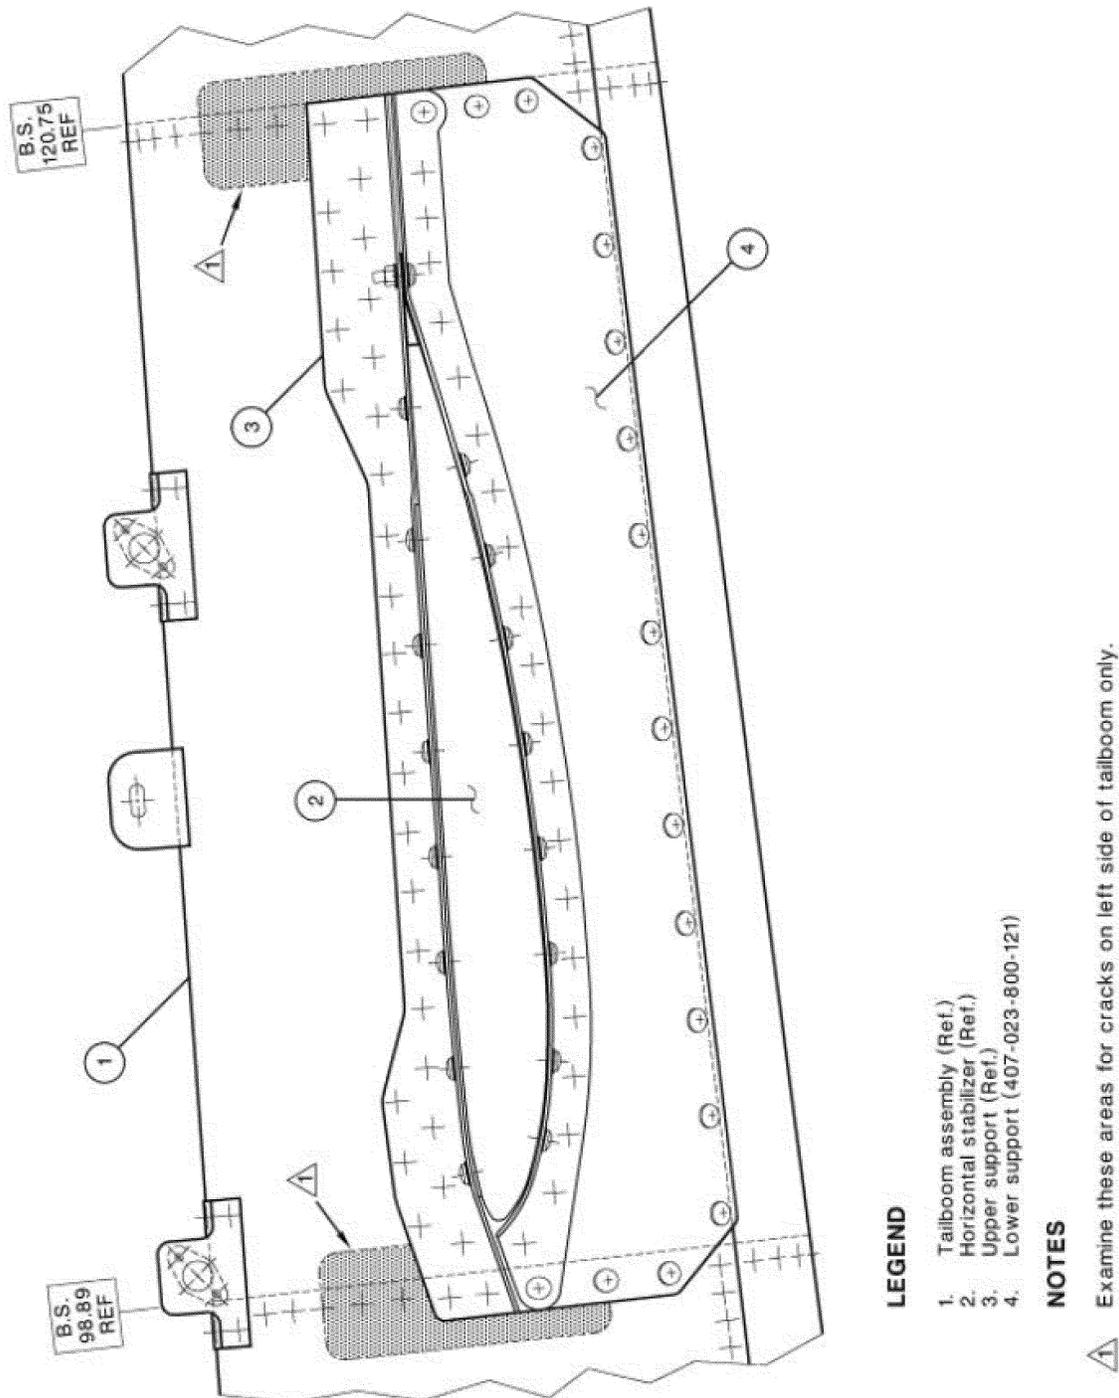
This AD defines the unsafe condition as cracks in the tailboom skin on the left side in the area of horizontal stabilizer, which could result in separation of the tailboom and subsequent loss of control of the helicopter.

(A) Before the first flight of each day, visually check the tailboom for a crack, as depicted in Figure 1 to Paragraph (f)(1)(i)(A) of this AD.

(3) If there is a crack, before further flight, replace the tailboom.
