**[Docket No. FAA-2014-0034; Directorate Identifier 2013-SW-006-AD; Amendment 39-17948; AD 2014-16-24]**

**Airworthiness Directives; Airbus Helicopters Deutschland GmbH (Previously Eurocopter Deutschland GbmH) (Airbus Helicopters) Helicopters**

**ACTION:** Final rule.

**2014–16–24 Airbus Helicopters**

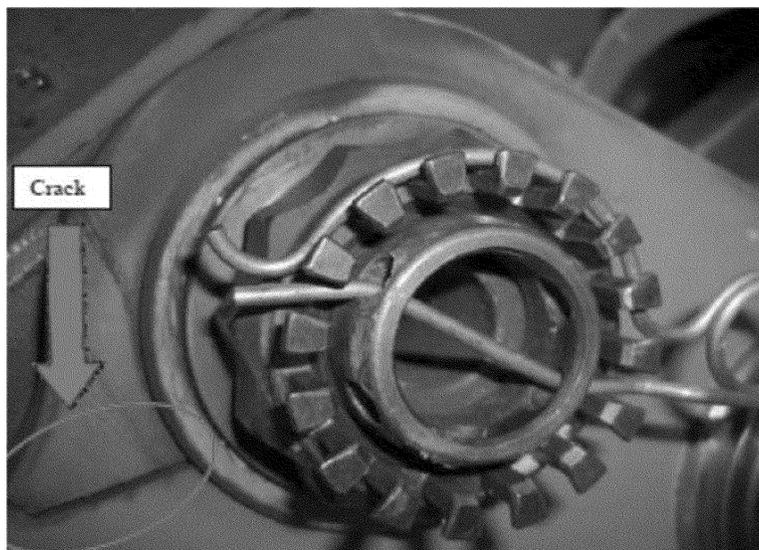
Figure 1 to Paragraph (f)(1)

This AD defines the unsafe condition as a crack in the MRH shaft flange, which could result in failure of the MRH and subsequent loss of control of the helicopter.

(1) Before further flight, and thereafter at intervals not to exceed 6 hours time-in-service (TIS), check the MRH shaft lower flange and the visible area of the MRH shaft upper flange for a crack. Figures 1 and 2 to Paragraph (f)(1) of this AD are examples of cracks that have been discovered in the MRH shaft lower flange. The actions required by this paragraph may be performed by the owner/operator (pilot) holding at least a private pilot certificate, and must be entered into the aircraft records showing compliance with this AD in accordance with 14 CFR 43.9 (a)(1) through (4) and 14 CFR 91.417(a)(2)(v). The record must be maintained as required by 14 CFR 91.417, 121.380, or 135.439.

(3) If there is a crack in the upper or lower MRH shaft flange, before further flight, replace that MRH shaft with an airworthy MRH shaft. Replacing the MRH shaft with an MRH shaft having a P/N listed in paragraph
