Airworthiness Directives; Various Restricted Category Helicopters

2014–22–03 Various Restricted Category

Helicopters: Amendment 39–18008; Docket No. FAA–2014–0337; Directorate Identifier 2014–SW–029–AD.

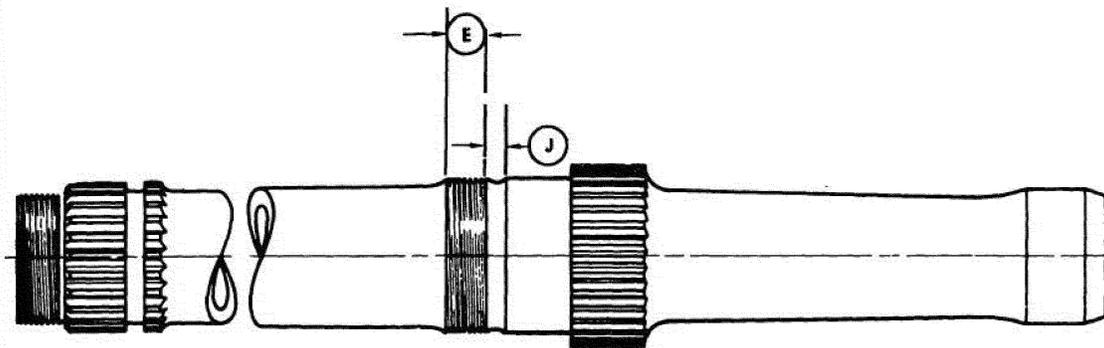
This AD defines the unsafe condition as a crack in the main rotor mast, which could result in failure of the mast and subsequent loss of control of the helicopter.

(i) Remove any surface rust with a wire brush or steel wool and, using a 10X or higher power magnifying glass, inspect the areas of the mast as shown in area E and area J of Figure 1 to Paragraph (f) of this AD for pitting, corrosion, or a crack.

(2) If there is a crack, pitting, or corrosion, before further flight, replace the mast with an airworthy mast.
