[Docket No. FAA-2014-1083; Directorate Identifier 2014-CE-036-AD]

#### Airworthiness Directives; Various Aircraft Equipped With Wing Lift Struts

**ACTION:** Notice of proposed rulemaking (NPRM).

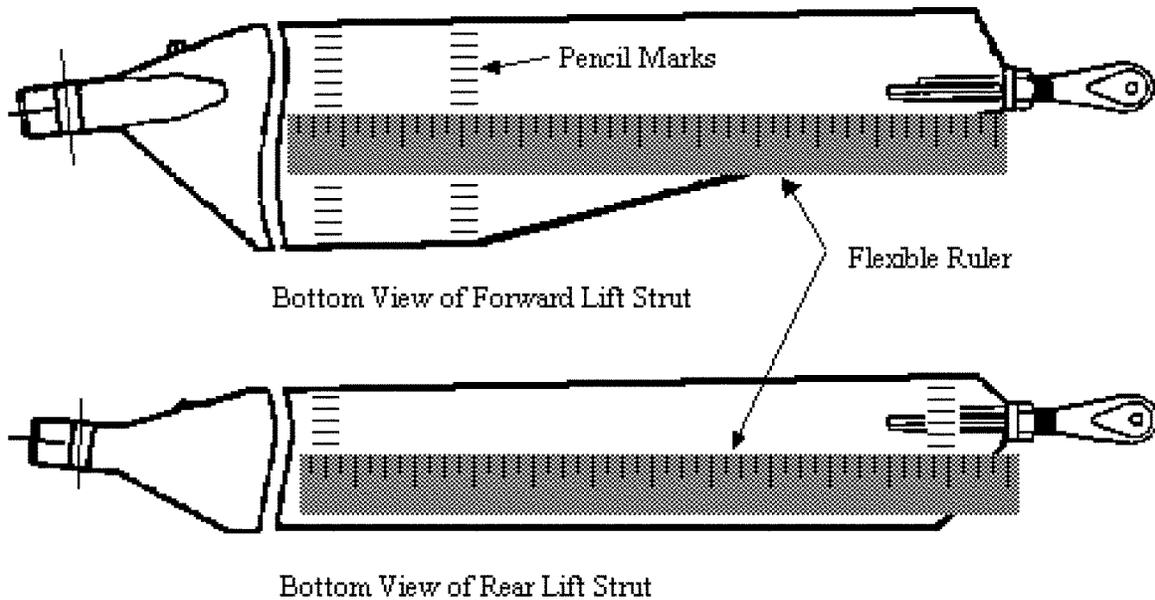
Figure 1

8. A measurement of 0.024-inch or less shall require replacement of the strut prior to further flight.
