DEPARTMENT OF TRANSPORTATION

Federal Aviation Administration

[Docket No. FAA-2014-1083; Directorate Identifier 2014-CE-036-AD; Amendment 39-18140; AD 2015-08-04]

Airworthiness Directives; Various Aircraft Equipped With Wing Lift Struts

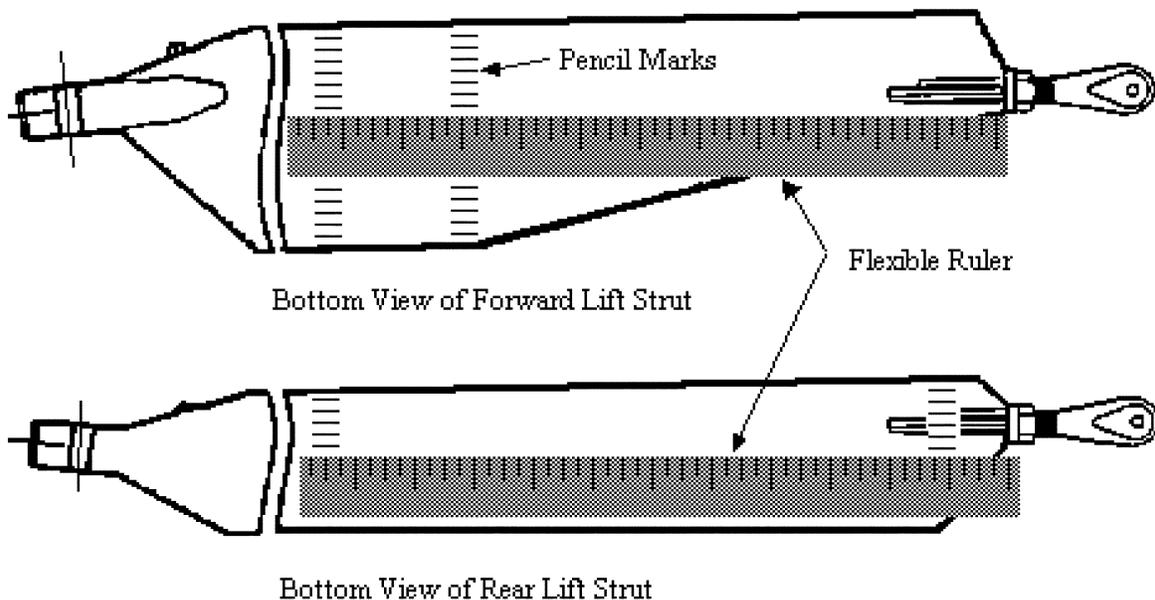
Figure 1

8. A measurement of 0.024-inch or less shall require replacement of the strut prior to further flight.
