DEPARTMENT OF TRANSPORTATION**National Highway Traffic Safety Administration****Denial of Motor Vehicle Defect Petition**

ACTION: Denial of a petition for a defect investigation.

SUMMARY: This notice sets forth the reasons for denying a petition (DP14–003) submitted to NHTSA 49 U.S.C. 30162, 49 CFR part 552, requesting that the agency open “an investigation into low-speed surging in the 2006–2010 Toyota Corolla [vehicles] with ETCS-i, in which the brakes fail to stop the vehicle in time to prevent a crash.”

Appendix—Petition Analysis—DP14–003**1.0 Introduction**

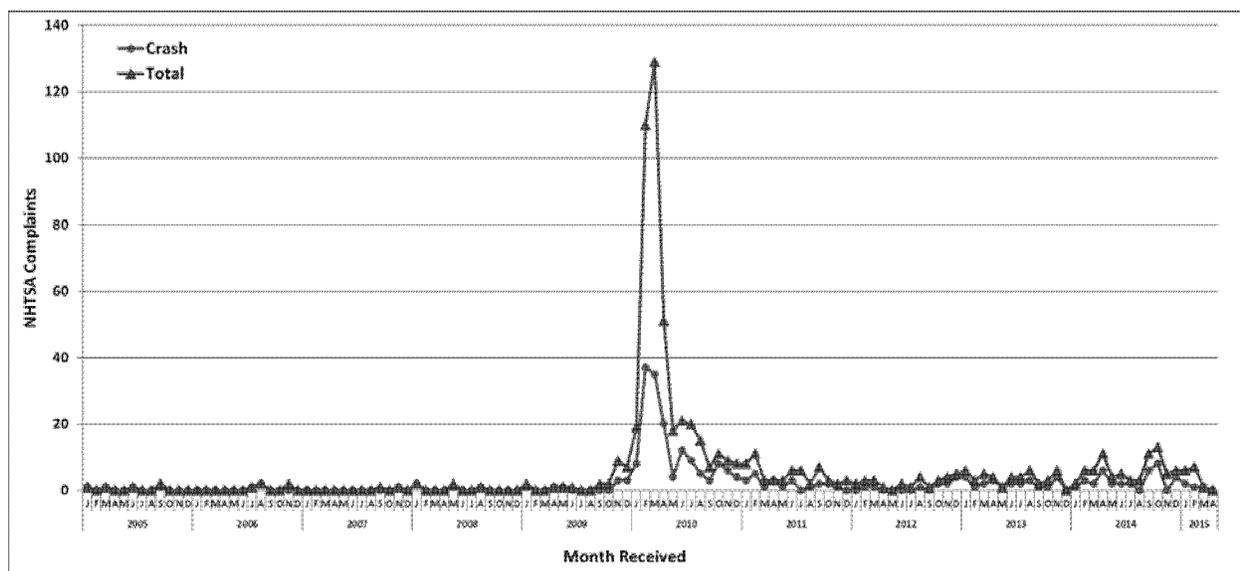
Figure 2. MY 2005-2015 Toyota Corolla Speed Control Complaints by Month Reported.

Complaints to ODI alleging SA related crashes are far less common. In the same period from 2004 through 2008 that the pedal error study identified over 2,400 pedal error related crashes in North Carolina police reports, ODI received less than 40 complaints alleging SA crashes in North Carolina in all light vehicles—or less than 2 percent of the number of crash incidents identified in the pedal error study. However, publicity can significantly increase ODI complaint volumes, as is evident for Toyota Corolla vehicles equipped with

ETCS-i, which saw a 7,900% increase in speed control complaints alleging crashes and a 12,800% increase in total speed control complaints from the first quarter of 2009 to the first quarter of 2010, after news media coverage of Toyota's pedal entrapment and sticky pedal recalls (Figure 2). Each of these factors, as well as the incident characteristics used for identifying complaints likely to be related to a common cause (see Section 2.1, *Definitions*), must be considered before conducting any analysis of, or drawing
