Airworthiness Directives; Agusta S.p.A. (Agusta) Helicopters

2015–11–08 Agusta S.p.A. Helicopters (Agusta): Docket No. FAA–2015–1937; Amendment 39–18171, Directorate Identifier 2014–SW–067–AD.

This AD defines the unsafe condition as a missing or broken lock wire securing the tail rotor (T/R) duplex bearing locking nut (locking nut). This condition could result in loosening of the locking nut, failure of the T/R, and subsequent loss of control of the helicopter.

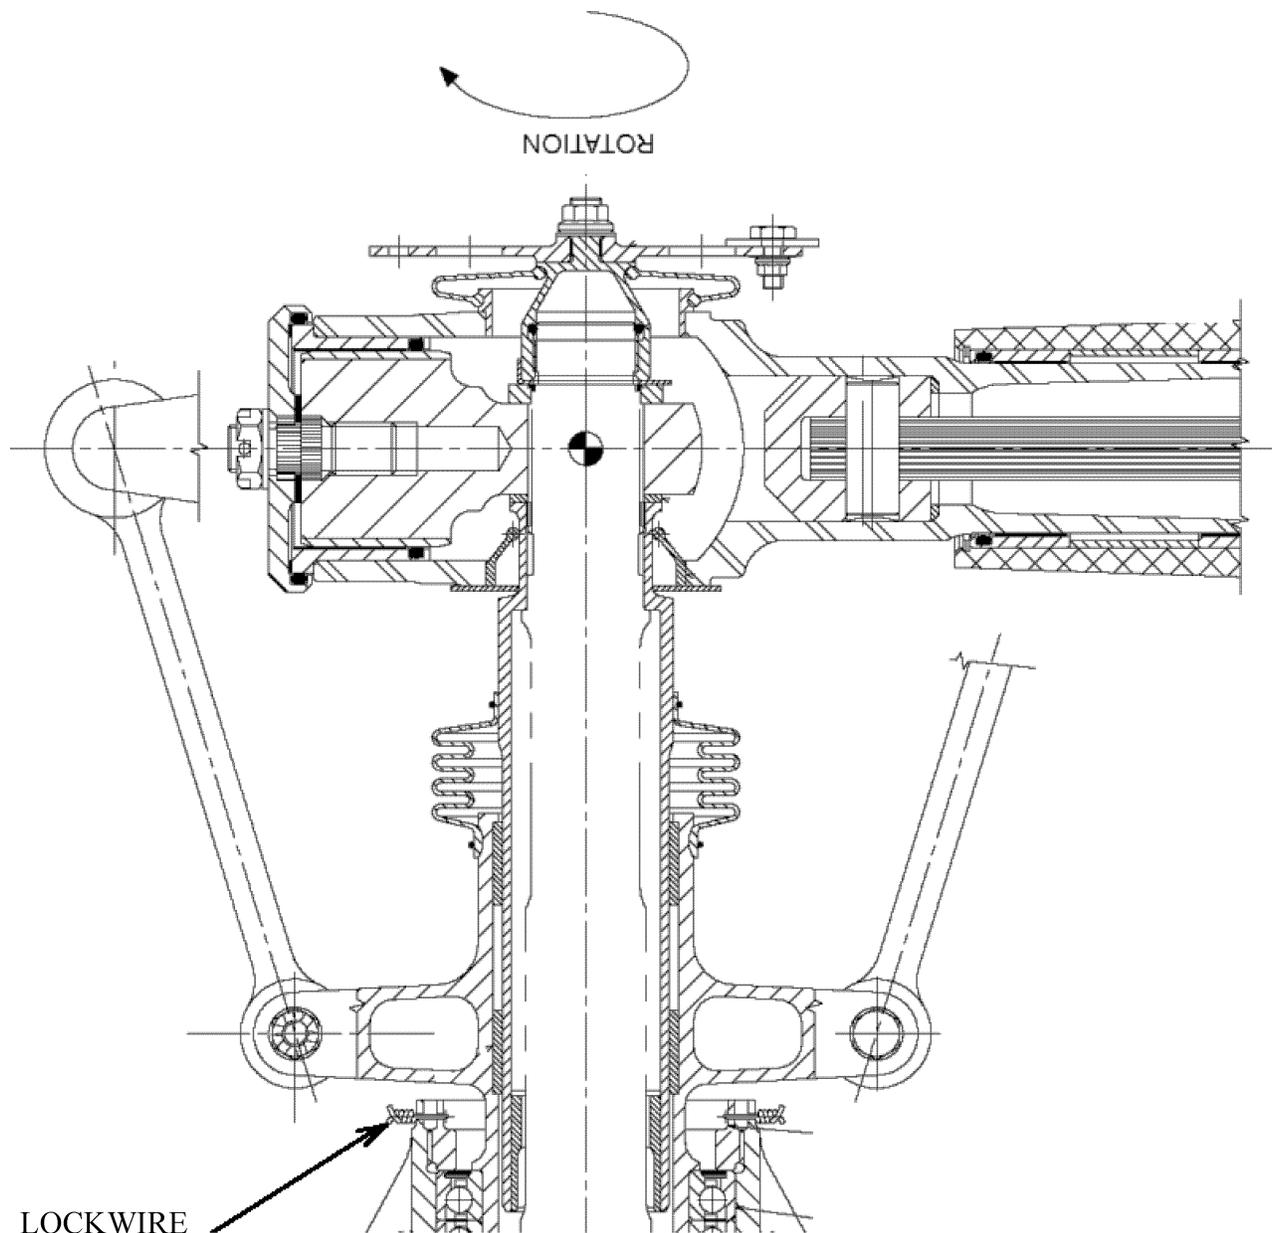
Figure 1 of paragraph (f)(1)

(1) Within 24 hours and thereafter before the first flight of each day or at intervals not exceeding 24 hours, whichever occurs later, check each lock wire securing the T/R locking nut to the housing. The location of the housing wire is depicted in Figure 1 to paragraph (f)(1) of this AD.

(4) If one or both lock wires are missing or damaged, before further flight, remove and reassemble the housing and slider group of the T/R rotating controls.
