[Docket No. FAA-2015-3989; Directorate Identifier 2014-NM-250-AD]

Airworthiness Directives; Airbus Airplanes

ACTION: Notice of proposed rulemaking (NPRM).

SUMMARY: We propose to adopt a new airworthiness directive (AD) for all Airbus Model A318; A319; A320; and A321 series airplanes. This proposed AD was prompted by reports of premature aging of certain passenger chemical oxygen generators that resulted in the generators failing to activate. This proposed AD would require an inspection to determine if certain passenger chemical oxygen generators are installed and replacement of affected passenger chemical oxygen generators. We are proposing this AD to prevent failure of the passenger chemical oxygen generator to activate and consequently not deliver oxygen during an emergency, possibly resulting in injury to the airplane occupants.

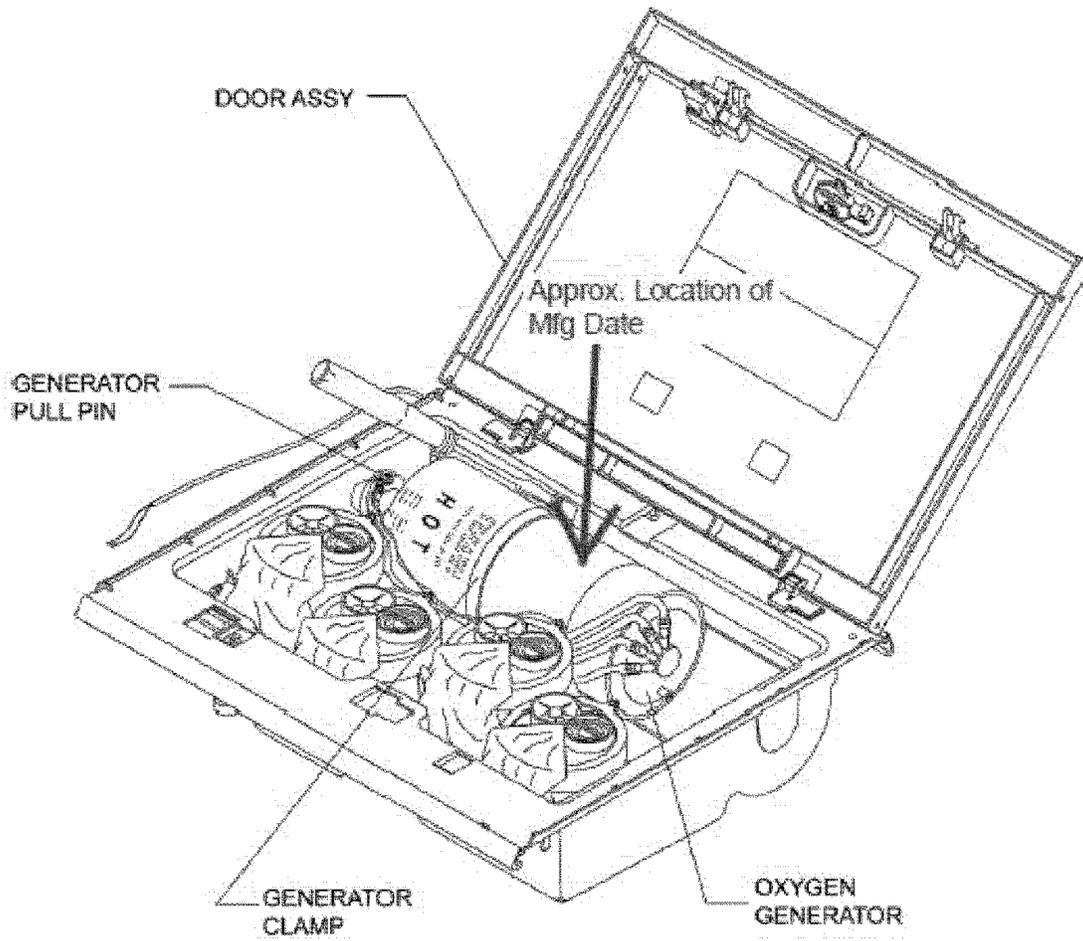
Within 30 days after the effective date of this AD, do a one-time inspection of passenger chemical oxygen generators, part numbers (P/N) 117042-02 (15 minutes (min)-2 masks), 117042-03 (15 min-3 masks), 117042-04 (15 min-4 masks), 117042-22 (22 min-2 masks), 117042-23 (22 min-3 masks), and 117042-24 (22 min-4 masks) to determine the date of manufacture as specified in Airbus Alert Operators Transmission (AOT) A35N006-14, dated December 10, 2014, including Appendix 01. Refer to figure 1 and figure 2 to paragraph (g) of this AD for the location of the date. A review of airplane maintenance records is acceptable for the inspection required by paragraph (g) of this AD, provided the date of manufacture can be conclusively determined by that review.

Figure 1 to paragraph (g) of this AD - location of date (MM-YY)

If, during any inspection required by paragraph (g) of this AD, any passenger chemical oxygen generator having a date of manufacture in 1999, 2000, or 2001 is found: At the applicable time specified in paragraph (h)(1), (h)(2), or (h)(3) of this AD, remove and replace the affected passenger chemical oxygen generator with a serviceable unit, in accordance with the Accomplishment Instructions of B/E Aerospace Service Bulletin 117042-35-001, dated December 10, 2014 (for 15 minute passenger chemical oxygen generators); and Airbus AOT A35N006-14, dated December 10, 2014, including Appendix 01 (for 22 minute passenger chemical oxygen generators).

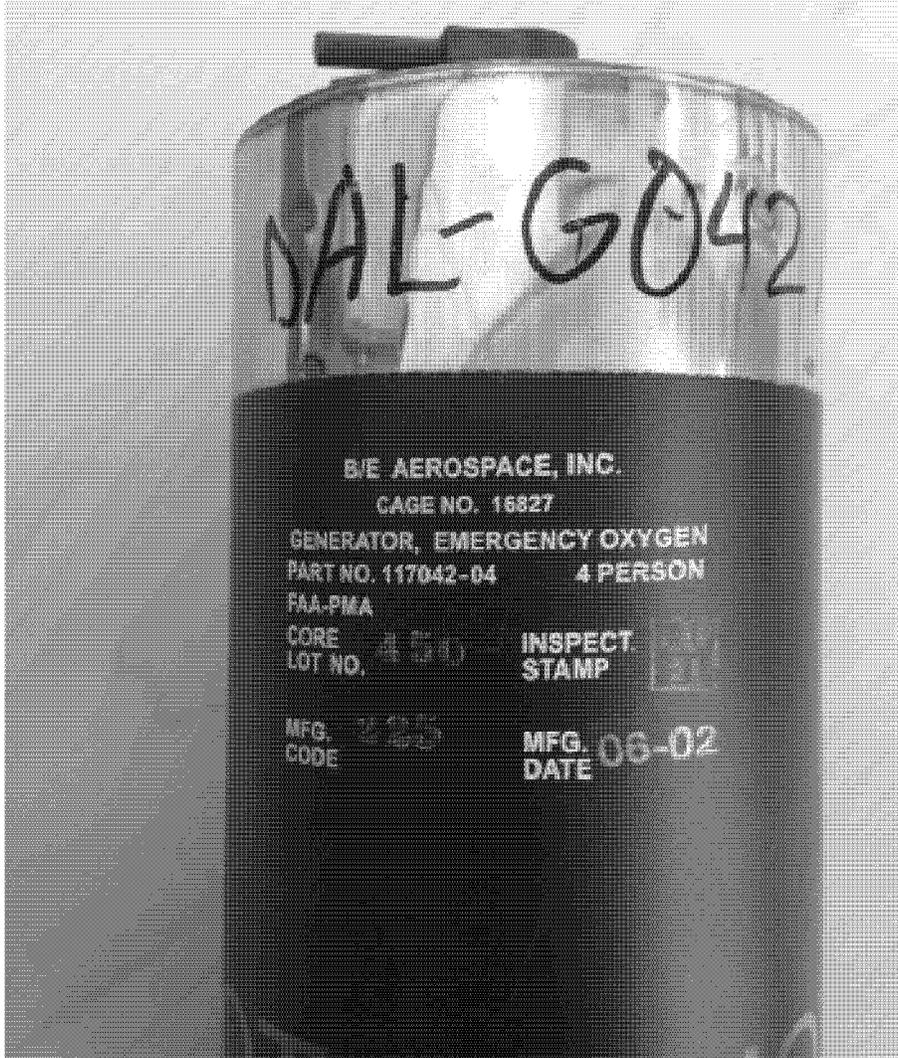
Figure 2 to paragraph (g) of this AD - MFG.DATE (06-02 = June 2002) example
