[Docket No. FAA–2015–8463; Directorate Identifier 2014–NM–226–AD]

#### Airworthiness Directives; Airbus Airplanes

**ACTION:** Notice of proposed rulemaking (NPRM).

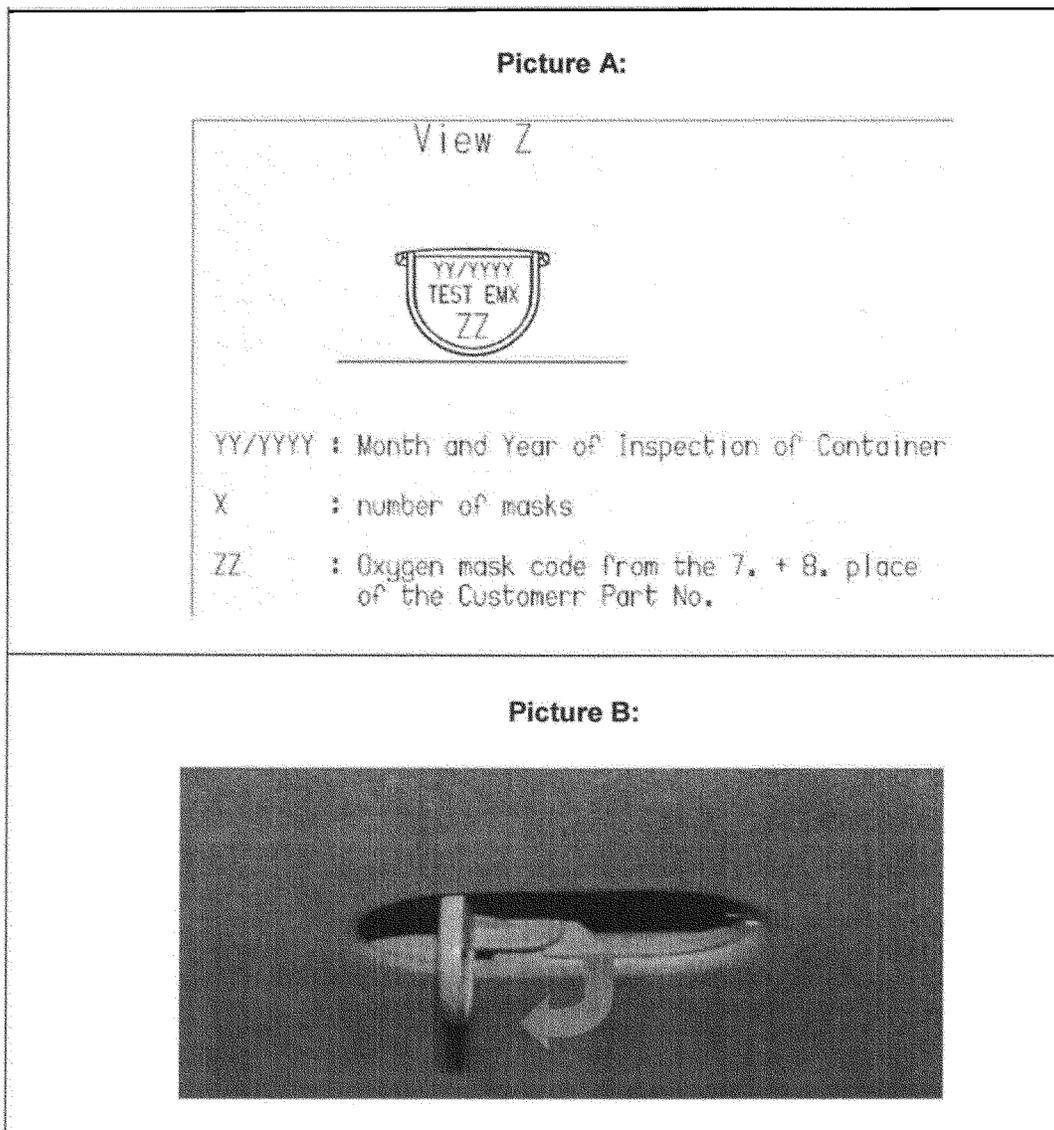
### Figure 1 to Paragraph (l)(4) of this AD – Design A of the Passenger Oxygen Containers

**Note 2 to paragraph (l)(4) of this AD:** For "Design A," the placard on the passenger oxygen container test button is as described in "Picture A" in figure 1 to paragraph (l)(4) of this AD. The mask configuration ("ZZ" in "Picture A") is a number, and the test button is as shown in "Picture B."
