**[Docket No. FAA-2015-8463; Directorate Identifier 2014-NM-226-AD; Amendment 39-18612; AD 2016-16-14]**

**Airworthiness Directives; Airbus Airplanes**

**2016–16–14 Airbus:** Amendment 39–18612; Docket No. FAA–2015–8463; Directorate Identifier 2014–NM–226–AD.

**(g) Retained Oxygen Container Assembly Modification, With Service Information Referenced in a New Paragraph**

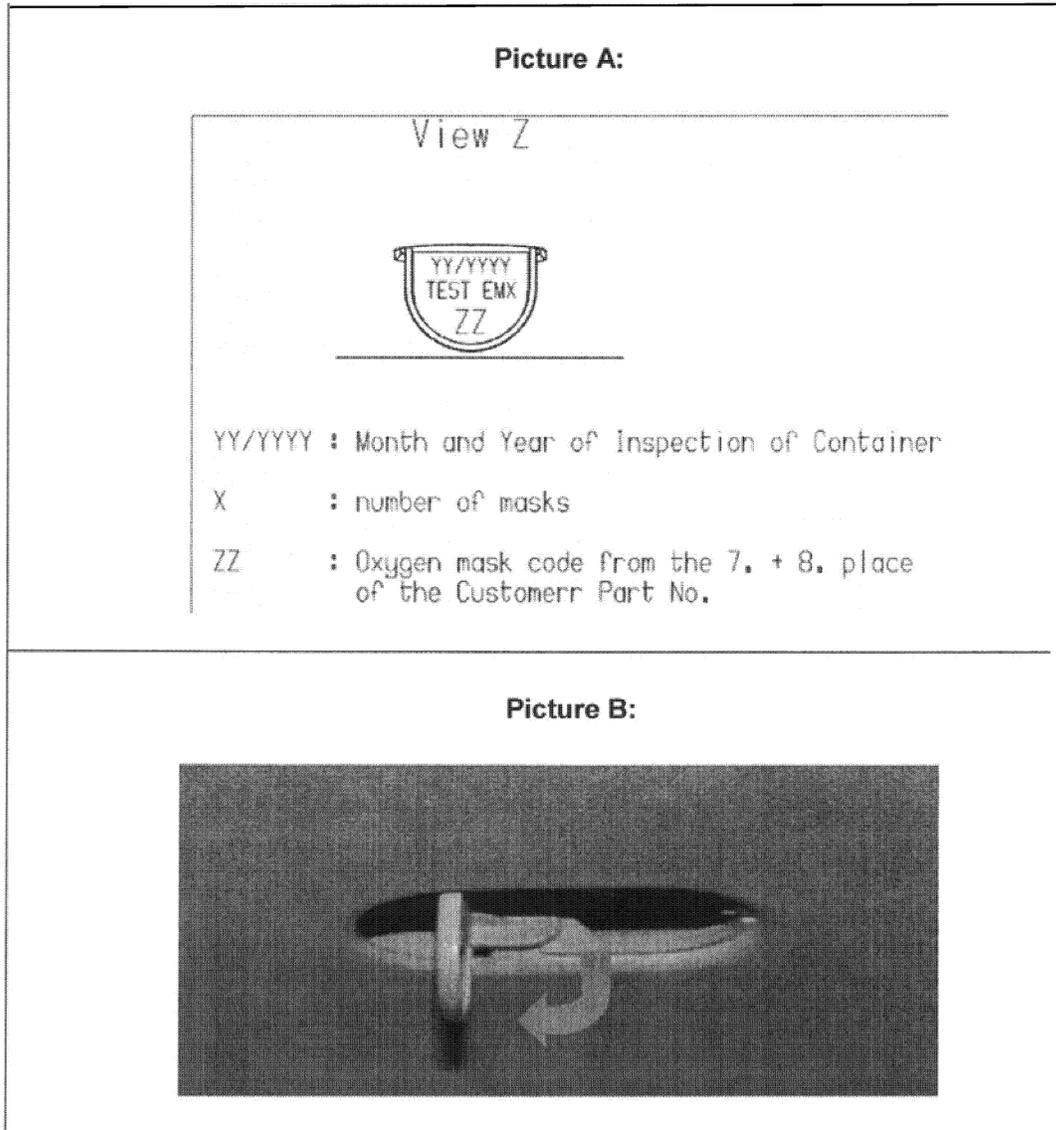
**Figure 1 to Paragraph (l)(4) of this AD – Design A of the Passenger Oxygen Containers**

(4) Airplanes on which the design of the passenger oxygen container is not Design A, as defined in figure 1 to paragraph (l)(4) of this AD, are excluded from the requirements of paragraph (i) of this AD for that passenger oxygen container.

**Note 2 to paragraph (l)(4) of this AD:** For "Design A," the placard on the passenger oxygen container test button is as described in "Picture A" in figure 1 to paragraph (l)(4) of this AD. The mask configuration ("ZZ" in "Picture A") is a number, and the test button is as shown in "Picture B."
