Federal Register

Friday, October 21, 2016

[Docket No. FAA-2016-9254; Directorate Identifier 2015-CE-030-AD]

#### Airworthiness Directives; Piper Aircraft, Inc. Airplanes

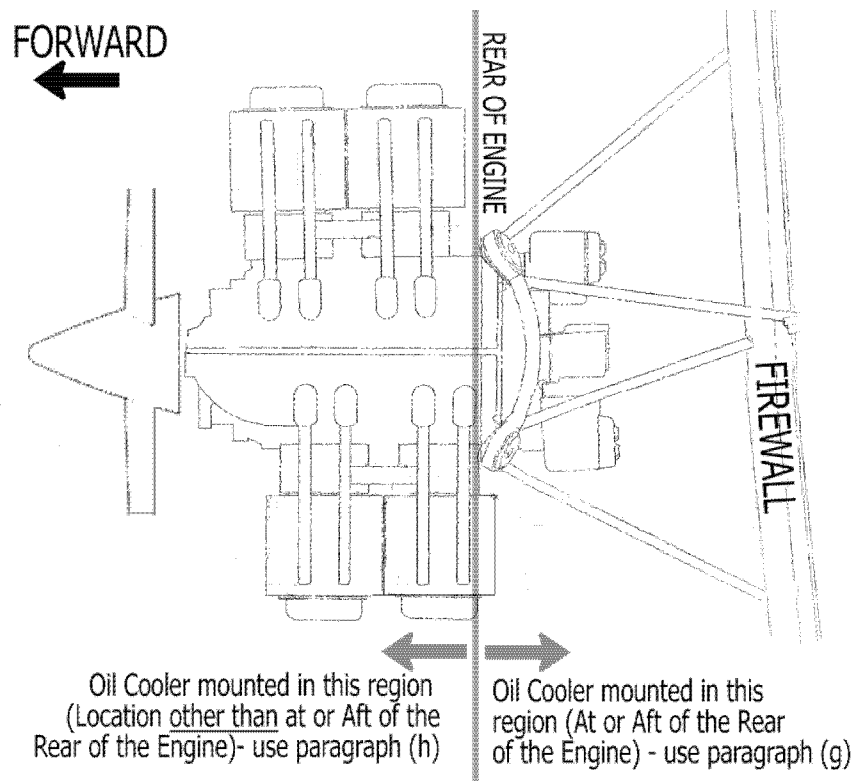
Figure 1 to paragraphs (g) and (h) of this AD: Oil cooler

*For applicable airplanes with the oil cooler mounted at or aft of the rear of the engine (See figure 1 to paragraphs (g) and (h)):* Within the next 100 hours time-in-service (TIS) after February 5, 1996 (the effective date retained from AD 95-26-13), and repetitively thereafter at intervals not to exceed 100 hours TIS, inspect the oil cooler hose assembly for oil soaked in the fire sleeve of the oil hose assembly, a brownish or whitish color of the fire sleeve of the oil hose assembly, and any evidence of brittleness or deterioration of the fire sleeve of the oil hose assembly as a result of heat or oil seepage.

(1) *For applicable airplanes with the oil cooler mounted in a location other than at or aft of the rear of the engine (See figure 1 to paragraphs (g) and (h)):* Within the next 100 hours TIS after February 5, 1996 (the effective date retained from AD 95-26-13), and repetitively thereafter at intervals not to exceed 100 hours TIS, inspect the oil cooler hose assembly for oil soaked in the fire sleeve of the oil hose assembly, a brownish or whitish color of the fire sleeve of the oil hose

assembly, and any evidence of brittleness or deterioration of the fire sleeve of the oil hose assembly as a result of heat or oil seepage.

(1) If any of the conditions described in paragraph (g) of this AD are found on the oil cooler hose assembly during the inspection required in paragraph (g) of this AD, before further flight, replace the oil cooler hose assembly with TSO-C53a Type D oil cooler hose assembly or TSO-C53a Type C oil cooler hose assembly that has been inspected following paragraph (g) of this AD and found to be airworthy.

(2) Replacement of the oil cooler hose assembly with TSO-C53a Type D oil cooler hose assembly is terminating action for this AD.

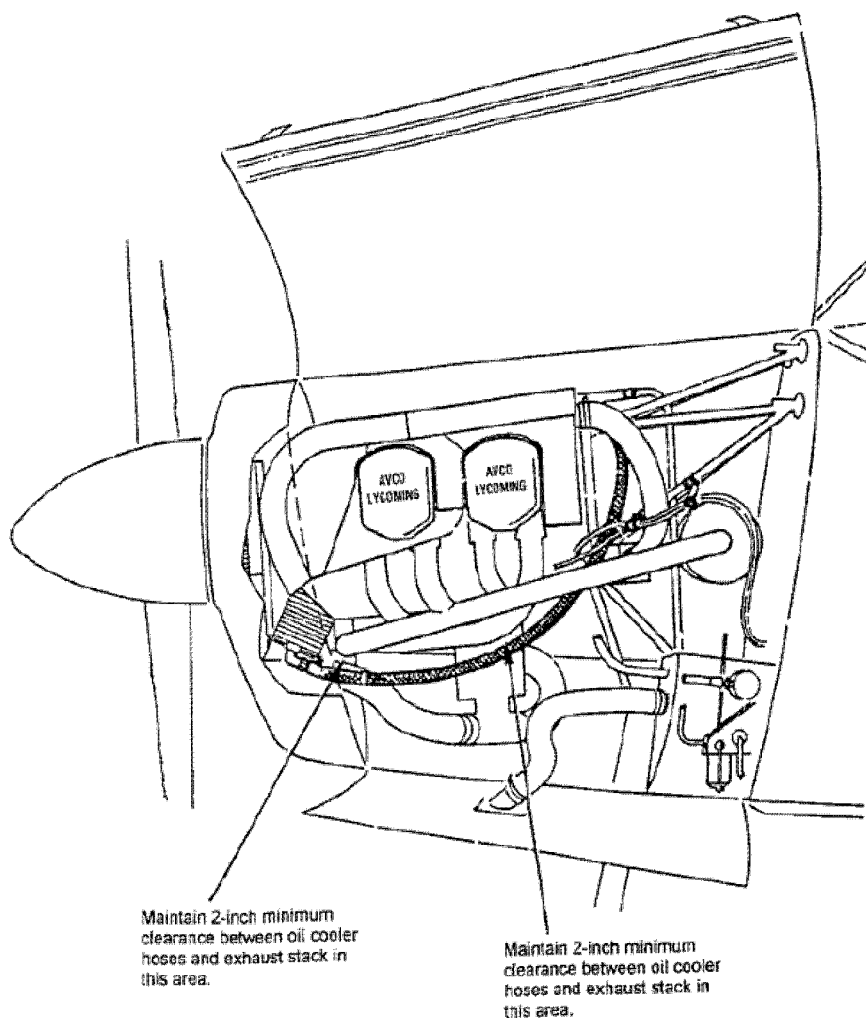
Figure 2 to paragraph (h) of this AD: Acceptable clearances

(3) Within the next 100 hours TIS after February 5, 1996 (the effective date retained from AD 95-26-13) and each time the oil cooler hose assembly is replaced for any reason or inspected following paragraph (h)(1) of this AD, inspect to ensure the installation conditions in paragraphs (h)(3)(i) through (iii) of this AD are met. If the conditions listed in paragraphs (h)(3)(i) through (iii) of this AD are not met, before further flight, make any necessary adjustments. Please see figure 2 to paragraph (h) of this AD for additional information.

(i) The oil cooler hose assemblies pass underneath and behind the electrical ground cable and in front of the lower of the two engine mount.

(ii) The oil cooler hose assemblies are secured to the engine mount strut and a clearance of at least 2 inches exists between the oil cooler hose assemblies and the exhaust stack.

(iii) Oil cooler hose assemblies with a minimum outer diameter of 0.75 inch are installed with a bend radius of at least 6.5 inches.

(3) Replacement of the oil cooler hose assembly with TSO-C53a Type D oil cooler hose assembly and meeting the installation conditions listed in paragraphs (h)(3)(i) through (iii) of this AD terminate the requirements of this AD.
