[Docket No. FAA-2015-7527; Directorate Identifier 2015-NM-094-AD; Amendment 39-18686; AD 2016-21-05]

**Airworthiness Directives; The Boeing Company Airplanes**

**2016–21–05 The Boeing Company:**  
Amendment 39–18686; Docket No. FAA–2015–7527; Directorate Identifier 2015–NM–094–AD.

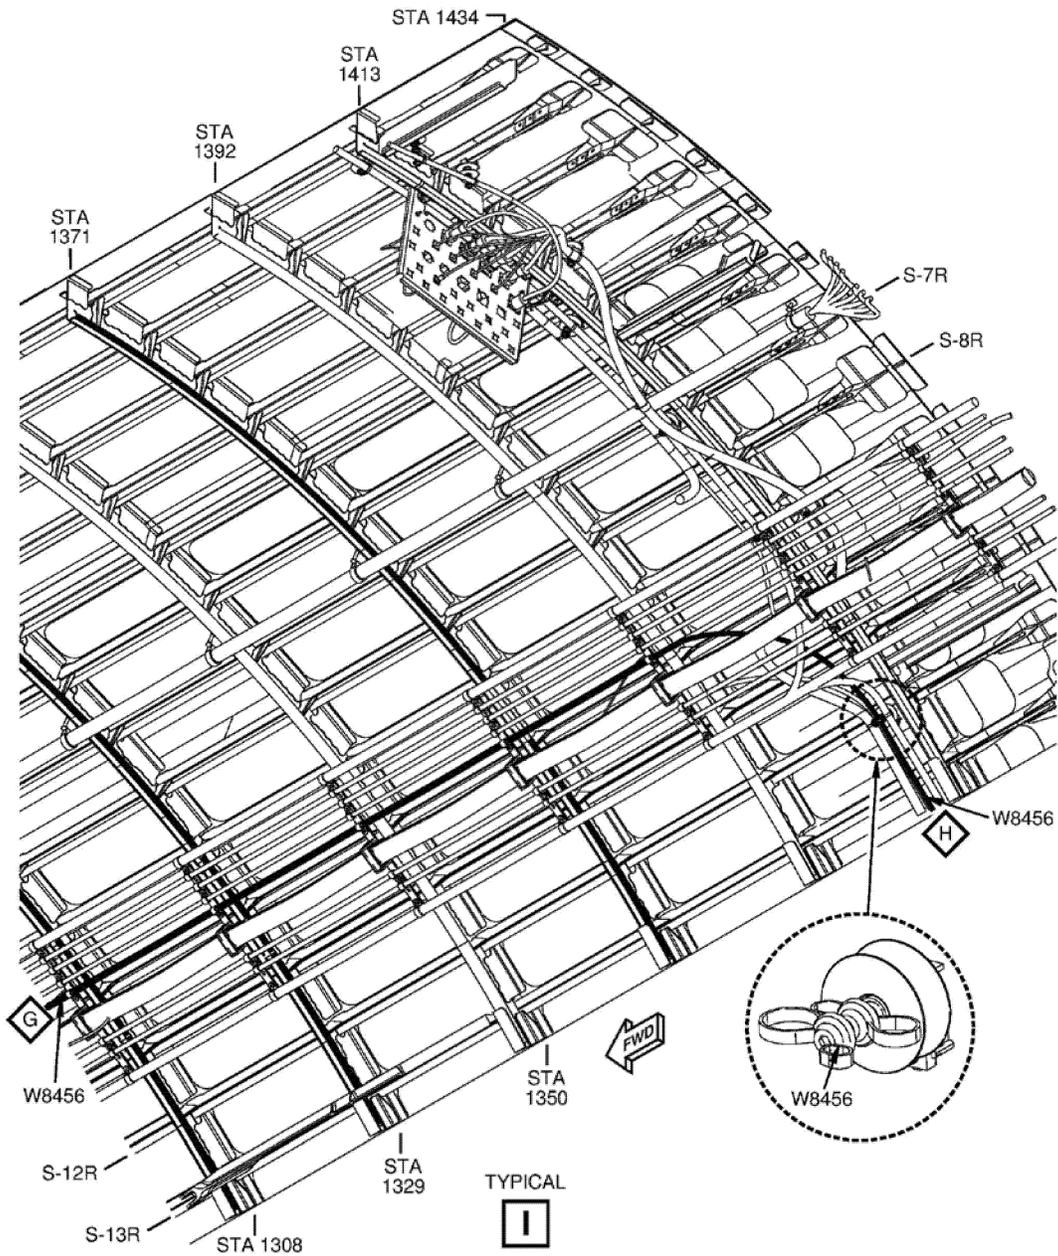
**Figure 1 to paragraph (h) of this AD: Wiring Installation - Right Engine Fuel Spar Valve**

appropriate source of service information in this AD because it is not an FAA-approved document. However, we acknowledge that for certain airplanes, Figure 22, Sheet 9, of Boeing Special Attention Service Bulletin 777-28-0061, Revision 2, dated May 4, 2015, includes an editorial error, which shows incorrect wire routing. Boeing Service Bulletin Information Notice 777-28-0061, IN 03, dated November 16, 2015, allows for a modification of Group 2 airplanes that meets the requirements of the AD without an additional burden to operators. We have included a corrected figure in paragraph (h) of this AD to address this issue.

(1) Where Boeing Special Attention Service Bulletin 777–28–0061, Revision 2, dated May 4, 2015, specifies to use Figure 22, Sheet 9, for the wiring installation of the right engine fuel spar valve, this AD requires using figure 1 to paragraph (h) of this AD.
