**[Docket No. FAA-2016-4228; Directorate Identifier 2015-NM-107-AD; Amendment 39-18734; AD 2016-25-08]**

#### Airworthiness Directives; Airbus Airplanes

**2016–25–08 Airbus:** Amendment 39–18734; Docket No. FAA–2016–4228; Directorate Identifier 2015–NM–107–AD.

Air Transport Association (ATA) of America Code 35, Oxygen.

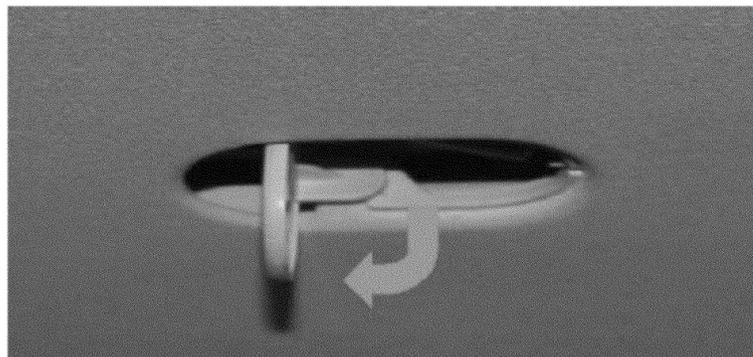
Figure 1 to Paragraph (i)(7) of this AD – Design A of the Passenger Oxygen Containers Affected by this AD

(7) The requirements of paragraphs (g) and (h) of this AD apply only to passenger oxygen containers that are Design A, as defined in figure 1 to paragraph (i)(7) of this AD.

**Design A:** The placard on the passenger oxygen container test button is as described in Picture A of Appendix 1 of this AD. The Mask configuration ("ZZ" in Picture A) is a number and the test button is as shown in Picture B.

**Picture B:**

**Note 2 to figure 1 to paragraph (i)(7) of this AD:** For "Design A," the placard on the passenger oxygen container test button is as described in "Picture A" in figure 1 to paragraph (i)(7) of this AD. The mask configuration ("ZZ" in "Picture A") is a number, and the test button is as shown in "Picture B."
